# **Ethics in Design and Oversight: Florida International University Bridge Collapse**

**The Florida International University Bridge Collapse - An Issue of Oversight?**

All direct quotes are from the National Transportation Safety Association Report, “Pedestrian Bridge Collapse over SW 8<sup>th</sup> Street, Miami, Florida March 15, 2018”

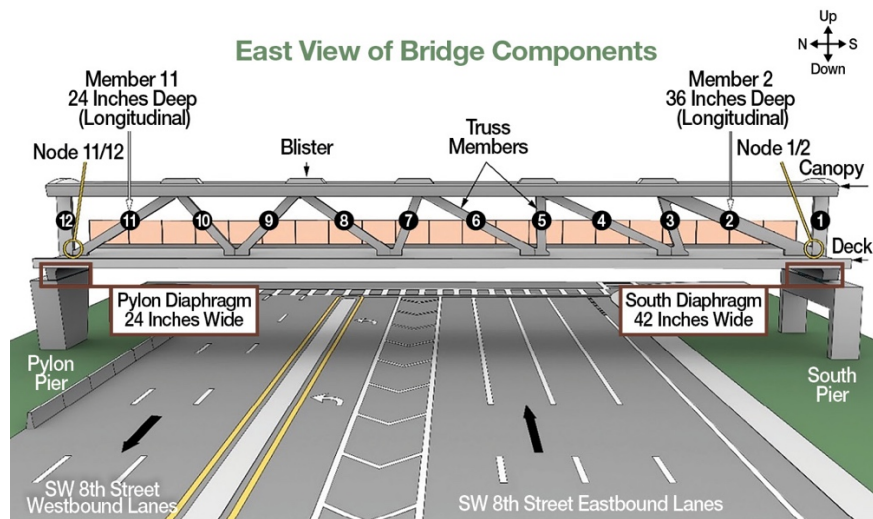
The failure of the bridge was determined by The National Transportation Safety Board (NTSB) to be caused by shear force overwhelming the truss 11/12 node after the main section of the bridge was set in place above SW 8 Street.

**Figure 3** – Depiction of main span of bridge in place over SW 8<sup>th</sup> Street. Node 11/12, which failed due to horizontal shearing when the main span was in this position, is at the left at the deck level.

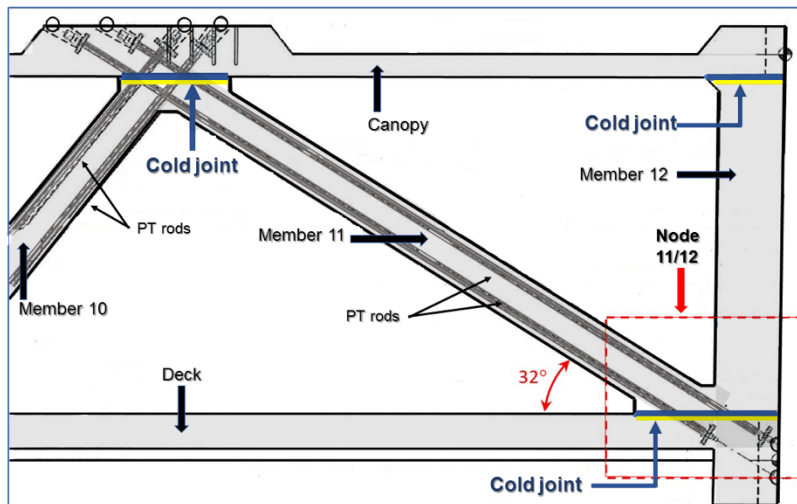
**Figure 4** – Diagram of node 11/12 showing the cold joint at the interface and the post tensioning (PT) rods crossing the interface. Reinforcing steel bars (rebar) also crossed the interface.

These design errors would lead FIGG to under-design the combination of the size of the concrete trusses and steel rebar housed within them that crossed the connection interfaces and provided resistance to shear forces, which were maximum in the intermediate construction phase when the main span was in place over the road but the back span connecting to it was not yet in place. Given the angle of 32 Degrees between the deck and truss member 11, post tensioning of that member would not increase resistance to the shear force at this interface. In fact, it would rather increase the shear force by a factor of 1.6 over the compressive force.

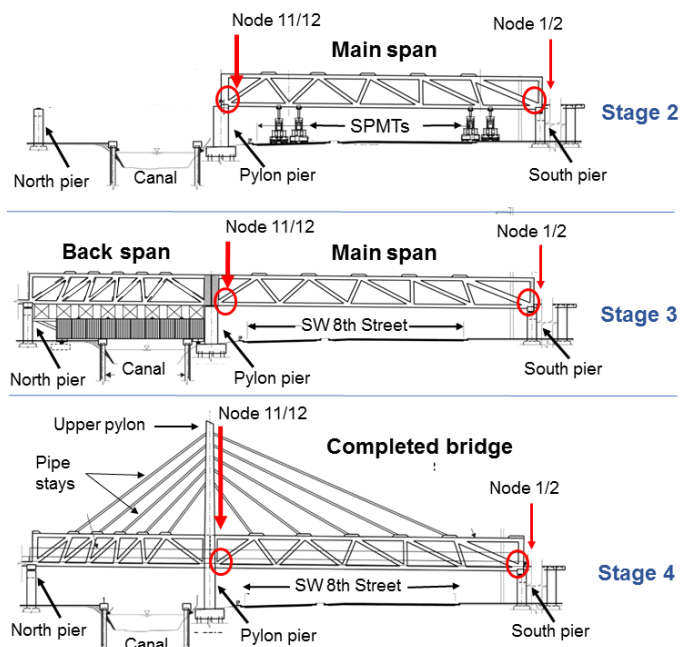
**Figure 5** – Stages of bridge construction following the Accelerated Bridge Construction (ABC) method. Only the final stage was reviewed by the independent design firm, Louis Berger.

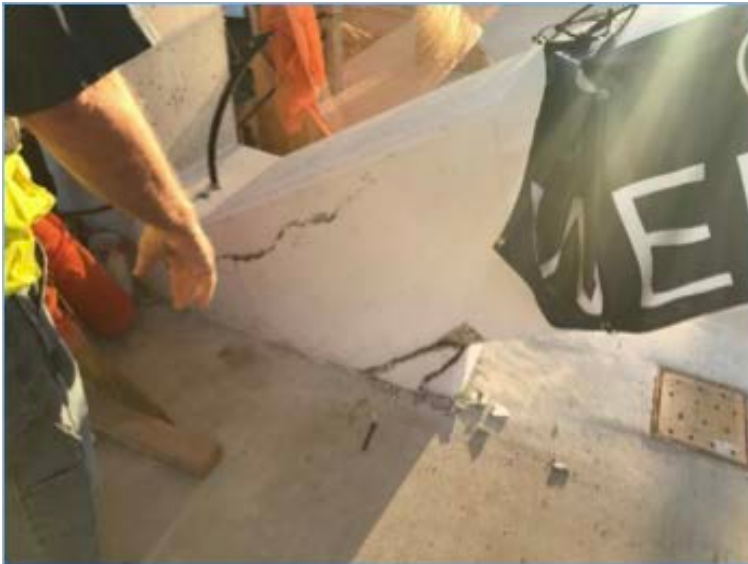
Increases in the cracking at node 11/12 were again observed three weeks later after the main span was set into place. The FIU pedestrian bridge was designed to have all structural elements under compression during its operation. For the bridge to be in the fully compressive state in its final configuration, however, not all of the PT rods needed to be tightened. In particular, the design called for the PT rods in trusses 2 and 11 to remain de-tensioned when the bridge was in place. For the move of the main span into place over the road, however, the truss 2 and 11 PT rods were to be tightened, according to the design plan, to put the main span in a fully compressed state for the move. Once in place, the PT rods in trusses 2 and 11 were then to be released. It was after the release of these PT rods that more cracking was observed at the 11/12 nodal connection. FIGG reasoned that since more cracking had occurred upon release of the truss 11 PT rod, then the proper remedial action would be to retighten the rod and leave it so in the final configuration, even though this was not the way the bridge was designed to operate. This “significant deviation” from the design would normally require written design approval, which would require a review of this new aspect of the design. This did not occur. FIGG insisted throughout the process that the cracks were not a safety issue.

**Figure 6** – Cracks at node 11/12 after the main span was set in place over SW 8<sup>th</sup> Street and the PT rods in member 11 were de-tensioned.

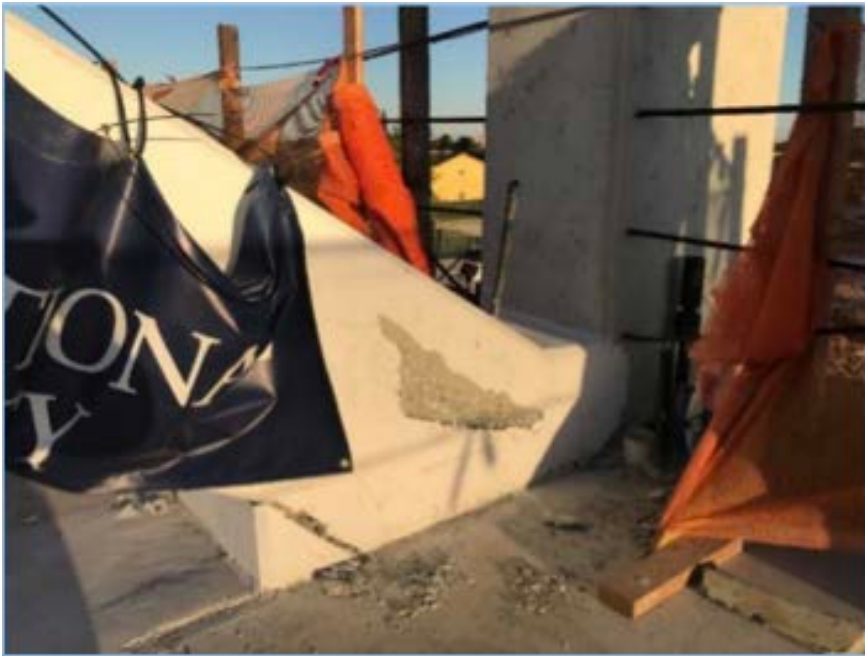
**Figure 7** – Cracks at node 11/12 after the main span was set in place over SW 8<sup>th</sup> Street and the PT rods in member 11 were de-tensioned.

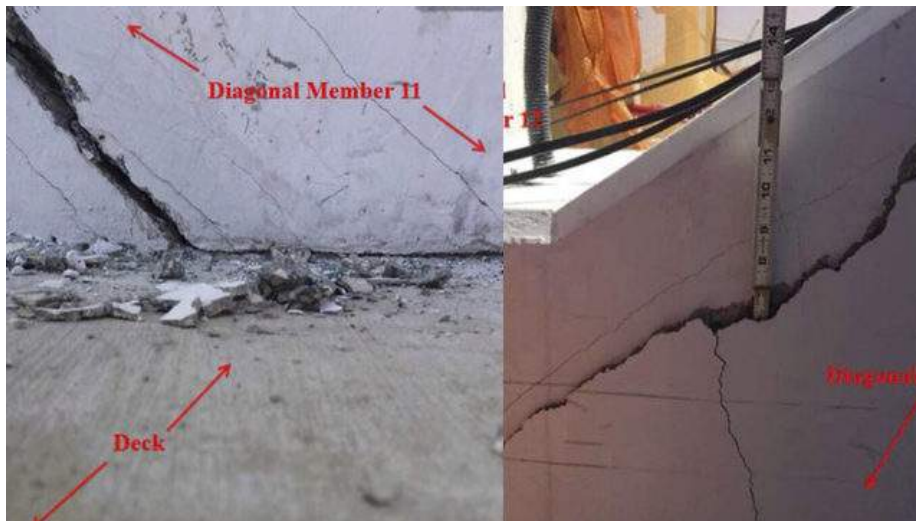
**Figure 8** – Close up view of cracks at node 11/12 after the main span was set in place over SW 8<sup>th</sup> Street and the PT rods in truss member 11 were de-tensioned.

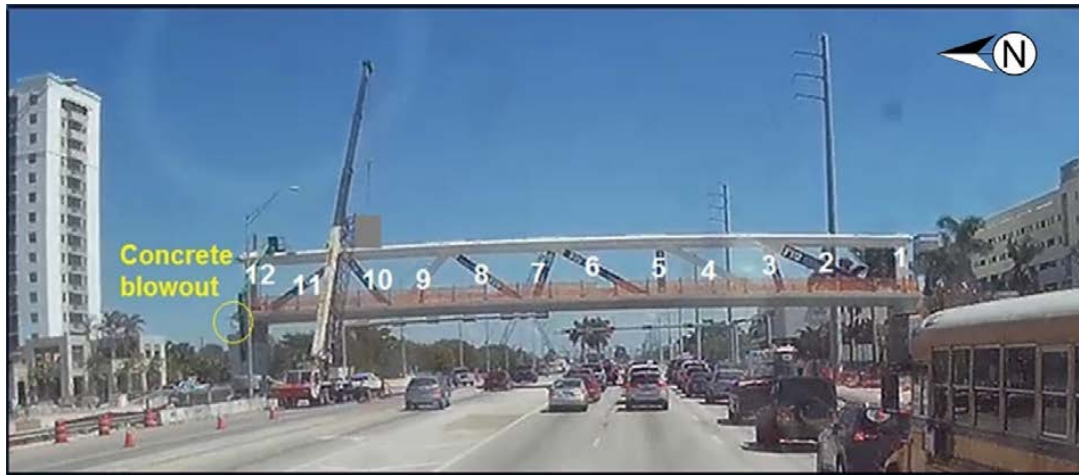
As noted, the angle of truss 11 to the deck was 32 Deg so that tightening the PT rod would actually increase the shear force on the joint by a factor of 1.6 over the compressive force. During the re-tensioning of the truss 11 PT rod, at 1:46 p.m. on March 15 the shear forces overwhelmed the 11/12 nodal connection, blowing concrete debris out horizontally from the end of the span at the deck level, and the bridge span collapsed onto the road.

Figure 9 – Still frame from in vehicle video showing concrete dust and debris blowout at node end of main span north of node 11/12.
