A SunCam online continuing education course

9/11 Attacks | WTC 1 & 2 Engineering Analysis

Luke Zollinger, P.E.

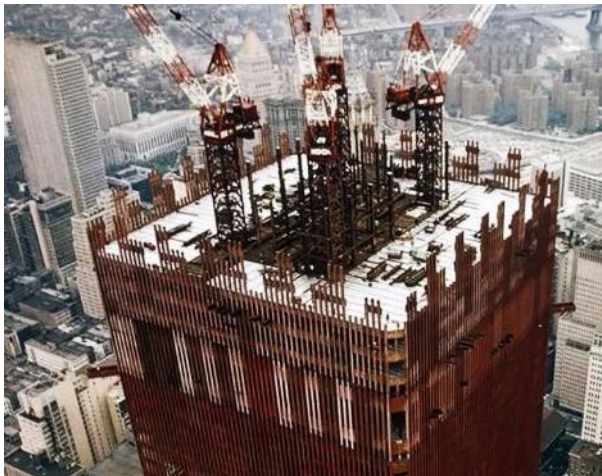
Under the towers, a six-story subterranean structure created the foundation for the skyscrapers. Geotechnical testing revealed that the site contained layers of marginal soil. Bedrock lay between 65-80 feet below street level. The ground water table was only a few feet below street level. Additionally, two subway tubes for the Port Authority Trans-Hudson (PATH) rail line lay buried in the site location. With potential for the Hudson River breaching the excavation, major geotechnical and civil engineering challenges were encountered.

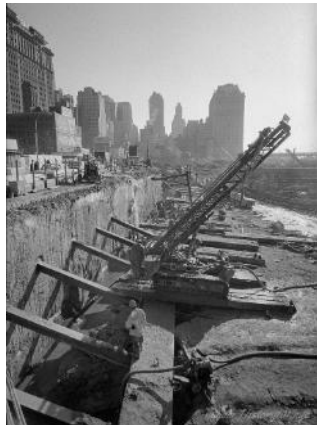
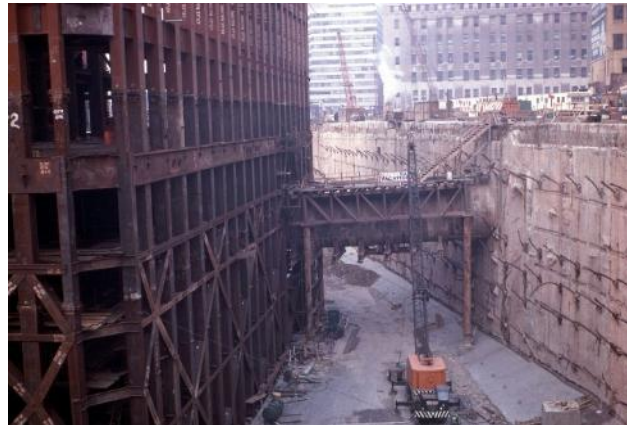
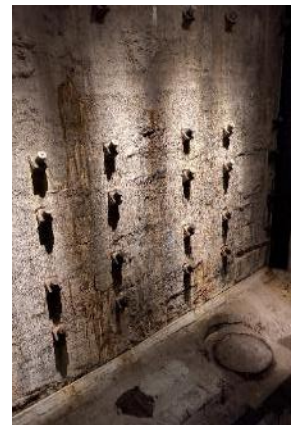
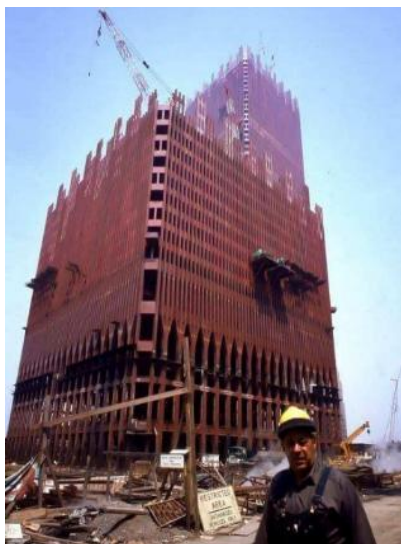
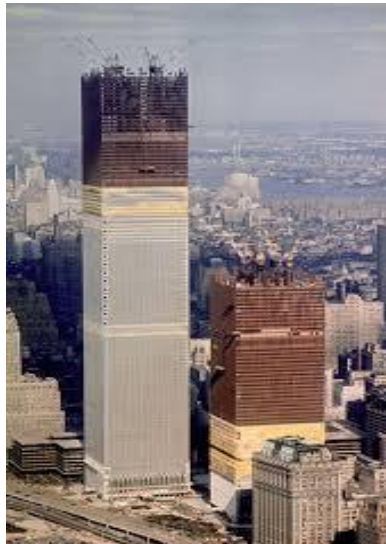
WTC Slurry Walls & Tiebacks

To prevent deflections and movement of the wall, tieback reinforcement was necessary. Sleeves were installed in rows, and drills advanced through the exposed concrete wall diagonally into the bedrock below. Each tieback was grouted in place and tensioned to hold against lateral earth pressure, creating a robust and stable foundation system. Approximately 1,500 tiebacks were installed at the WTC site and were considered temporary and were eventually replaced by floor slabs that provided lateral wall support.

The structural integrity of the slurry wall is a testament to the design and construction, which was severely put to the test on 9/11. When the towers collapsed, the floors that had resisted lateral loads no longer existed. This put the slurry wall at risk of collapse; not only causing risk of flooding the entire NY subway system (via PATH tunnels), but the possibility of the Hudson River breaching the site and flooding Lower Manhattan. Portions of the wall deflected more than 4 feet; but amazingly, the wall held. Temporary structural efforts prevented further risk and bolstered the remaining infrastructure so rescue and recovery work could be done in relative safety. A portion of the original slurry wall is now preserved and visible in the 9/11 Memorial Museum.

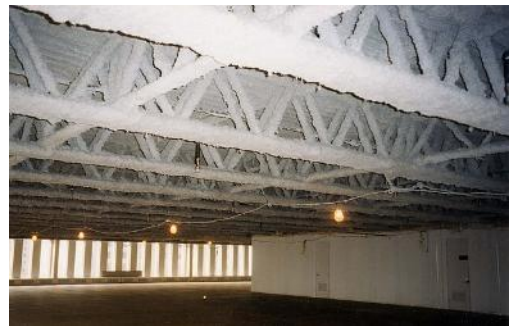
Sprayed fire-resistant material (SFRM) installed in the original WTC structures were applied to steel framing with the intent to temporarily provide fire resistance and lengthen evacuation time, not prevention against prolonged fires and total collapse. Fire-protection of a truss-supported floor system with spray-on fireproofing was innovative and not consistent with then-prevailing practice. Asbestos-containing types (mineral wool, Portland cement, and chrysolite) were installed on lower core columns, exterior walls, and floor trusses. Asbestos-free types (mineral wool, and glass fiber) were installed on upper floors, in addition to gypsum plaster and board. Original coating thicknesses ranged from $\frac{1}{2}$ " – $\frac{3}{4}$ ", and were later upgraded in part to nearly 2-1/2" thick. Note: $\frac{1}{2}$ " thickness was specified when WTC towers were built to maintain Class 1-A fire rating requirement of the NYC Building Code.

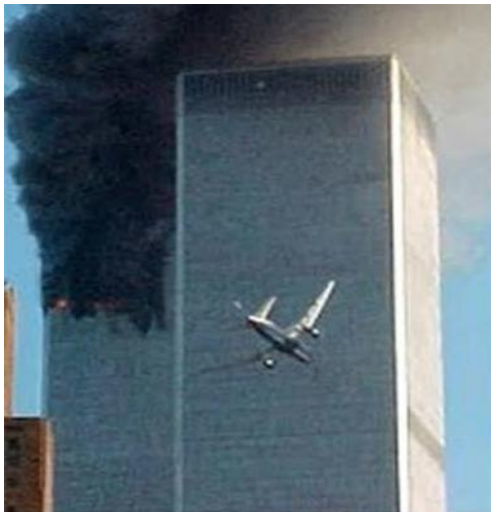
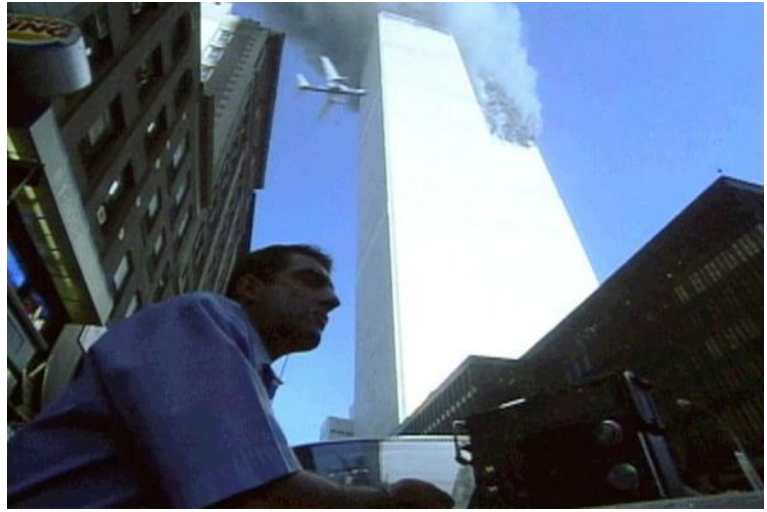
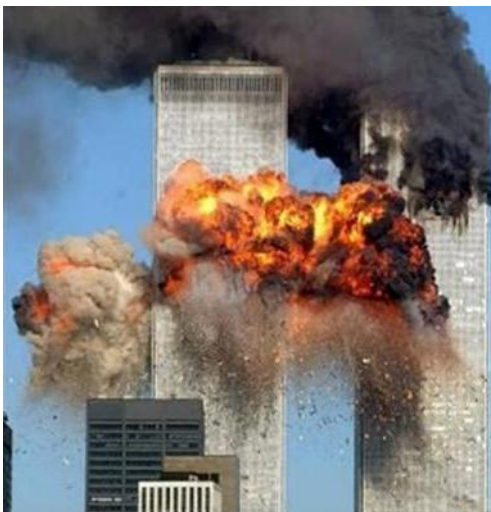
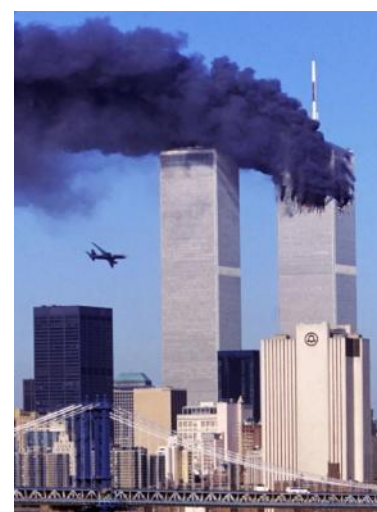
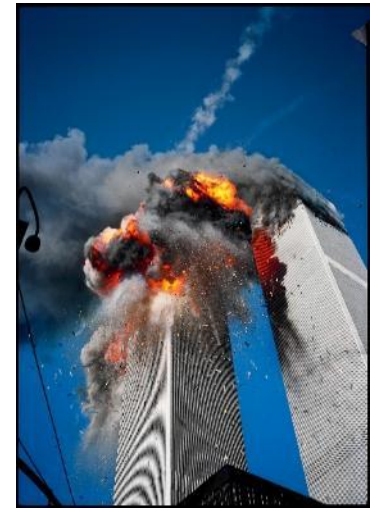
American 11 crashed into WTC 1 between the 93th-99th floors, and was essentially centered on the building's north face. United 175 crashed into WTC 2 between the 77th-85th floors, and was offset toward the east side of the south face.

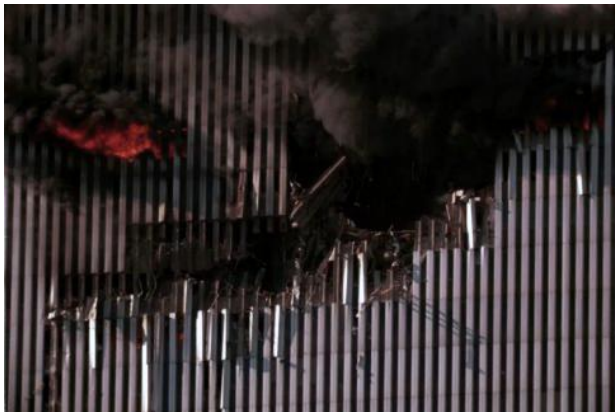
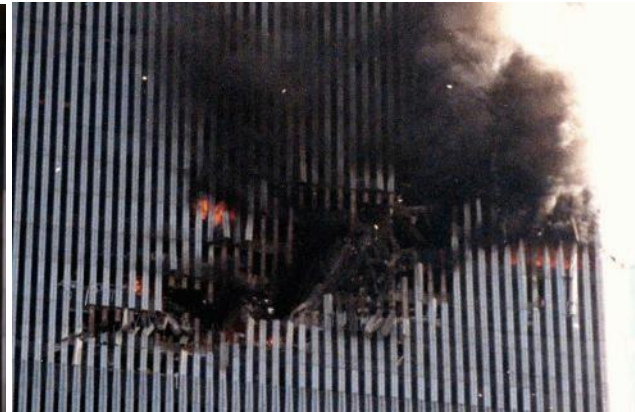
The images below show an overlaid 767 outline and the floor levels of impact on each tower. The following pictures are actual images of the same vicinity soon after the crashes occurred. The initial collisions into the WTC towers severely damaged the structure, compromising many of the exterior columns, collapsing a large area of the floor slabs near the entry points, and causing structural harm to the core columns. Damage patterns were asymmetric, and extended sideward and up/down into adjacent floors.

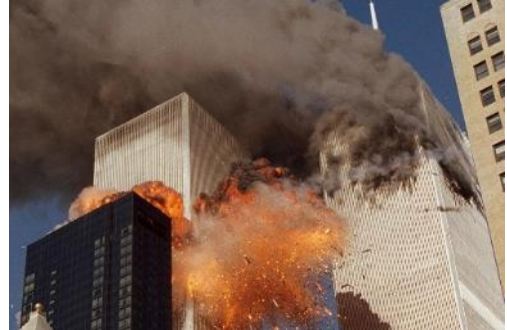
Photos show large amounts of debris and dust falling from the impacts. Some of this debris is higher than the impact floors, indicating that initial debris was expelled from the building and carried upward by the fireballs. Closeups also show the air around the towers to be filled with thousands of sheets of paper floating down. After the largest flames were extinguished, the heated gases rose, and formed a mushroom cloud of smoke and dust.

Post-analysis of photos and videos show that both towers swayed heavily (possibly several feet, even up to 10 feet) due to the aircraft impact. Original design permitted structural deflections of up to 12 inches during high wind loads, incorporating the effects of viscoelastic dampers. While relatively insignificant for such a tall tower, even that much would be enough to feel. On 9/11, witnesses inside the tower during the initial impacts reported explosion and violent jolts, followed by the sensation of falling or tipping over. The excessive movement caused physical damage within the structures, such as ceiling panels falling, windows shattering, and door frames twisting. After the initial sway, the buildings stabilized; yet another testament to their structural design and resilience.

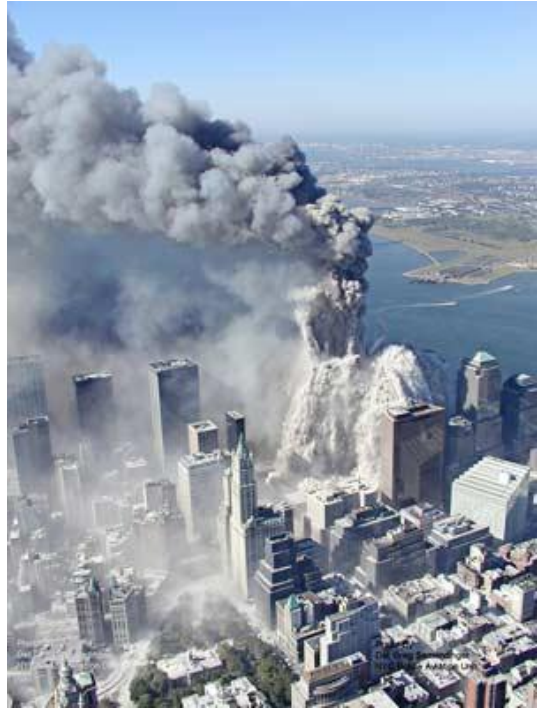
As the fires continued to burn inside the towers, the structural weakening became critical. The initial impacts of the aircraft knocked loose much insulation that could have protected the steel structure for a time. Post-damage analysis concluded that were it not for prolonged fire damage, the towers would not have collapsed. This quote from an engineer from the firm that conducted investigations after 9/11 stated that: *“The fact that Tower 1 stood for 103 minutes after losing approximately 53 column lines and that Tower 2 stood for 56 minutes after losing approximately 34 column lines is a testament to the strength of the buildings and the skill of Leslie Robertson and the other engineers who designed them. I believe that few, if any, other buildings could suffer that amount of damage and not collapse immediately.”*

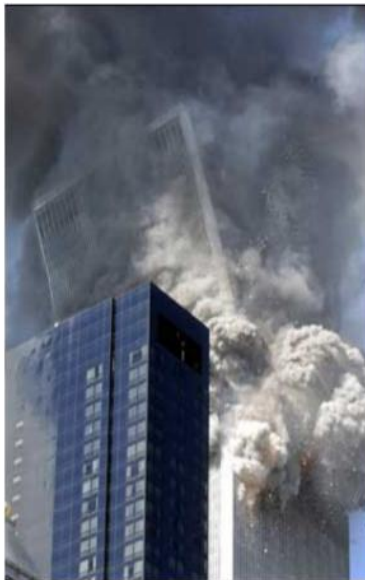
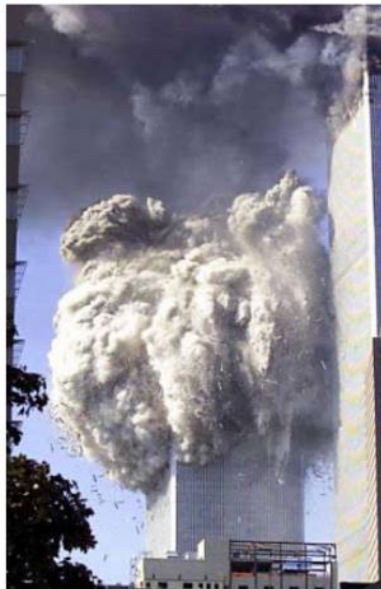
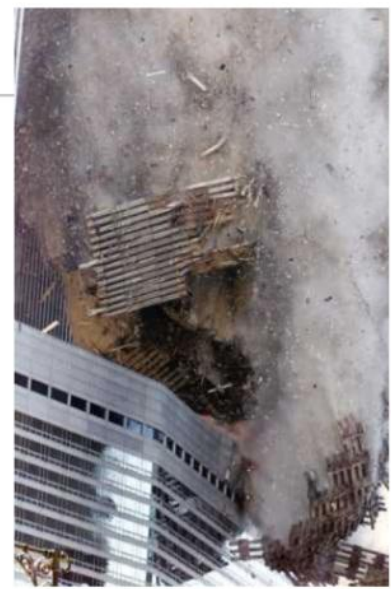
WTC Tower 2 Collapses: 9:59 AM

After burning for only 56 minutes, the South Tower began a progressive collapse. Because Tower 2 was hit off center, it was left without one of its corner columns in the core of the building and, like a table losing one of its legs, had less ability to redistribute the weight that was meant to be carried by the weakened or lost columns. Large portions of the perimeter columns and core columns were left without support, and soon the local area of impact began to catastrophically fail as the columns yielded and buckled due to the prolonged heat. The hat truss at the top of the tower shifted loads to the perimeter columns as the core columns weakened. Simultaneously, the floor trusses began to buckle, pulling the perimeter walls toward the center of the tower. The floors above the impact zone fell freely onto the structure below. This sudden gravity load was more than any one story could take, and thus the sequence began until there was no more building to collapse.

The initial collapse caused the upper stories to tilt, but the remainder of the tower collapsed virtually straight down, in a progressive manner. As the rubble fell, it pushed the perimeter walls outward, causing the rubble to spread as the building rapidly disassembled itself. The sudden compressing of the building created high pressure air which blew out windows below the destruction above. The result was an enormous dust cloud and incredible debris pile, amid widespread chaos and terror.

- In WTC 2, the core was damaged severely at the southeast corner and was restrained by the east and south walls via the hat truss and the floors. The steady burning fires on the east side of the building caused the floors there to sag. The floors pulled the heated east perimeter columns inward, reducing their capacity to support the building above. Their neighboring columns quickly became overloaded as columns on the east wall buckled. The top section of the building tilted to the east and to the south and began its descent.

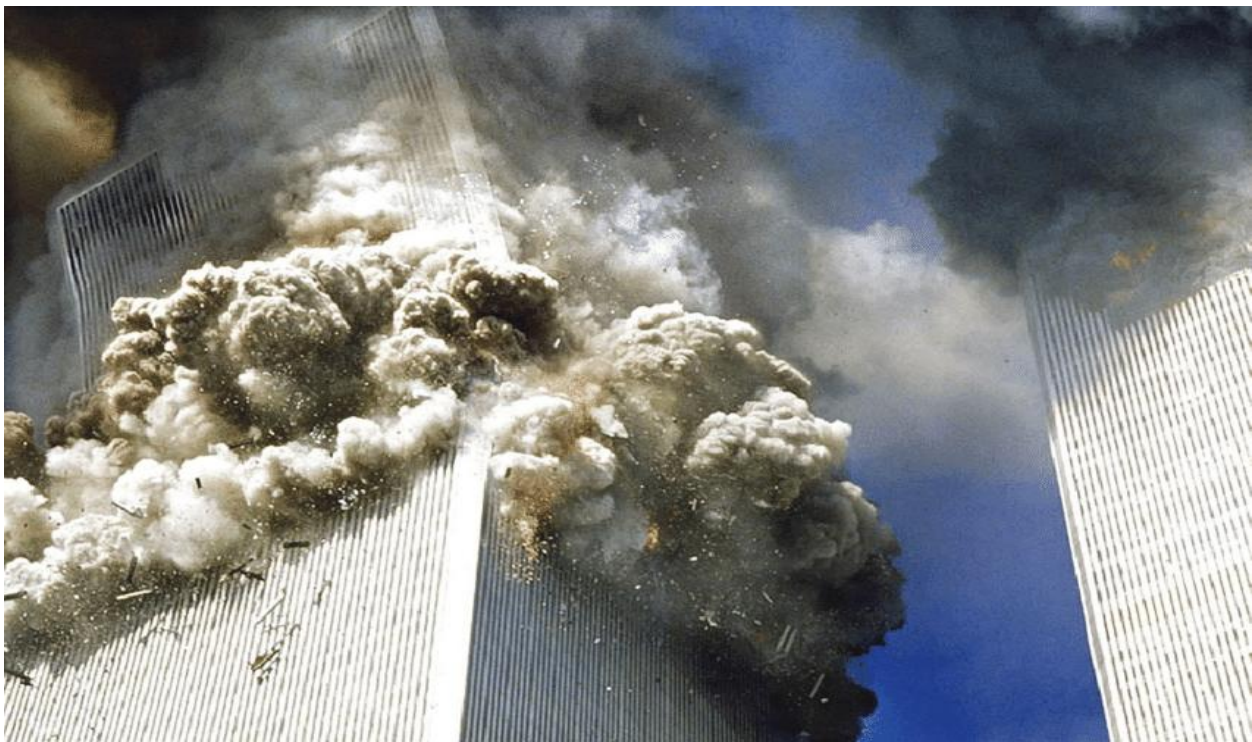
WTC Tower 1 Collapses: 10:28 AM

hit higher on the tower, thereby significantly reducing the gravity load on the affected stories. The core of the North Tower retained its corner columns and, like a table with all four of its legs, it was better able to redistribute the weight meant to be carried by lost columns. Similar to the South Tower, the North Tower experienced prolonged fire and therefore loss of steel strength due to elevated temperature, in combination with the loss of structural integrity due to distortion of the steel. The impact zones compromised the columns, and again the structure became critical. NYPD airborne helicopter pilots reported that the North Tower was leaning, followed by confirmation that a corner of the building was beginning to buckle and the roof looked unstable. Shortly after, WTC 1 collapsed.

- In WTC 1, the fires weakened the core columns and caused the floors on the south side of the building to sag. The floors pulled the heated south perimeter columns inward, reducing their capacity to support the building above. Their neighboring columns quickly became overloaded as columns on the south wall buckled. The top section of the building tilted to the south and began its descent.

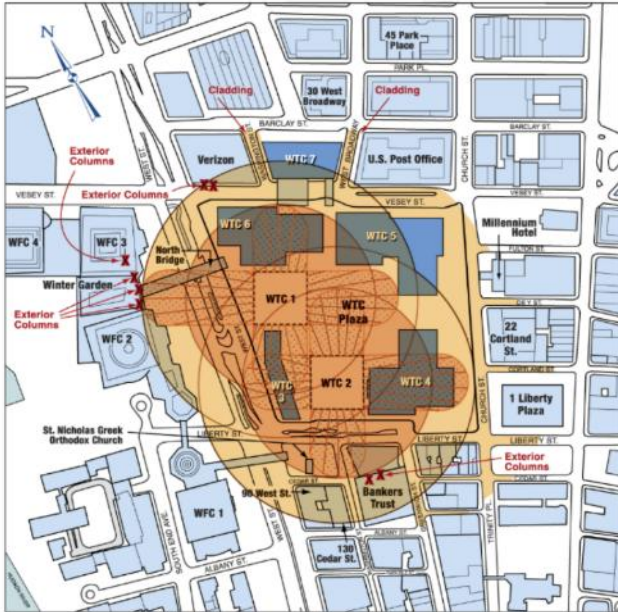
Debris Affected Areas

Post-analysis established that the collapse of Tower 2 did not cause any significant structural damage to Tower 1. Because the towers were offset, Tower 1 stood out of the way of the falling Tower 2 walls, and debris only superficially damaged Tower 1. Studies also showed that each collapse was initiated separately by a combination of the immediate damage from the impact of an airliner and the resulting fires on the floors that were struck.
