Repair Techniques for Metal Plated Wood Trusses

Part 2: Moderate Truss Repairs

Derek L. Rhodes, P.E.

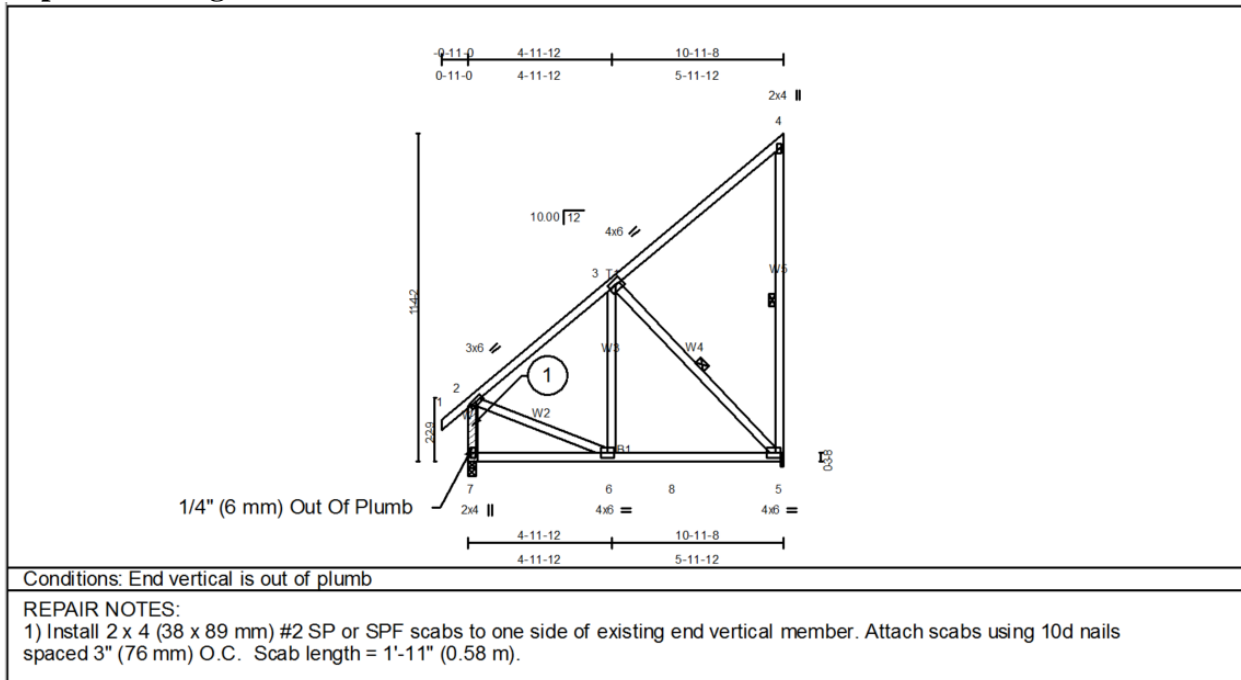
Repair Drawing

The short end vertical of the mono truss was fabricated at a non-vertical angle.

The member just needed to line up with similar members in other trusses. Since no plates were compromised, a simple scab was sufficient to prevent any ripples in the exterior finish.

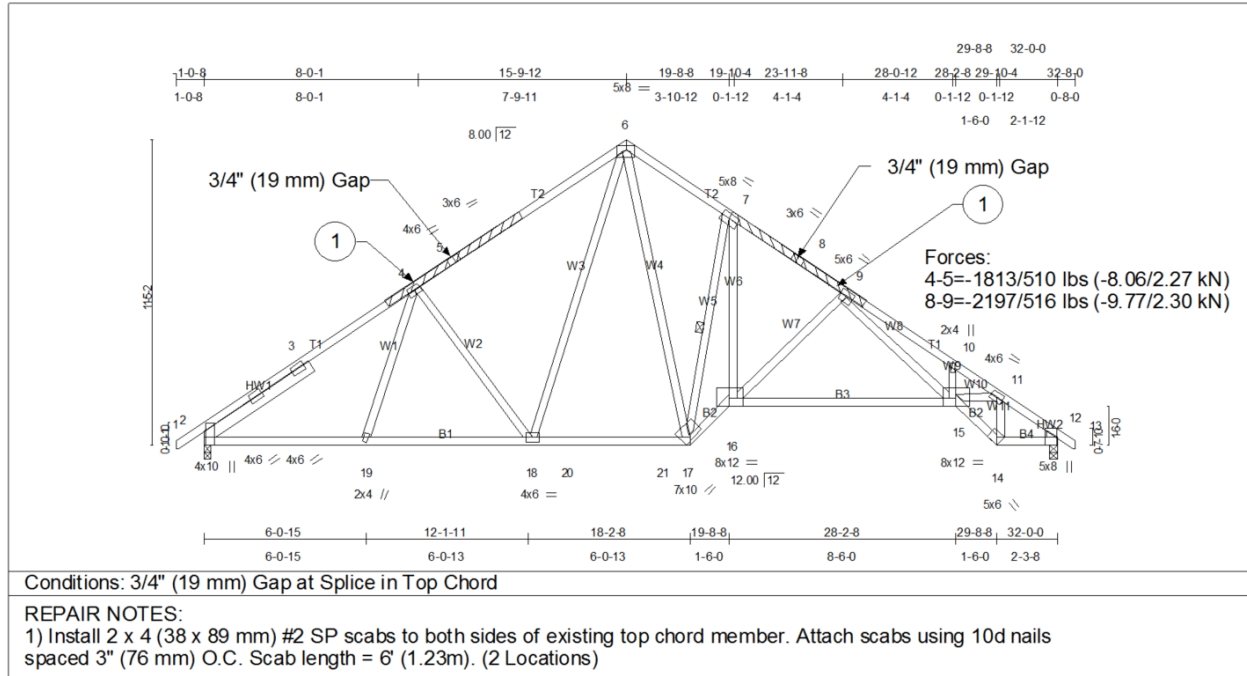
Repair Drawing

Top chord members were too short causing a gap at the splice joint.

According to ANSI/TPI 1-2014 section 3.7.6, the maximum allowable gap between wood members at a joint is between 1/16" (1.6 mm) and 1/8" (3.2 mm), depending on the joint type configuration. The 3/4" (19 mm) gap found at both of the top chord splice joints exceeds this maximum allowable gap. The gaps created a similar situation as if the top chord member was broken or the splice plate had been damaged. The controlling force is the compressive force from joint 8 to joint 9 of -2197 lbs (-9.77 kN). From Table 3-1, the shear capacity of a 10d nail in a roof application with 2x4 (38 x 89 mm) SP scabs is 122 lbs (0.54 kN) requiring a minimum development length of 5' (1.52 m) for a scab applied to one side if the nails are placed 3" (76 mm) o.c. The solution that was selected used 6' (1.82 m) scabs on both sides of the truss because the repair designer prefers two sided repairs whenever possible to eliminate eccentricity.

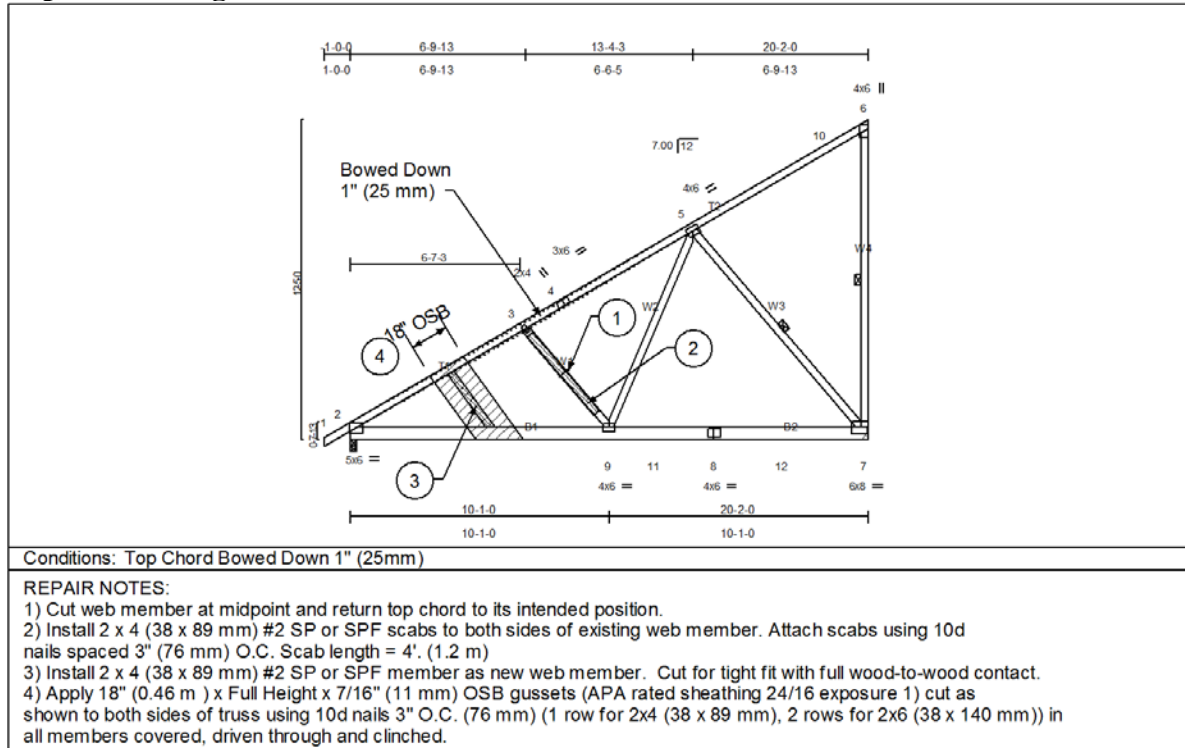
Repair Drawing

The top chord of the truss has a dip caused by a web that was either too short or not installed properly.

When a bow is present in a truss chord member, it is usually between two joints and is often caused by a lumber defect, but in this case the maximum bow was at the joint. In the fabrication process, lumber is usually cut accurately and a jig connection is established at or near each joint so that each joint location is usually within a 1/4" (6 mm) tolerance making this type of error rare. A common repair approach is to scab a member along the existing top chord to get the desired roof plane alleviating the need to cut truss, and that would have been an appropriate repair if the roof sheathing had not already been installed. However, the roof sheathing and the shingles were already in place. The connection between the roof sheathing and the top chord of the truss would require being severed in order to reestablish the desired roof plane. Then, the shingles would have to be removed in order to reconnect the sheathing to the top chord according to the requirements of the building code. The repair as designed allows for the connection between the roof sheathing and the top chord of the truss to remain intact by cutting the key web, moving the top chord to the correct location, and repairing the web with a simple scab repair. The extra web was added to alleviate any bow that may be set in the lumber of the top chord member due to the incorrect location of the joint.

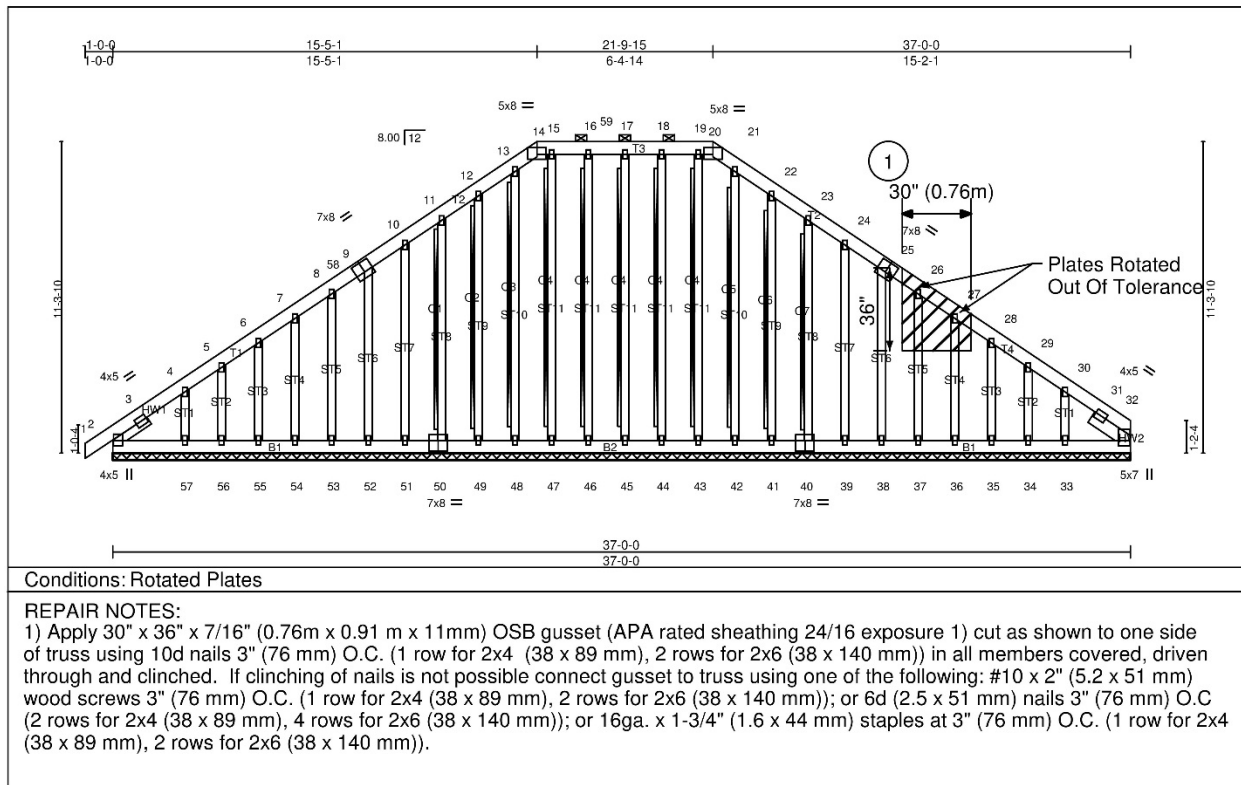
Repair Drawing

Two truss plates at top chord joints were rotated beyond acceptable tolerances.

Trusses are usually built flat on large tables in modern truss manufacturing facilities making only one face of the truss clearly visible to the truss builders. If there are plate placement issues, the problem usually occurs on the face of the truss that is face down. These issues can be treated just like a damaged plate. Since there were two plates that were rotated in this case, one OSB gusset was sized to cover both joints.

In a gable truss, sheathing is usually already applied to one side, so a one sided repair is necessary. Also, since the truss is continuously supported, the forces in each member are relatively small and so the size of the OSB was chosen based on the geometry of the members and not the forces like other repairs. The standard gun nails can be used if the exterior finish has not yet been installed so that the nails can be clinched, meaning bent over, without damaging the exterior finish. The options for the various shorter connectors were based on the total thickness of the assembly, and were chosen so as to not protrude through to and damage the exterior finish if it has already been installed.

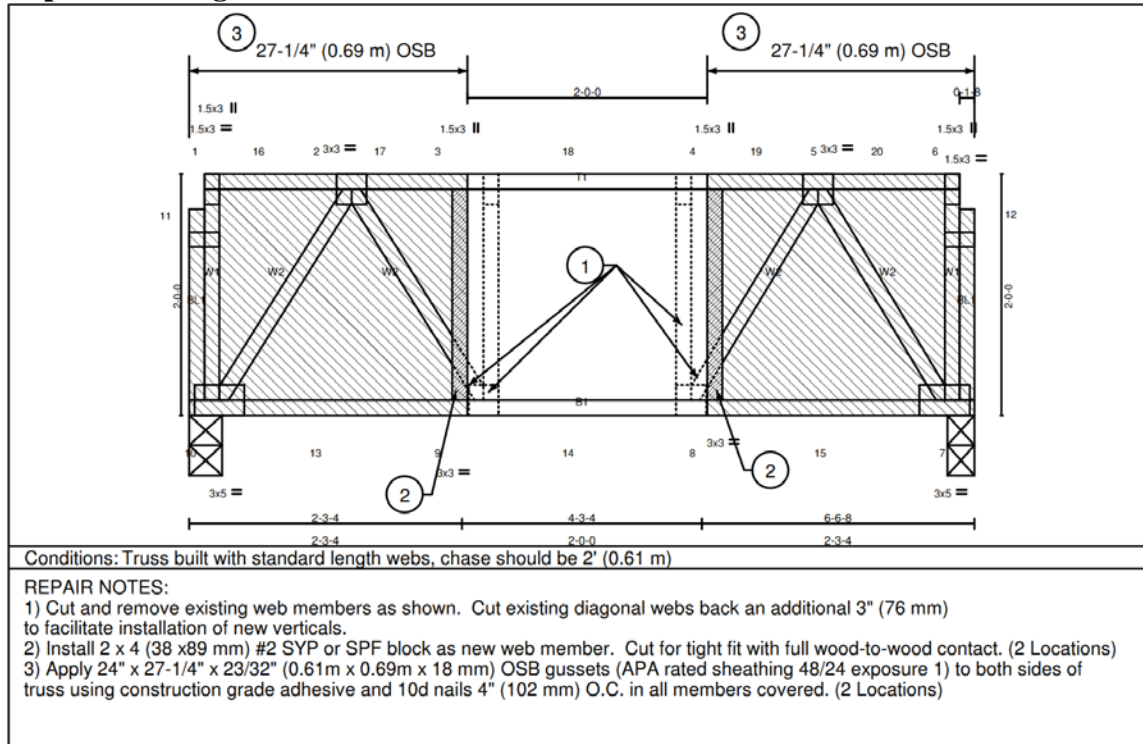
Repair Drawing

The truss manufacturer used standard cut pieces instead of the custom length pieces per the truss design for the diagonal web members resulting in a small chase.

Errors in the size or location of a floor truss chase is a common problem and can be caused by design errors, minor variations in lumber thickness of the top and bottom chord members, setting a non-symmetrical truss backwards, changing the size of the ductwork that is to pass through the truss, or manufacturing errors. In this case, the fabricators simply chose diagonal webs that were too long causing the chase to be undersized for the required ductwork. Since the truss was relatively short and the forces were small, the diagonal webs were cut back to allow for the new vertical webs and OSB gussets were sized to provide good perimeter nailing.

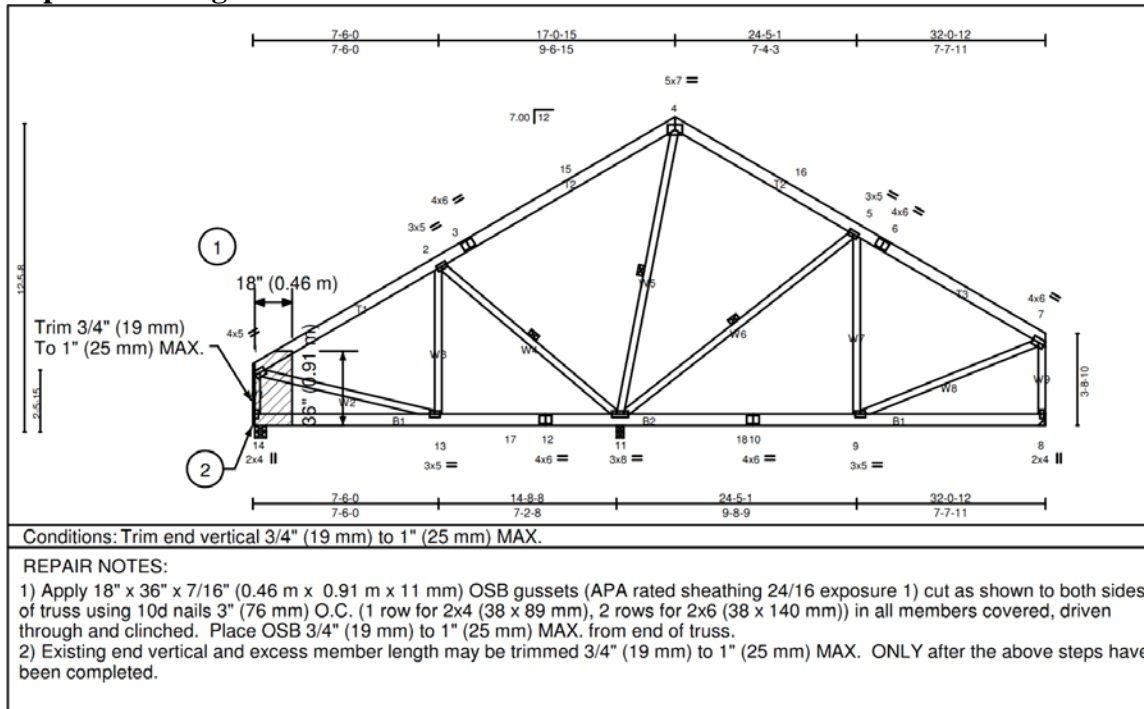
Repair Drawing

The truss is too long for the application and needs to be shortened a small distance.

This repair is an example of a relatively small change required in the horizontal dimension of the truss often caused by the supporting wall not being exactly where it was supposed to be or there was a misinterpretation of the plans. As an example of a possible misinterpretation, some plans may show the dimensions to the framing whereas others may have dimensions to the outside of sheathing resulting in a potential difference up to 1" (25 mm). A key question on repairs of this nature is whether any reinforcement needs to be applied to the truss when a small part is removed. A general rule of thumb is that if the trim does not damage any plates and the forces are relatively low then no reinforcement is required. It was decided to use small OSB gussets in this case because if the full 1" (25 mm) was trimmed off the end of the truss, there would be some damage to the truss plates on both joints at the heel.

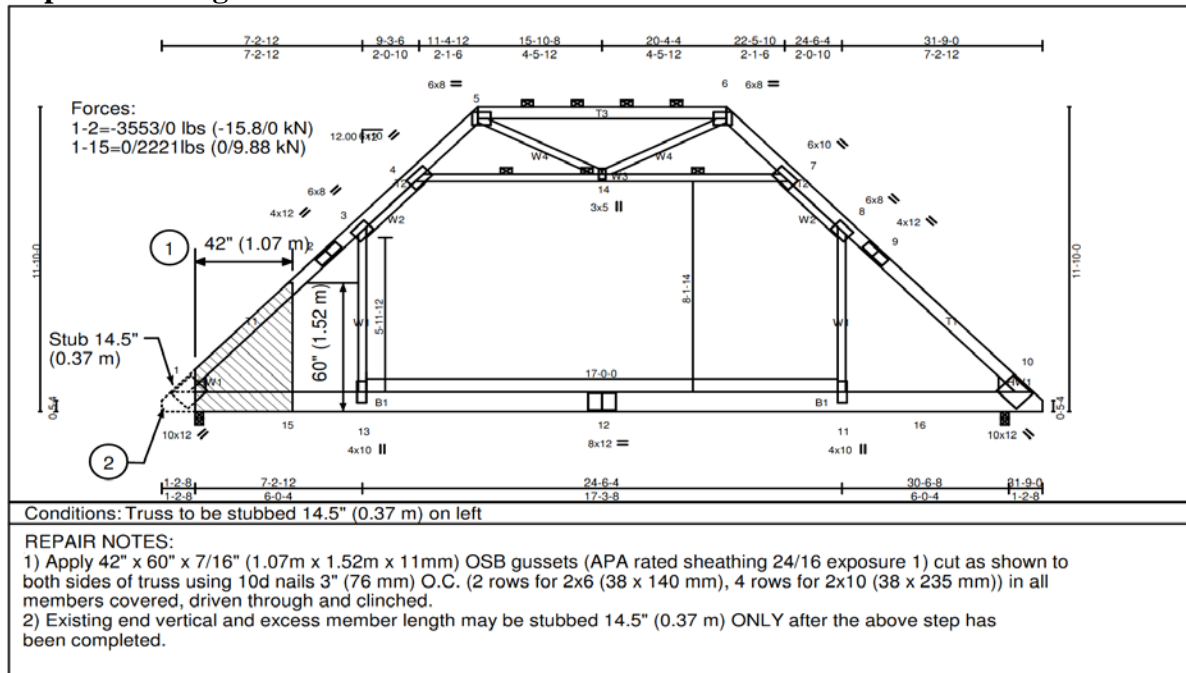
Repair Drawing

The cantilever portion of this attic truss needs to be removed.

Removing the cantilever portion of either a roof or floor truss is a relatively common modification. If there is a vertical web at the bearing causing at least three separate joints (one at the bearing on the bottom chord, one at the top chord above the bearing, and one or more joints in the cantilever) then usually the cantilever may be removed without any further reinforcement even though one or more plates in the cantilever may be completely removed. However, due to the large chord sizes of this attic truss, there was only one plate covering the bearing and the cantilever, and most of the single plate at the heel joint would be cut off when the cut was made. Therefore, additional reinforcement was needed.

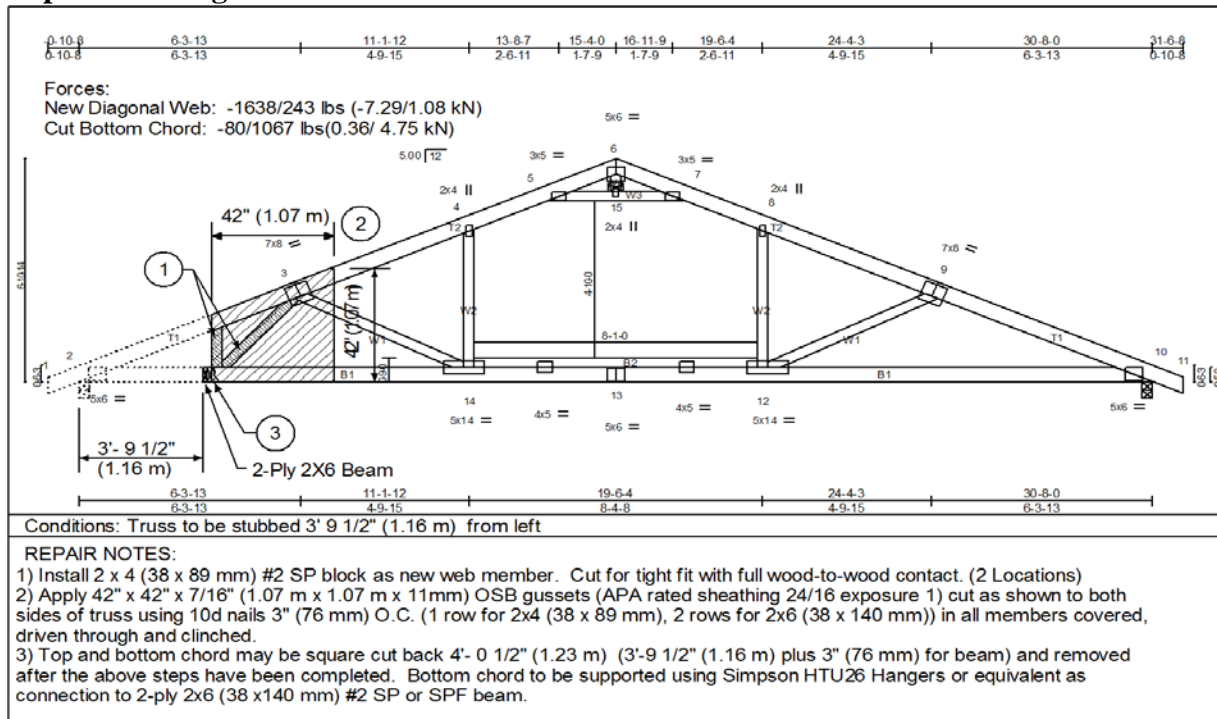
Repair Drawing

The truss needs to be stubbed and supported by a beam.

When the stub location is not at a joint, additional members are usually required to make the truss structurally sound. After software modelling of the truss, it was determined that two the additional webs shown in the repair drawing were needed to transfer the forces to the bearing support. The specific solution for these types of repairs will vary based on stub location, truss span, chord size, and design loads.

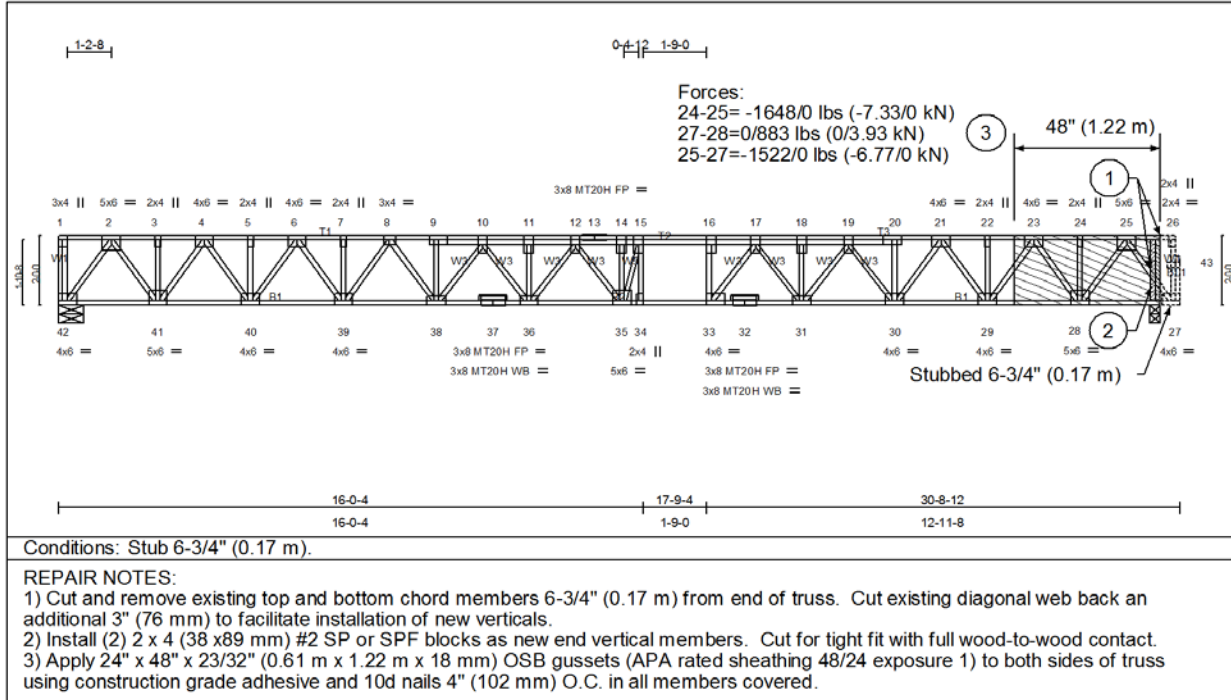
Repair Drawing

The floor truss needs to be shortened.

Conditions: Stub 6-3/4" (0.17 m).

New web members are required for this stubbed floor truss to be structurally sound similar to the prior roof truss repair in Example 7-3. The existing diagonal web member must be cut back further than the stub length in order to install the new vertical web members. From Table 3-1, a 10d nail has a shear capacity of 91 lbs (0.40 kN) for a floor truss with 23/32" (18 mm) OSB gussets. The diagonal web member has a controlling compressive force of -1522 (-6.77 kN) and would require 34" (1.93 m) of development length per side with the nails at 4" (102 mm) o.c. The web itself is not long enough to develop the required nailing as is often the case in floor truss repairs. However, if the forces in the top and bottom chord members of a floor truss can be developed with the reinforcement, then it is not always necessary to develop the full connection for each web. It is recommended to make the height of the OSB gussets match the height of the truss to cover both the top and bottom chord member when doing floor truss repairs. The perimeter nailing creates a box beam that significantly increases the stiffness of the truss in the repair area and largely eliminates the need to develop the full connection in each web. The controlling force is the -1648 lbs (-7.33 kN) compressive force in the top chord in the panel adjacent to the modified region. This would require 38" of development length per side. In this case 48" (1.22 m) wide OSB gussets were applied to fully encapsulate the region.

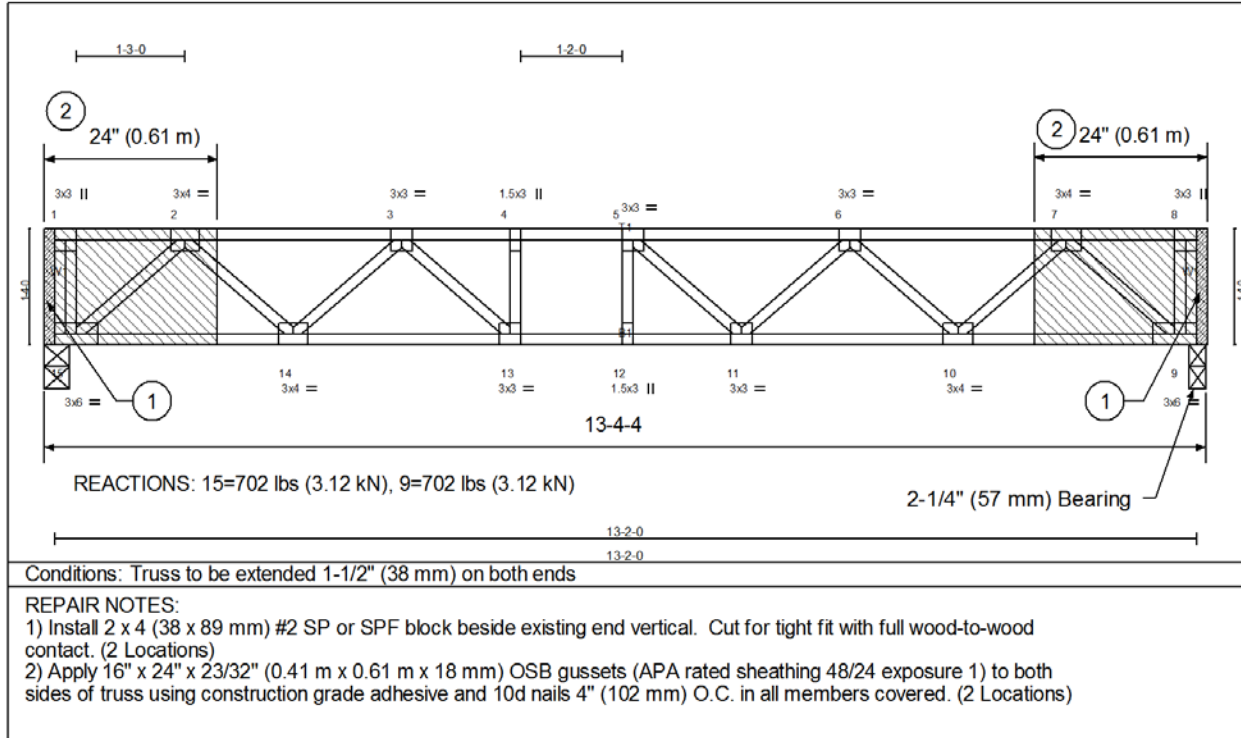
Repair Drawing

The floor truss needs to be extended a total of 3”.

The minimum recommended bearing width for most floor truss is 1 1/2" (38 mm). If the floor truss is shorter than the required application but still long enough to achieve the minimum recommend bearing width then usually no repair would be required. In this case the bearing surface at the right end was already reduced to 2 1/4" (57 mm) because the wall was being shared with other structural elements. Any additional reduction in the bearing surface would create an unacceptable bearing condition. Also, this truss was used in a multi-story structure and there was concern about load transfer from the upper floors if one end of the truss did not extend the full width of the bearing surface. It was therefore decided to center the truss and extend both ends 1 1/2" (38 mm) rather than extending one end by the required 3" (76 mm).

Centering the truss between the two bearing surfaces allowed for the simplistic nature of this repair detail. Since the existing truss was partially sitting on the bearing surface at both ends and the span is relatively small, the OSB gussets only needed to provide load transfer into the block of about half the reported reaction. Shifting the truss as shown was possible because there was some flexibility in the chase location. Had the chase location been fixed, an alternative single end extension solution would have been required.

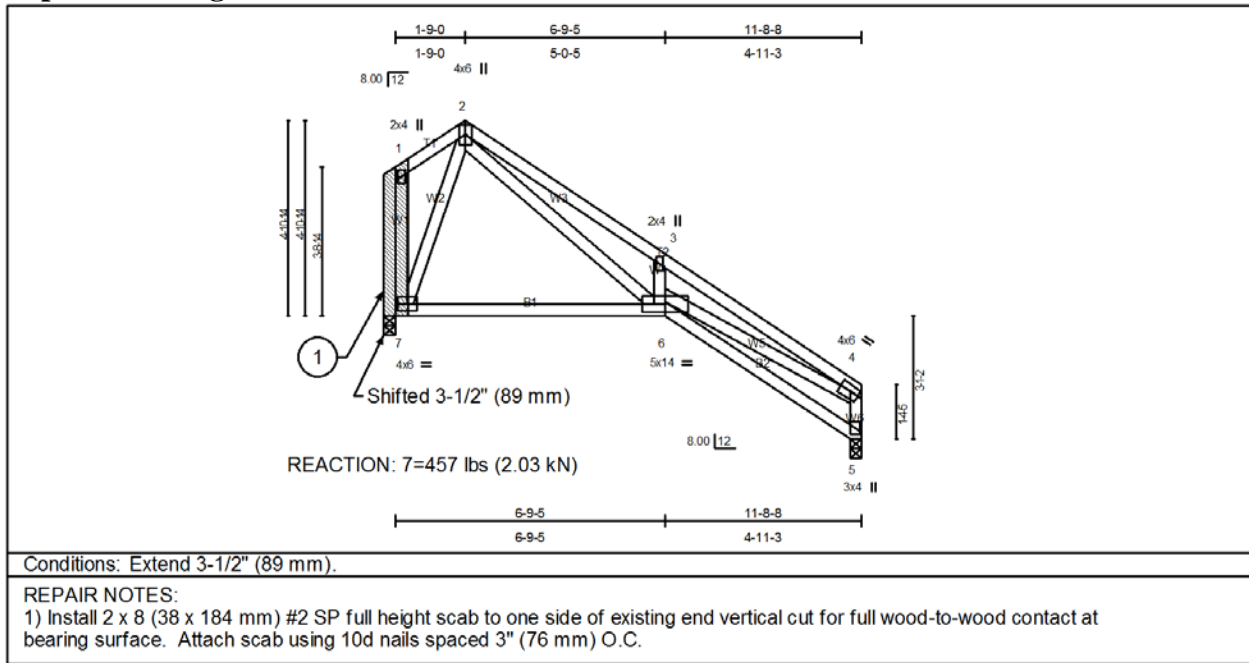
Repair Drawing

The roof truss needs to be extended a total of 3 1/2" (89 mm) on the left end.

Unlike the previous floor truss of Example 7-5, a roof truss cannot be centered between the bearing surfaces because the slopes of both the top and bottom chord members must align with the adjacent trusses. The 3 1/2" (89 mm) extension corresponds to a 2x4 (38 x 89 mm) frame wall and is the most common dimension for either stubbing or extending a truss. The cause of the required adjustment is usually due to a change in the vertical placement of a beam. A truss needs to be 3 1/2" (89 mm) longer if the beam is dropped and the truss is to bear on top of the beam than if the beam was flush and the truss sits in a hanger attached to the face of the beam. If the vertical placement of the beam is different than anticipated then the length of the truss needs to be adjusted by width of the beam

The original truss had a reaction of 457 lbs (2.03 kN) which equals the amount of shear transfer that is required. The 2x8 (38 x 184 mm) repair was chosen because of its simplicity and the fact that it can develop the required connection with the end vertical, extend the truss the required 3 1/2" (89 mm), and transfer the forces into the bearing surface. According to Table 3-1, the appropriate nail shear capacity for a roof application with SP lumber would be 122 lbs (0.54 kN). The development length would only need to be 15" (0.38 m), but to minimize the effects of the eccentric load, the scab was specified to be the full height of the end vertical.

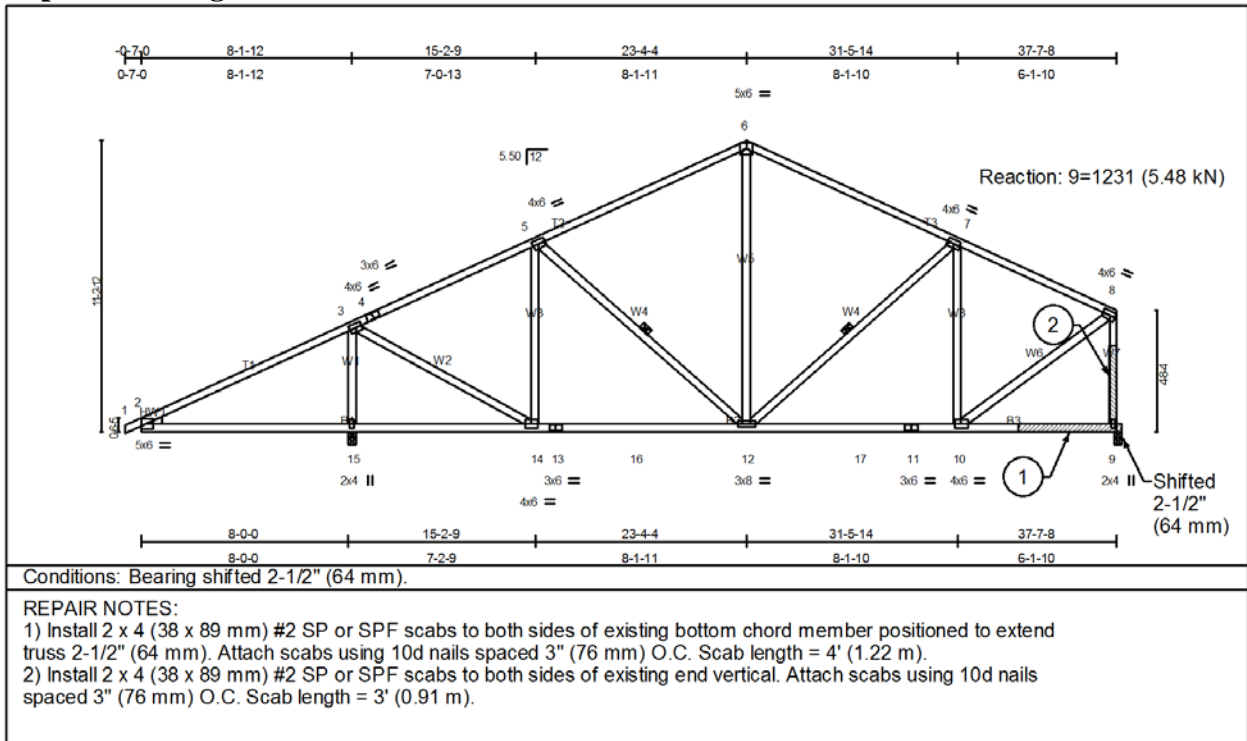
Repair Drawing

The roof truss needs to be extended a total of 2 1/2" (64 mm) on the right end.

This example is presented as an alternate solution to Example 7-6 for relatively short extensions of roof trusses with raised heels. Even though the reaction was substantially higher, it was not the deciding factor for the repair solution. In both examples the scab on the end vertical member allows development of the connection almost directly above the bearing surface. The advantage of using the two 2x4 (38 x 89 mm) scabs as opposed to the 2x8 (38 x 184 mm) scab from the previous example is the material availability at a jobsite.

According to Table 3-1, the shear value of a 10d nail in a roof application where one member is SPF lumber is 106 lbs (0.47 k N). The required vertical development length would be 3' (0.91 m) in total. However, it was decided to apply the repair to both sides to increase the shear capacity of the horizontal scabs and to eliminate eccentricity. The limit of the extension for this type of repair would be approximately 3 1/2" (89 mm) without considering the shear capacity of the scabs. Example 7-9 will demonstrate not only shear but also moment calculations for a larger extension.

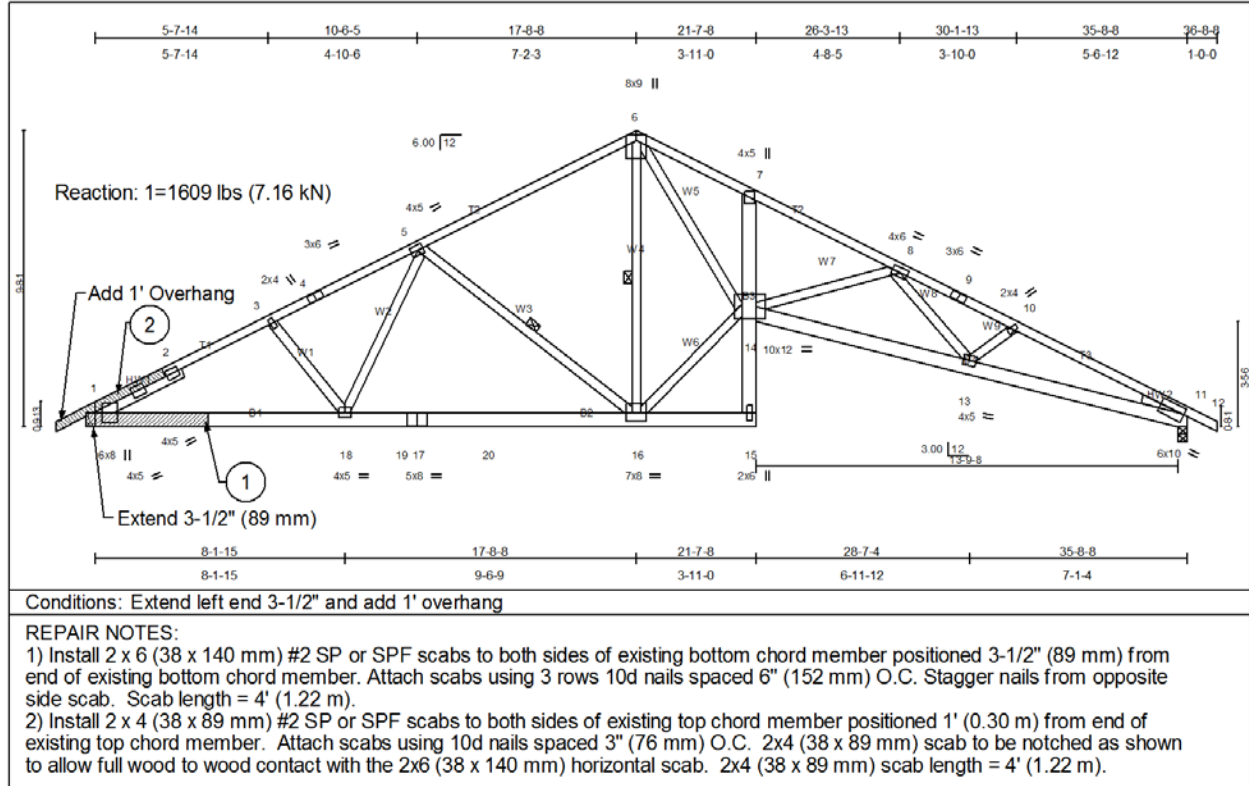
Repair Drawing

The roof truss needs to be extended a total of 3 1/2" (89 mm) on the left end and a 1' overhang needs to be added.

The additional need for the overhang was advantageous to this repair because it allowed for additional nailing above the bearing surface. The scabs working in tandem create a similar result as a truss heel allowing the compressive force in the top chord to be transferred into the bearing surface without creating a critical shear location. From Table 3-1, the shear capacity of a 10d nail in a roof application with SPF lumber is 106 lbs (0.47 kN). Therefore, 16 nails are required to transfer the 1609 lbs (7.16 kN) reaction. Due to the geometry of the joint, some of the nails in bottom chord scab count toward the required total with the remainder being installed in the top chord. A discussion for why the bottom chord scab is longer than the required development length is provided in Example 7-9.

If the repair had been only to add an overhang, it would have been sufficient to apply only a single-sided top chord scab. As a general rule of thumb when creating an overhang, the lumber scab should come back along the top chord at least twice the slope distance of the overhang.

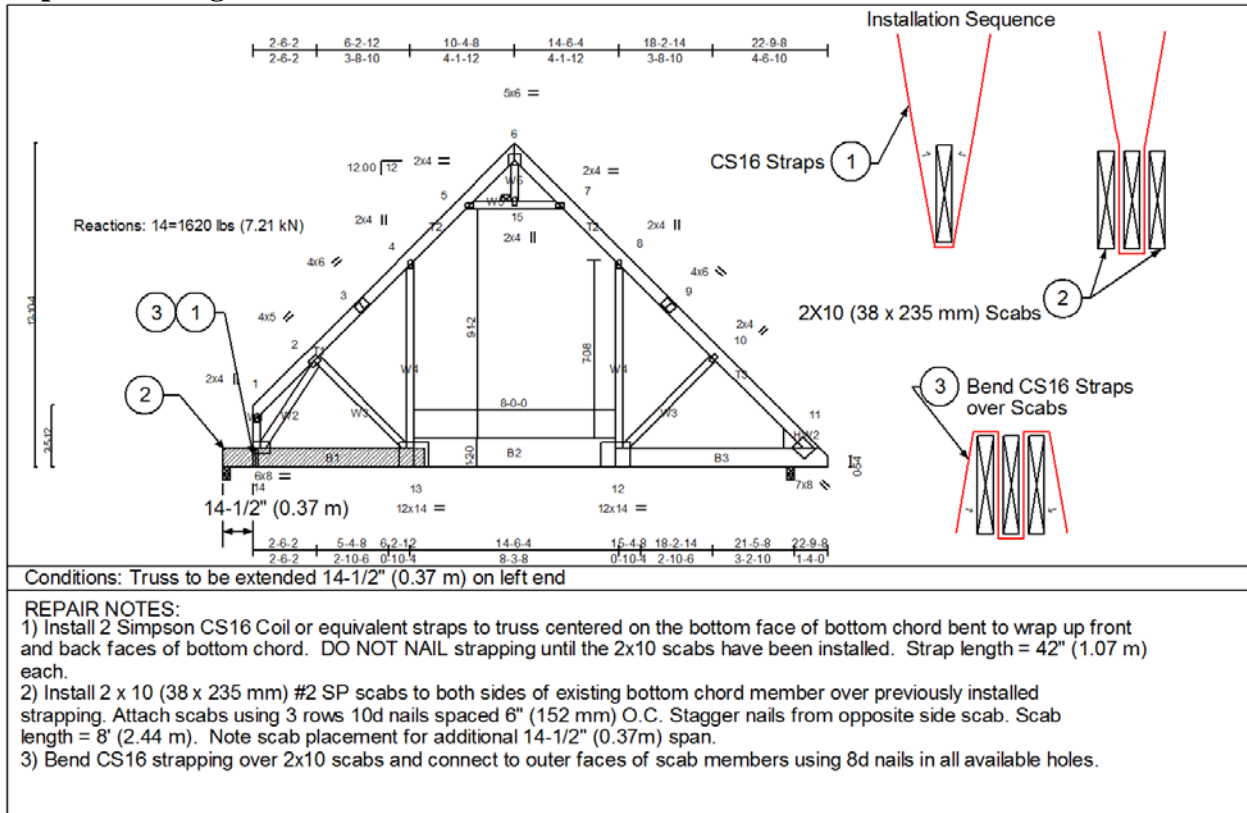
Repair Drawing

The roof truss needs to be extended 14 1/2" (0.37m) on the left end.

The principle concept in this repair is that the new scab members can be modeled as a simply supported beam with the truss reaction applied as a point load at the appropriate distance from the new bearing location. The metal straps which weave up and down between the members act as hangers to transfer the reaction from the base truss to the 2x10 (38 x 235 mm) scabs which act a beam, and the nailed connection transfers the beam reaction force at the right end back into the base truss. The order of the installation steps is critical in this repair design. The metal straps have to be applied to the base truss to form a U- shape before the scabs are applied. Once the scab members are applied, the straps are bent over the scab members forming the M shape shown in the detail and creating the hanger connection. The straps would nearly be useless if the scabs were installed first since the straps would be horizontal at the base of the truss and would have to take a deflected shape before actually carrying any load. The straps are required because the reaction of the base truss would act as a concentrated load on the beam. Using nails alone to transfer the load would force the nail pattern into a cluster that may cause the wood members to split.

The allowable shear and moment for the 2 member beam is sufficient to carry the reaction of the base truss. From the 2015-2016 Wood Construction Connectors (C-C-2015) publication by Simpson Strong-Tie, the CS16 is a 16 gauge (1.59 mm) strap that is 1.25'' (31.8 mm) wide and has a tension capacity of 1,705 lbs (7.58 kN) at a DOL (Duration of Load) of 1.60. The application of this repair would require a DOL of 1.15 reducing the effective tension capacity of the strap to 1,225 lbs (5.45 kN). Two straps are required to transfer the 1,947 lbs (8.66 kN) reaction plus the force couple. Any equivalent strap could be used but the CS16 was specified because the Simpson publication specifically allows this series of straps to be cut to the required length with appropriate adjustments if the full development length is not achieved.

For this repair, the scab length was chosen so that the right end of the scab was past the next bottom chord joint for two reasons. The first reason is that the joints are the strongest part

of the truss. If possible, any repair that changes the model of the truss and therefore changes the forces in the members should be attached at a joint to produce the minimal effect on the truss. The second reason is the basic principle of a lever arm in that an increase in the length of the lever arm means a decrease in the required connection at that end. The minimum length of the scabs should be 3x the extension distance so that there is at least 2x the extension distance beyond the original truss support. In this example, the distance that the scabs went beyond the original truss support was more than 4x the extension distance allowing the force couple at the right end of the beam model to be easily resolved with a nailed connection.

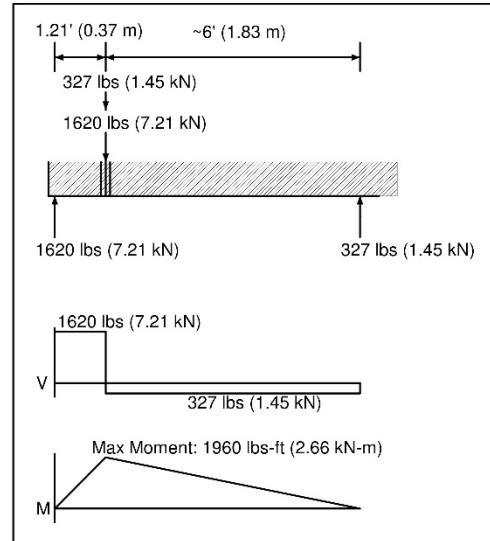
The design of the beam can be approached similar to a simply supported beam model with an off-center concentrated load. However, the connection to the truss generates a moment that can be modeled as a force couple which in this case works out to be 327 lbs (1.45 kN). The diagram to the right shows the free-body, shear, and moment diagrams for the beam. The allowable shear stress, f_v , for 2x10 (38 x 235 mm) SP No. 2 is 175 psi (1,207 kN/m²) and the allowable bending stress, f_b , is 800 psi (5,516 kN/m²) as given by the 2015 edition of the NDS Supplement. According to NDS-2015 equation 3.4-1 the allowable shear capacity of the wood beam is:

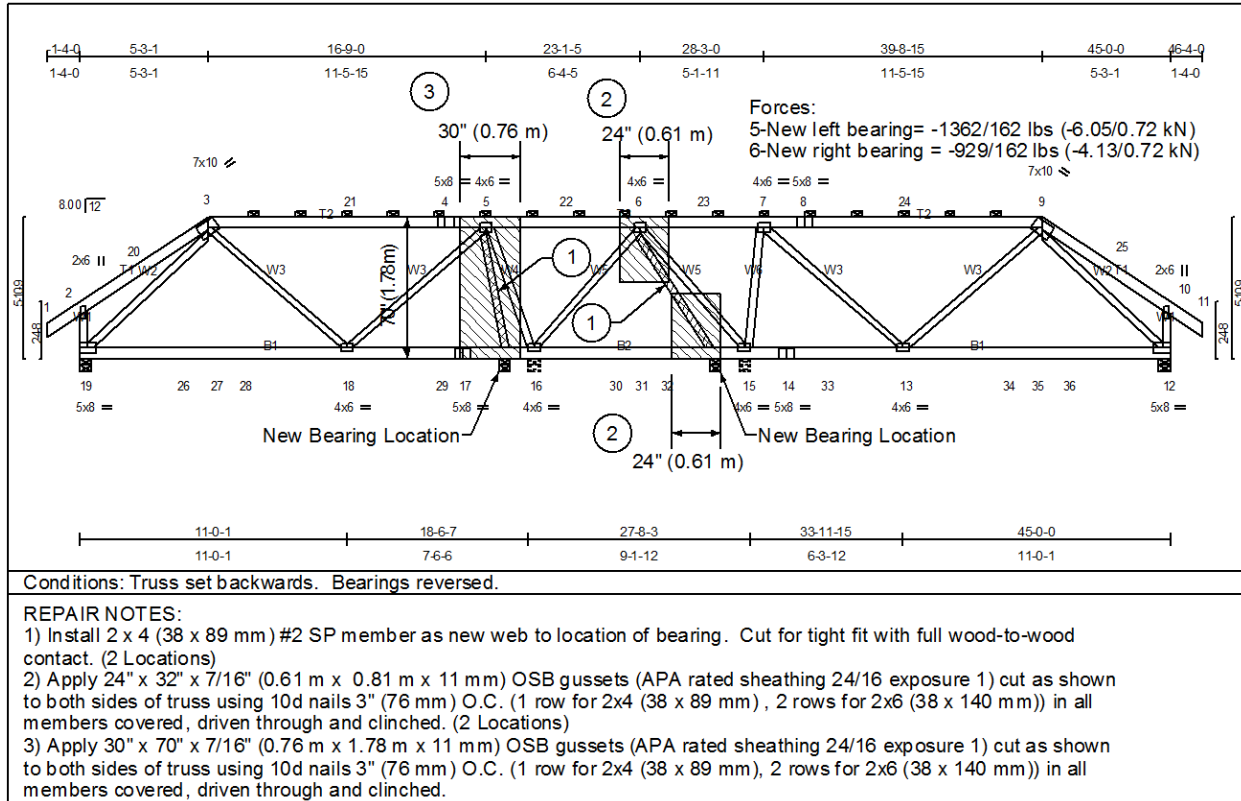
Repair Drawing

The roof truss was set backwards causing both interior bearing supports to be in a different location than originally designed.

Setting trusses backwards is not uncommon when the truss profile is nearly symmetric and there is some subtle difference such as an off-center interior bearing location. When cost effective, perfectly symmetric trusses are a desirable option to avoid this installation error. However, the trade-off is the extra cost of adding more webs if the bearings are not in symmetric locations versus the ease of installation. For the truss shown, several additional webs would have been needed to make the truss symmetric with two interior bearings and so the symmetric design was not practical.

To complete the repair, two webs were added to the truss at the revised bearing locations. The forces in the new webs are shown above. The development length for the forces in the new web on the left would require the OSB gussets to overlap, so the decision was made to make the gussets the full height of the truss.

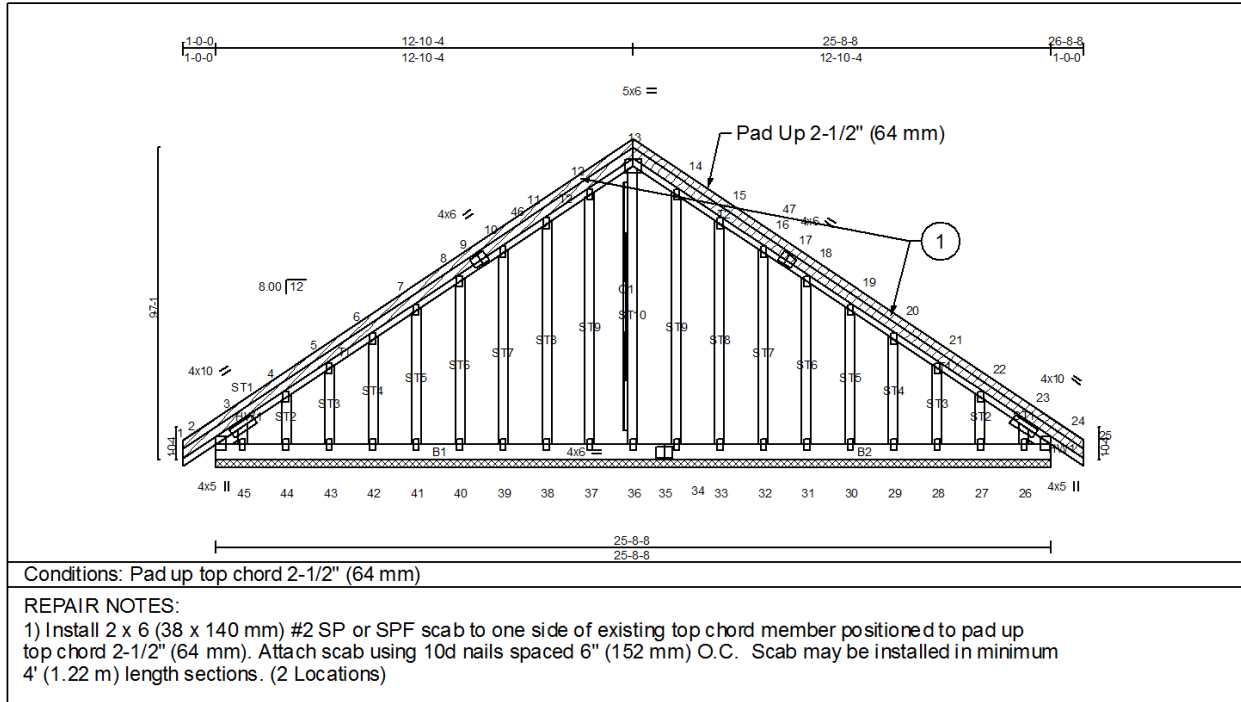
Repair Drawing

The roof truss was designed too short vertically for the required application.

This repair was required due a design error where the heel height was not set correctly. The distance the gable truss needed to be raised was small so a larger scab member applied to one side was sufficient. This repair would have been the same for a structural truss because the scab member that would be attached to the roof sheathing provides adequate bracing of the top chord members.

In general, larger dimensional lumber members can be applied as a scab to the side of the top chord to make up the difference in height as long as most of the original chord depth is covered and the connection is adequate. The recommended maximum distance for offsetting the roof sheathing from the top chord of the truss are that a 2x6 (38 x 140 mm) scab could be used to raise a 2x4 top chord member up no more than about 3" (73 mm), a 2x8 (38 x 184 mm) about 4 1/2" (114 mm), and a 2x10 (38 x 235 mm) about 6" (152 mm). It is not recommended to use this repair technique to raise the top chord of a truss more than 6". These recommended distances for the scabs to raise the top chord plane are perpendicular to the slope of the top chord so the actual allowable vertical height adjustment would vary with the pitch of the roof.

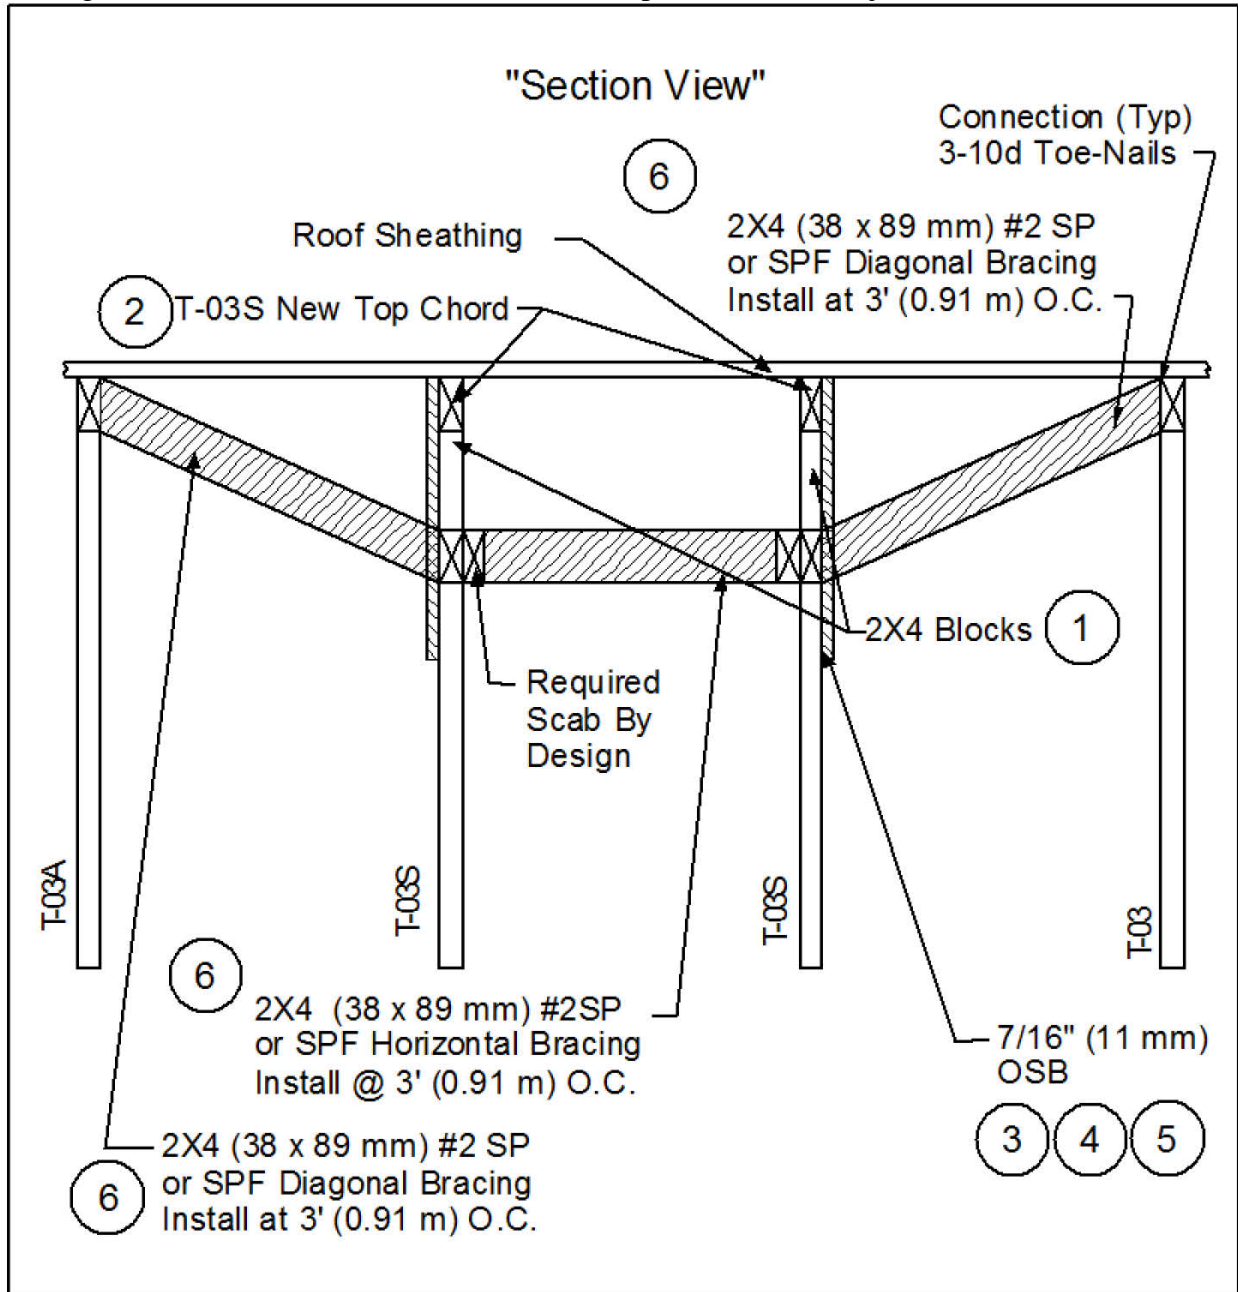
every 3'-1 7/16" (0.95 m) maximum to prevent buckling due to the compressive forces in the member. The 2' (0.61 m) spacing is an industry standard for applying purlins along a flat top chord which is not necessary in this case. To get the correct profile, new webs and new top chord members were installed with an OSB gusset on one face at each joint. In order to brace the original top chord members of each the T-03S trusses, 2x4 (38 x 89 mm) horizontal and diagonal bracing members were installed at 3' o.c. to the top chords of the adjacent trusses.
