Repair Techniques for Metal Plated Wood Trusses

Part 2: Moderate Truss Repairs

Derek L. Rhodes, P.E.

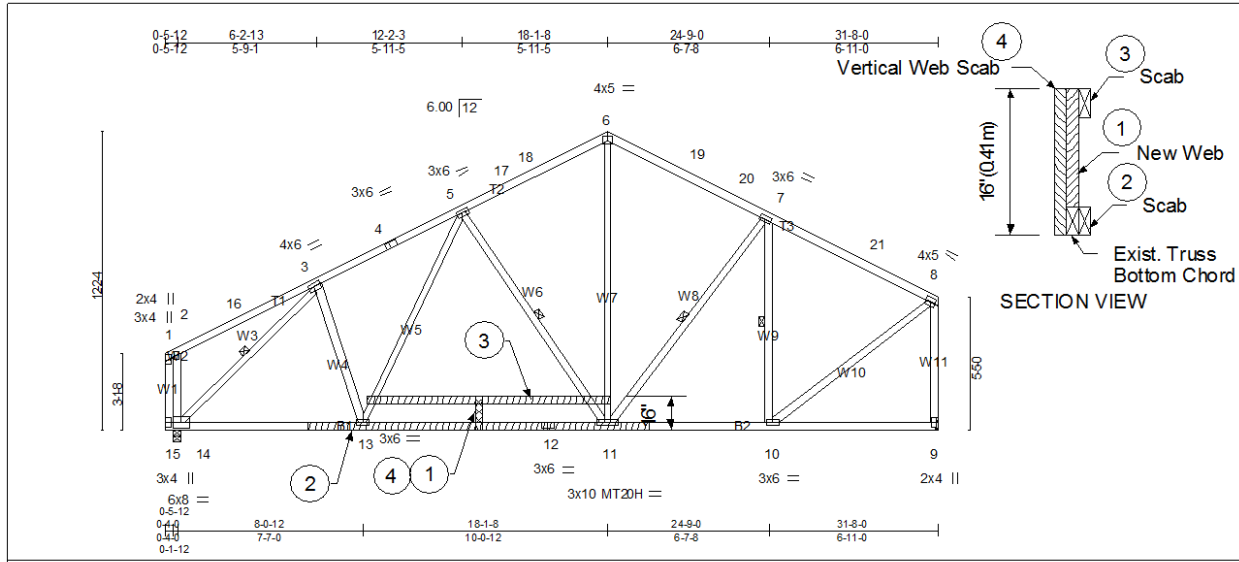
Repair Drawing

An HVAC platform was needed within the profile of the truss.

Conditions: Truss to support HVAC platform

The space within a roof truss is a common area to place HVAC units. If the location of the HVAC unit is known prior to the fabrication, then the design of the truss can accommodate the unit. Often, a platform similar to the one shown in this repair would be built into the truss to raise the platform above the insulation. According to Table R301.5 of the IRC2015, any horizontal area of the truss that is raised above the insulation and can fit a box 42" (1.07 m) tall by 24" (0.61 m) wide should be loaded with 20 psf (0.96 kN/m²) live load. When this load was added to the truss with a raised platform, the bottom chord required reinforcement because the CSI (Combined Stress Index) of that member exceeded 1.0. Once the bottom chord scab length was determined to be 14' (4.27 m) as shown, it was decided that a scab on the side of the truss at the elevation of the platform would be best solution. The vertical web was added to transfer load down to the bottom chord, and the vertical scab was added to complete the connection. If the bottom chord reinforcement was not required then the repair could have entailed adding the vertical web and the horizontal raised bottom chord members in the plane of the truss with OSB gussets at the three joints.

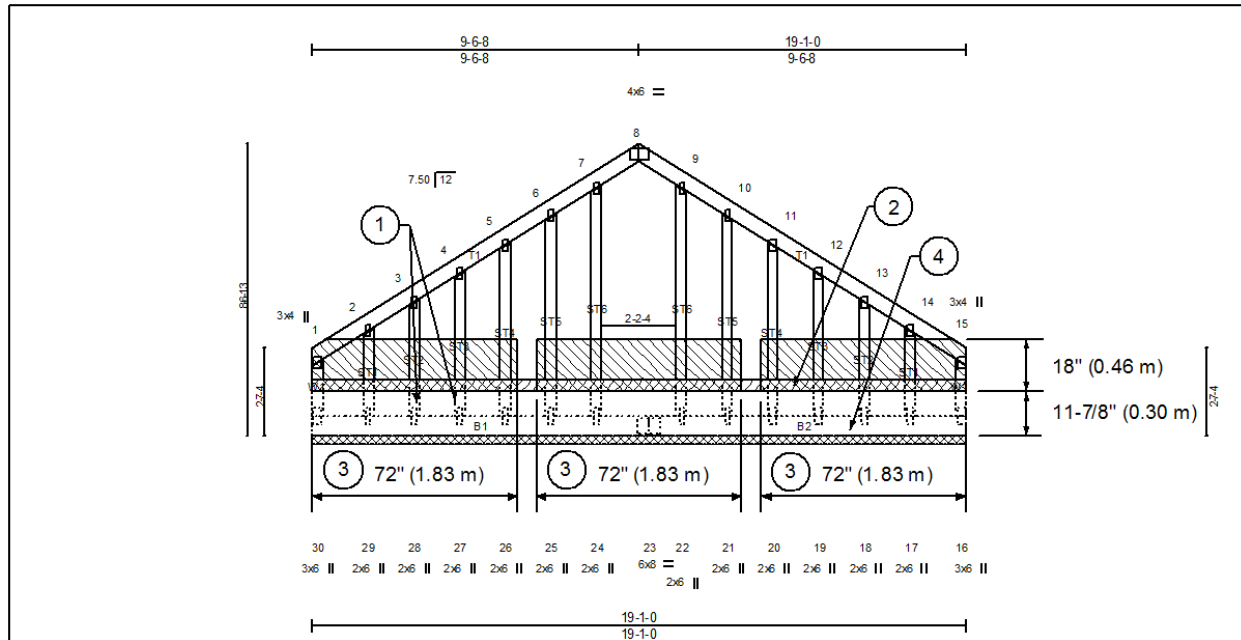
Repair Drawing

A raised beam interfered with the gable truss.

Conditions: Raise bottom chord of truss 11-7/8" (0.30 m)

This truss repair resulted because the builder needed to place a continuous beam across the garage to complete the portal framing. When a gable truss is too tall, the height adjustment can be made either to the top chord or to the bottom chord depending on the stage of construction and complexity of either repair. In this case, the repair to the bottom chord was chosen because of the simplicity that option presented. For gable trusses, the OSB gussets are sized based on geometric constraints rather than the force in each member as with normal structural trusses, and the three gussets shown proved to be an efficient way to cover all of the stud members.

There are more options provided in the connection of the gussets to the gable truss than for other trusses because if the truss is already erected including the exterior sheathing and siding, the 10d nails would potentially penetrate and damage the siding.

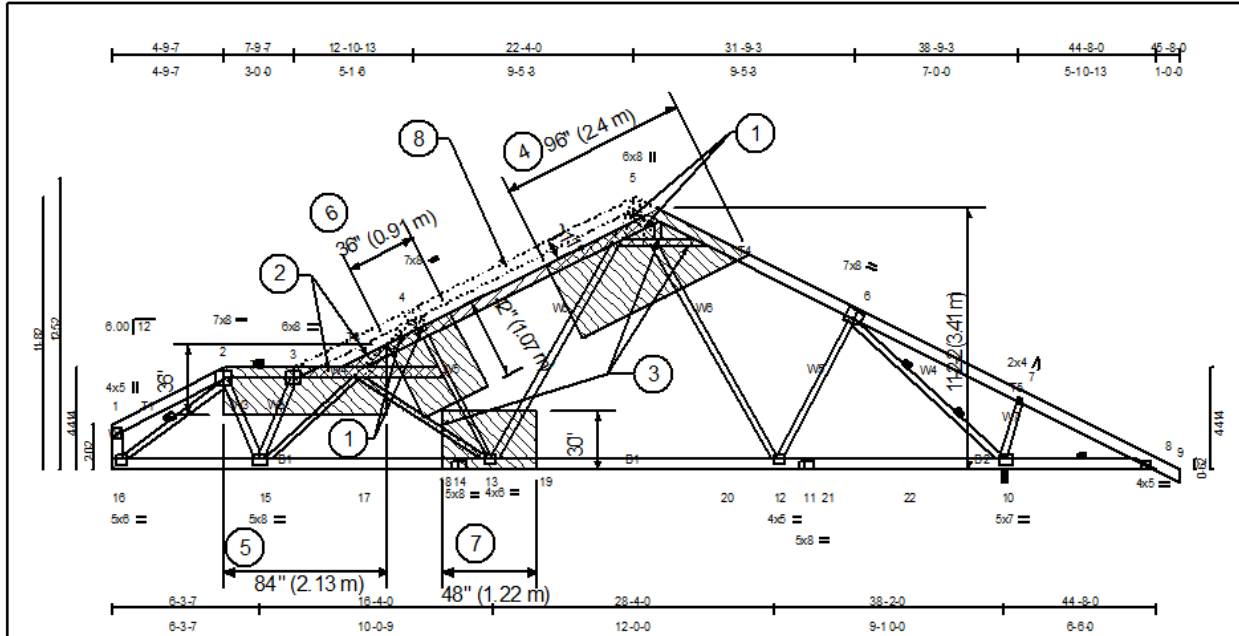
Repair Drawing

The middle sloping section of the top chord is too tall for the application and must be lowered.

Conditions: Top chord to be lowered for overall height of 11-2-2 (3.41 m)

Several concepts required consideration when developing the model for this truss repair. One consideration was making sure the length of each member was sufficient to develop the required connection. In the case of the new top chord member from joints 3 to 4, that piece required 24" (0.61m) of development length for the OSB connection which was approximately the distance between the joints. Because of the angled cut that was required at the left end, the member was extended to the next web to create joint 6.

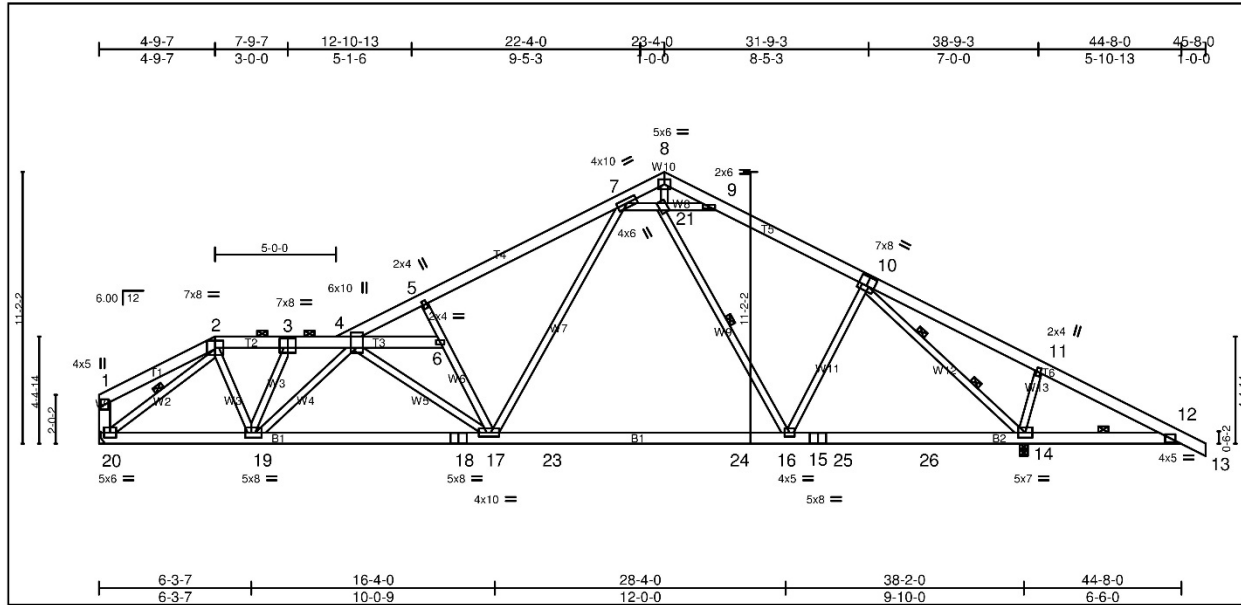
highest force, but because these are 2x6 (38 x 140 mm) members, more rows of nails are used which reduces the development length.

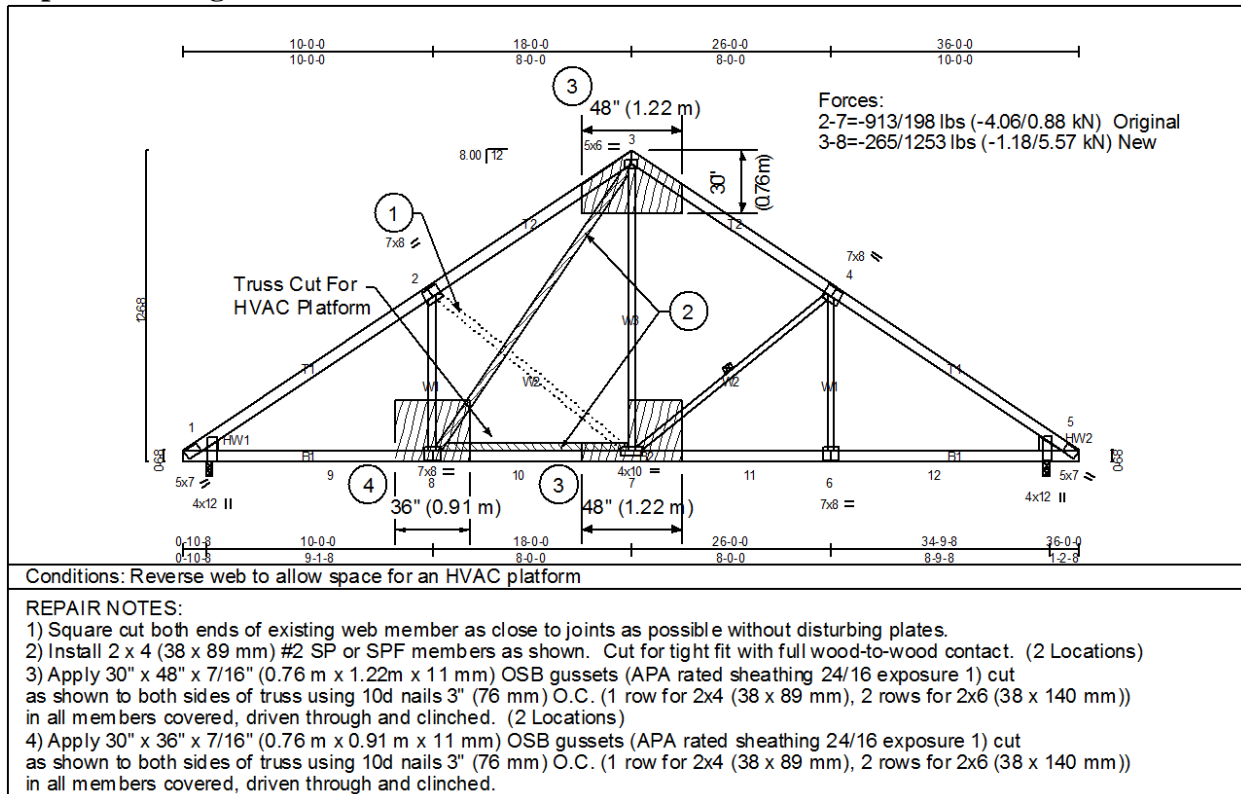
Repair Drawing

An HVAC platform needs to be placed inside the truss.

In this case the best way to provide the needed space for the HVAC platform was to reverse the direction of the web unlike Example 8-4 where there was already a large open area in the truss where the platform could be added. According to the light attic storage provision found in Table R301.5 of the IRC2015, the open region of the truss where the HVAC unit is to be placed should be loaded with 20 psf (0.96 kN/m²). This light attic storage load is sufficient to account for most residential HVAC units and was already applied to regions of the truss from joints 9 to 10 and joints 11 to 12. The original web was predominately in compression, but with the reversed web, the controlling force in that member was 1253 lbs (5.57 kN) in tension. According to Table 3-1, the shear capacity for a clinched nail in a roof truss with OSB gussets is 173 lbs (0.77 kN) requiring eight 10d nails requiring a development length of 24" (0.61 m). The forces in other members changed as well. For example the compressive force in the top chord member from joint 2 to joint 3 changed from -1700 lbs (-7.56 kN) to -2618 lbs (-11.6 kN), but these force changes did not require in any plate size changes at any other joint. The stacked bottom chord was added as a courtesy for the builder facilitating framing of the HVAC platform but was not needed to meet the structural requirements of the truss.

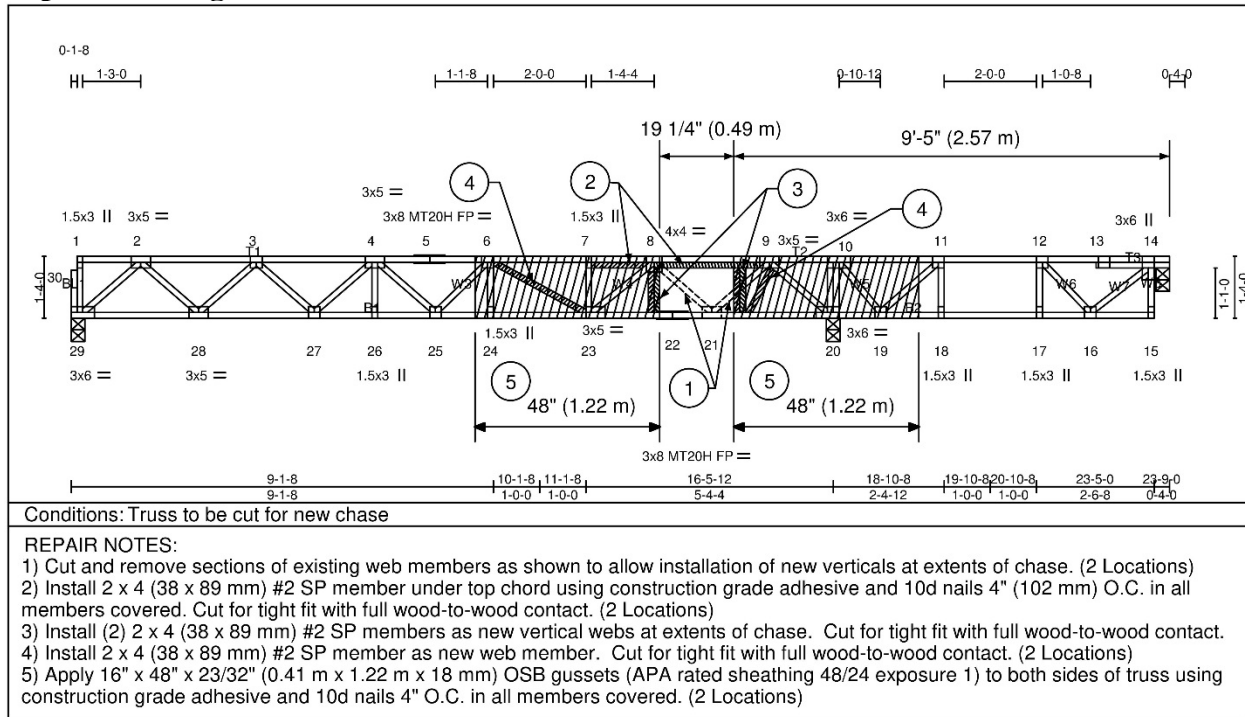
Repair Drawing

The floor truss chase is to be relocated closer to an interior bearing

The reason for this repair was that an adjacent floor truss was set backwards, and the chases needed alignment for passage of the ductwork. In general, the best location for a chase is in the middle of the truss span. A good rule of thumb for the best performance is that if the floor truss span were to be split into four quarters, the chase should be located within the center two quarters. When the chase is located outside that region, the shear force and differential deflection increase across the chase. The original chase was located within that ideal range between joints 6 and 7. However, the new chase location was outside the center zone, requiring a more severe repair. The remodeled truss with the revised chase location required the top chord to be doubled because of the increase in shear. The vertical webs were installed to define the chase and to provide perimeter nailing for the OSB gussets. The diagonal webs were added to provide more triangulation to improve the performance of the truss. As in Example 9-1, these diagonal webs were completely covered by the OSB gussets and an argument could be made that they are not needed, but with the new chase location in the last quarter of the span, these webs were added to increase rigidity.

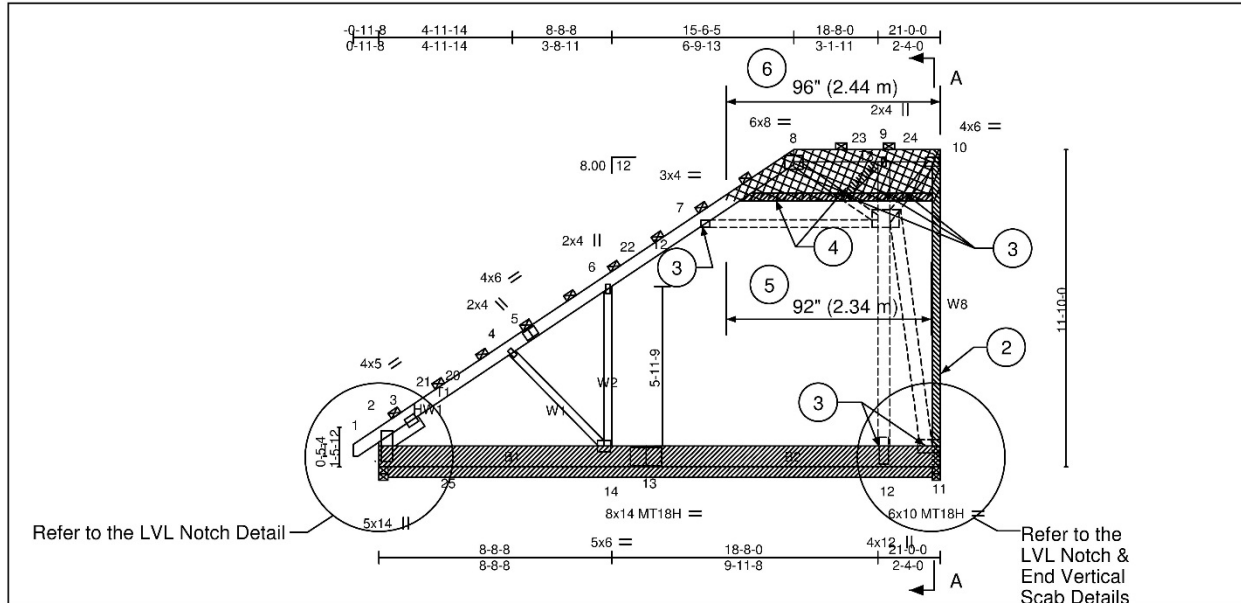
Repair Drawing

Both the room width and height were too small for the required application.

Conditions: The height of the attic room is to be increased to 9' and the width to 12'.

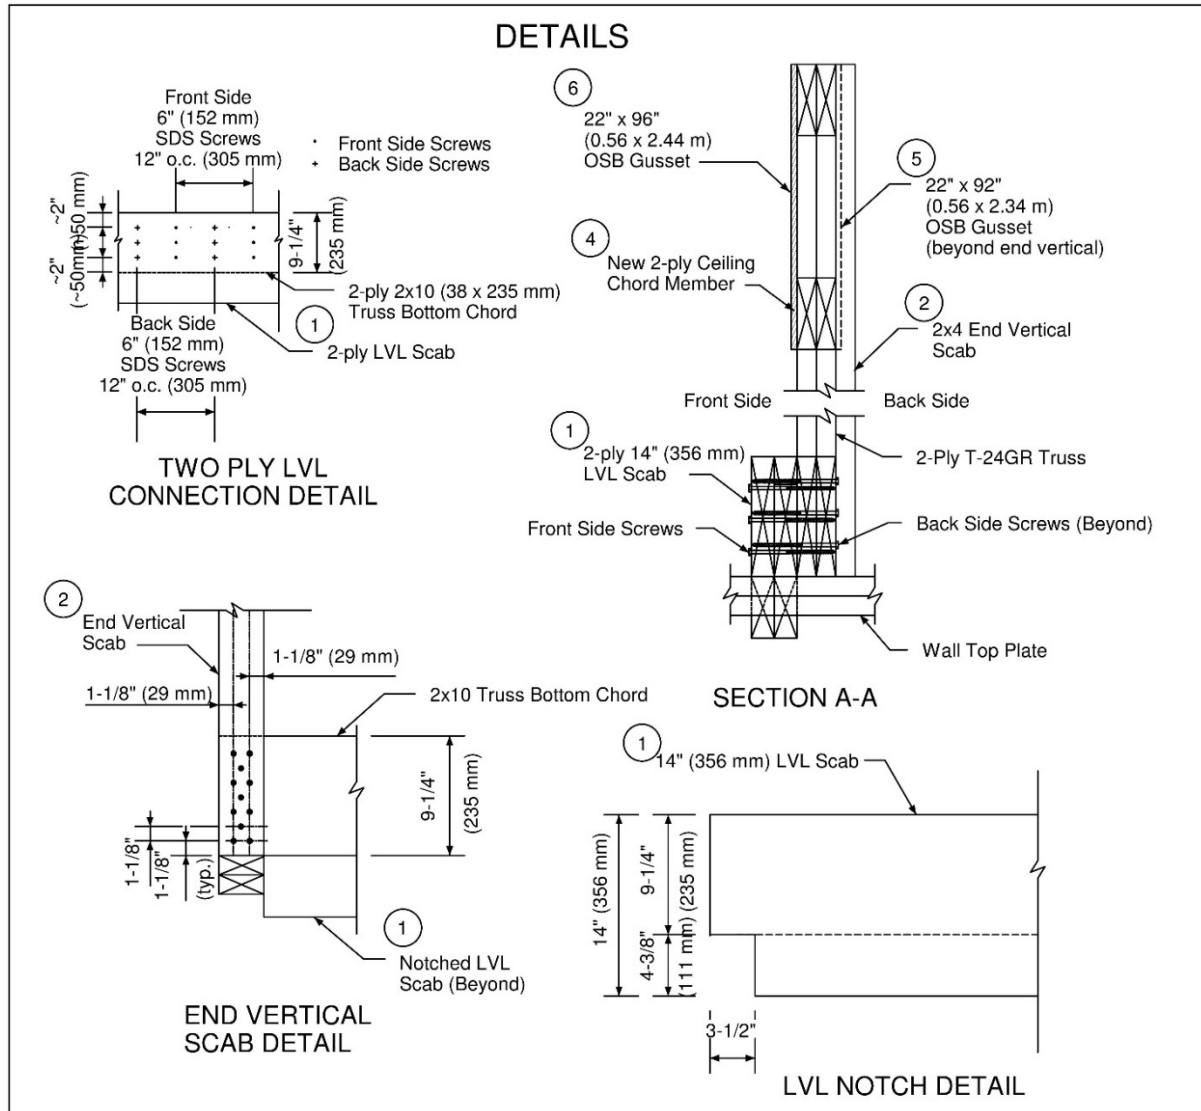
Remodeling of the 2-ply dormer girder truss with the adjusted loads and larger room showed some of the forces in the members actually reduced because of a conservative original design. The modification to this truss was still substantial and the extra details shown above were provided to insure proper installation. The bending stress in the bottom chord increased beyond acceptable limits for a 2x10 (38 x 235 mm) bottom chord. After negotiations with the affected parties, it was determined that best solution was to sacrifice some ceiling height below the trusses in a room that already had a 9' (2.74 m) ceiling rather than replace the trusses at that stage of construction. The 14" (356 mm) LVL material provided the required strength for the larger room. The LVL material was available in long enough lengths that there was no need for splice in the bottom chord.

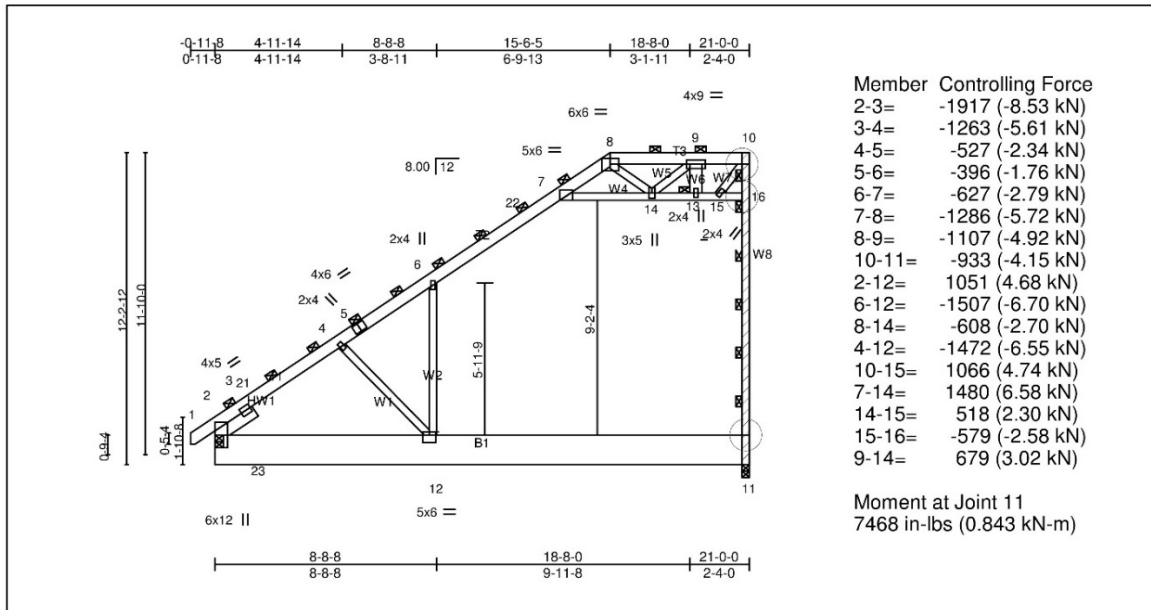
The end vertical member was the next most critical area to consider. The actual controlling tension force in the bottom chord and compression force in the end vertical member were relatively small. However, the revised model reported a moment at joint 11 of 7468 in•lbs (0.843 kN•m) which generated a bending failure in the end vertical member. In this model, the single scab was sufficient to reinforce the end vertical but could not develop the required moment connection given the geometry of the joint. Upon further review, the undamaged portion of the original truss plate was able to transfer most of moment and needed only a little reinforcement to finish the task. It was decided to apply the two bottom chord scabs to one side of the bottom chord and the end vertical scab to the other as shown in Section A-A. The end vertical scab overlapped the bottom chord allowing for the modest moment connection (as shown in the End Vertical Scab Detail) to reinforce the remaining truss plate. Part 3 of this course series will have a more in-depth discussion of developing a moment connection.

The revised model required the end vertical scab to go the full length of the member including the section above the new attic ceiling. This model also required two small webs to be added above the new ceiling member. However, the lengths were insufficient to develop the full connection requirements for separate gussets at each joint. The solution was to apply one 92” (2.34 m) wide OSB gusset on the same face as the end vertical scab and one 96” (2.44 m) wide OSB gusset on the opposite face that extended to the right end of the truss allowing for full perimeter nailing for that piece.

This repair involved a 2-ply truss located on either side of a dormer where the attic area continued to the left end of the truss. This truss was part of a series of mostly single ply attic trusses with the same profile where the room was similarly undersized. Since the whole series of trusses was affected, a small drop in the ceiling height was considered an option to resolve the issue. The revised truss and associated repair details are shown on the following pages.

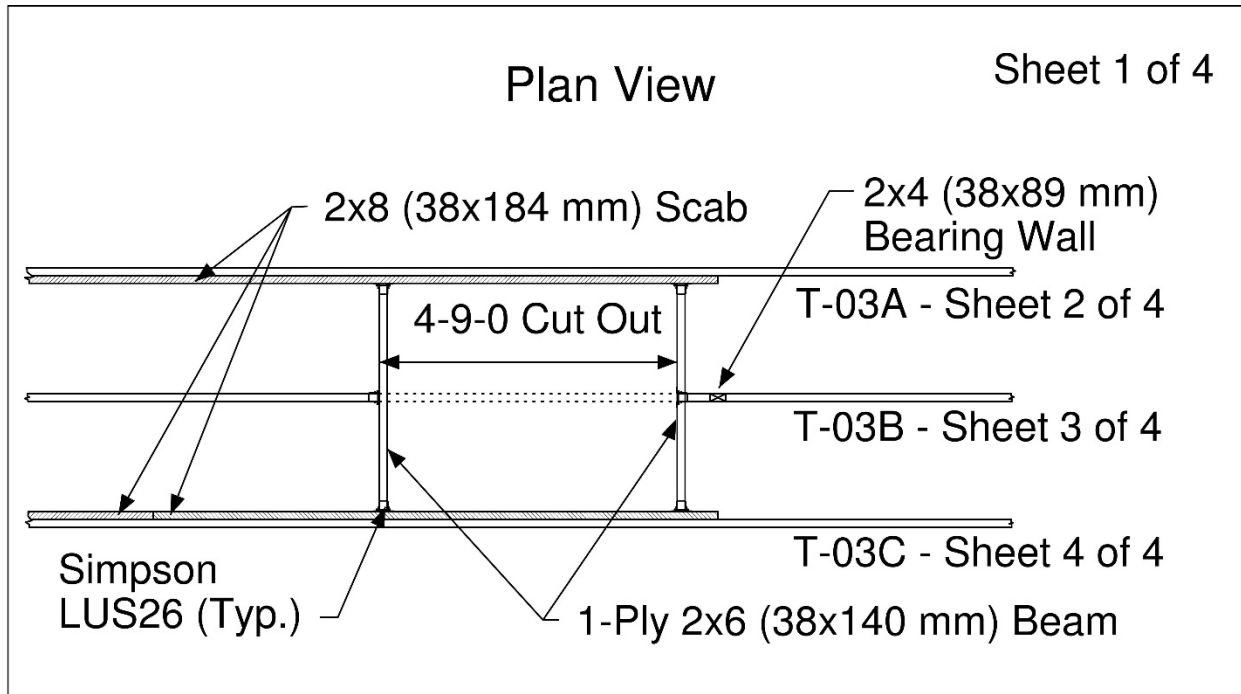
Repair Drawing

The required pull-down stair opening is wider than the spacing between the trusses. A section of the bottom chord must be cut and removed from the T-03B truss.

The issue of requiring a larger opening than the 22 1/2" (0.57 m) clear space between trusses for the pull-down stairs is fairly common. The error could have been made by the framers if they missed the special spacing requirement, by the truss design team for not specifying the location on the truss placement plan, or by the building designer for not locating the pull-down stairs prior to truss erection. On occasion, the long dimension of the stair opening may actually be perpendicular to the trusses requiring two or more trusses to be cut. The general principle of the repair is to cut the necessary portion of the bottom chord, use hangers on a beam to support the cut portions of the truss, and support the beams on the adjacent trusses using hangers.

This repair involved three different trusses: the one being cut for the opening and the two that support the beams. The repairs to all three trusses are presented as part of this example along with a plan view shown above.

In this case there were three different trusses involved in the repair (T-03A, T-03B, & T-03C). T-03B is the truss to be cut. T-03A and T-03C are the trusses redesigned to support the new beams. A plan view detail along with a repair drawing for each truss involved are shown above. The modifications of each truss were modeled inside the truss software. The builder was also able to provide a 2x4 (38x89 mm) bearing wall at joint 11 for T-03B. With the new bearing wall and the beam supporting the other end of the opening, no additional changes were required because the effective span of the truss had been reduced and the forces in the members were smaller than the original design.

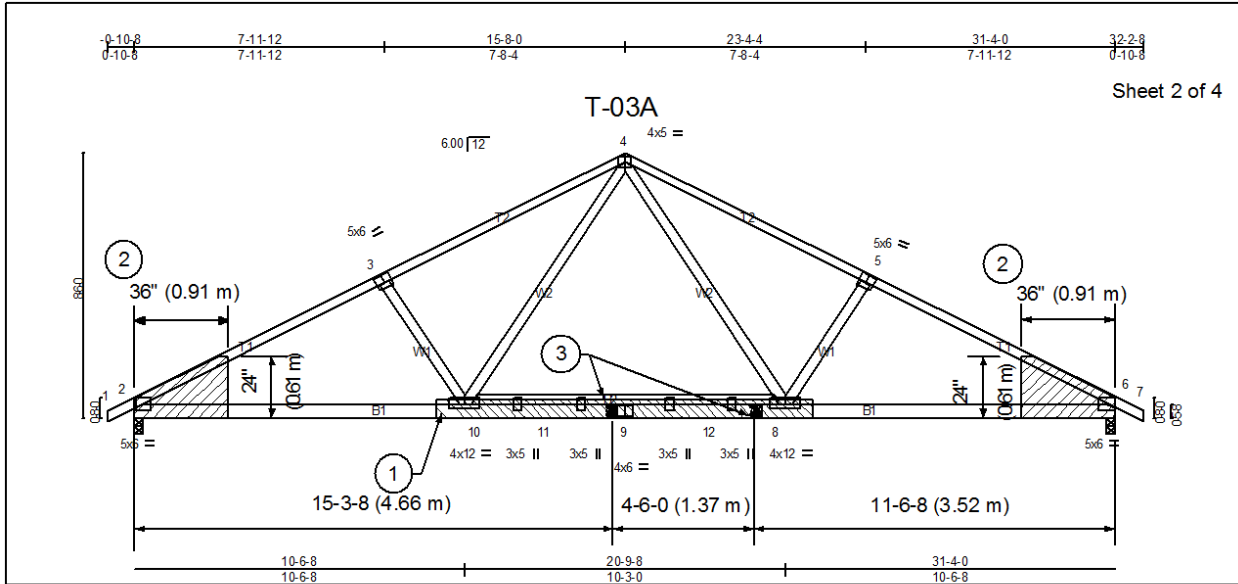
Sheet 2 of 4

Conditions: Truss support load from adjacent T-03B

- 1) Install 2 x 8 (38 x 184 mm) #2 SP scab to one side of existing bottom chord member. Attach scab using 3 rows 10d nails spaced 6" (152 mm) O.C. Scab length = 12' (3.66 m).
- 2) Apply 24" x 36" x 7/16" (0.61 m x 0.91 m x 11 mm) OSB gussets (APA rated sheathing 24/16 exposure 1) cut as shown to both sides of truss using 10d nails 3" (76 mm) O.C. (1 row for 2x4 (38x89 mm), 2 rows for 2x6 (38x140 mm)) in all members covered, driven through and clinched. (2 Locations)
- 3) Support 1-ply 2x6 (38x140 mm) #2 SP or SPF beam using Simpson LUS26 Hanger or equivalent. (2 Locations)

The new loads imposed on T-03A and T-03C caused some plates and lumber to be undersized. T-03A required reinforcement at the heel joints and T-03C required reinforcement at the top chord joints 4 and 7 and along the bottom chord between joints 14 and 15. Also, both trusses required reinforcement in the area of the bottom chord where the hangers were attached.

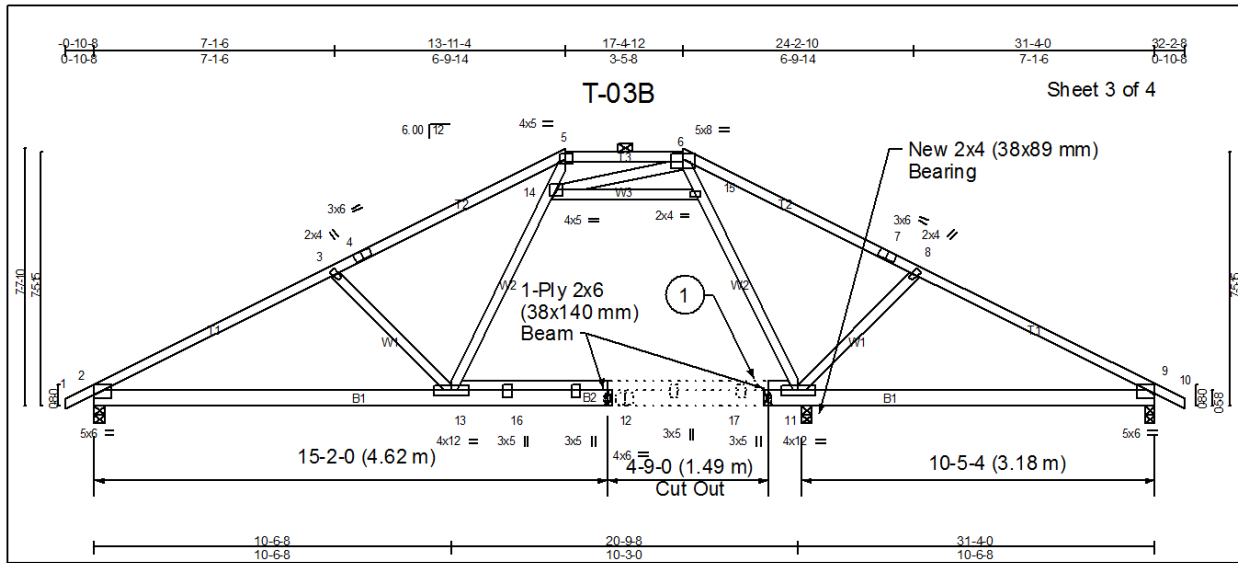
Sheet 3 of 4

Conditions: Truss to be cut for pull-down stair

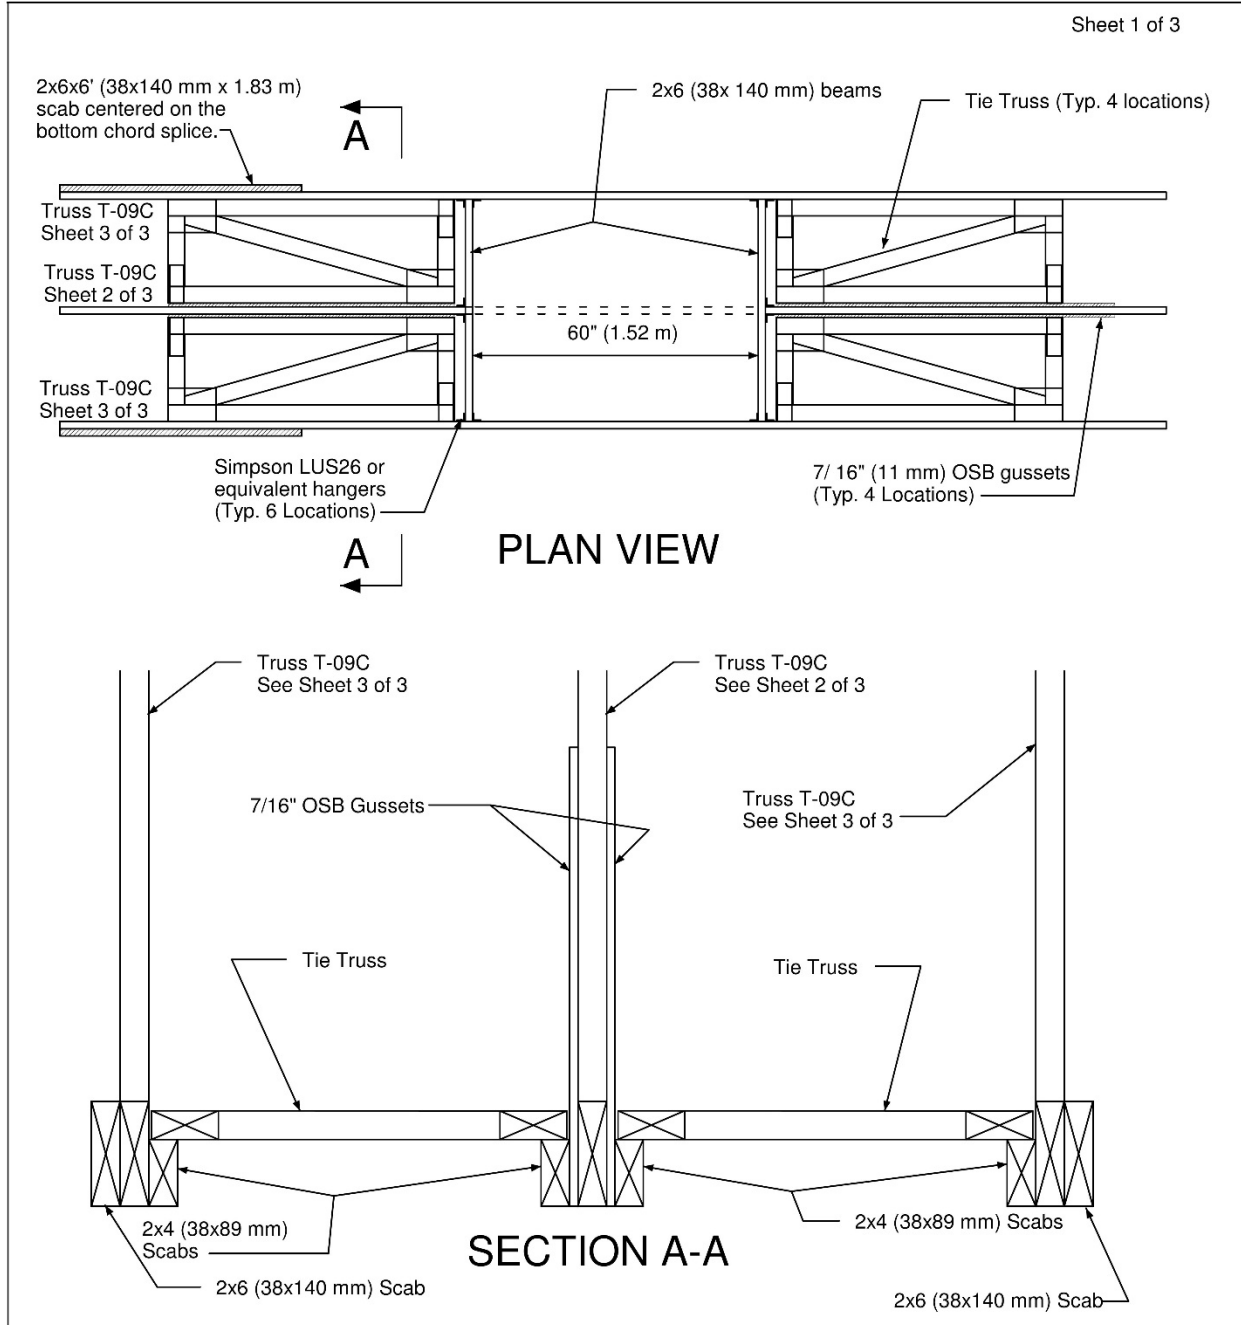
Repair Drawing

The required pull-down stair opening is wider than the spacing between the trusses. A section of the bottom chord must be cut and removed from the T-09C truss.

This repair accomplishes the same goal as Example 9-6 by allowing a section of the bottom chord of the truss to be removed, but the method presented in this example relies on a completely different concept. In Example 9-6 the cut truss was essentially modeled as two half trusses where the vertical reactions were transferred to and supported by the adjacent trusses. However, this example considered the direction of force in the bottom chord member and used a system concept as opposed to an individual truss design to allow the adjacent trusses to share the load. The predominant force in the bottom chord member was tension which was in the horizontal direction due to the orientation of the member. The primary concept in this repair was that the tension force of the cut truss is transferred horizontally so that the bottom chord members of the adjacent trusses can share the tension force. As a system concept, there were three individual trusses before one truss was cut; now there are two bottom chord members carrying the tension load of three in the region of the interruption. This repair concept is only effective when the adjacent bottom chord members have excess CSI capacity to take up the extra load.

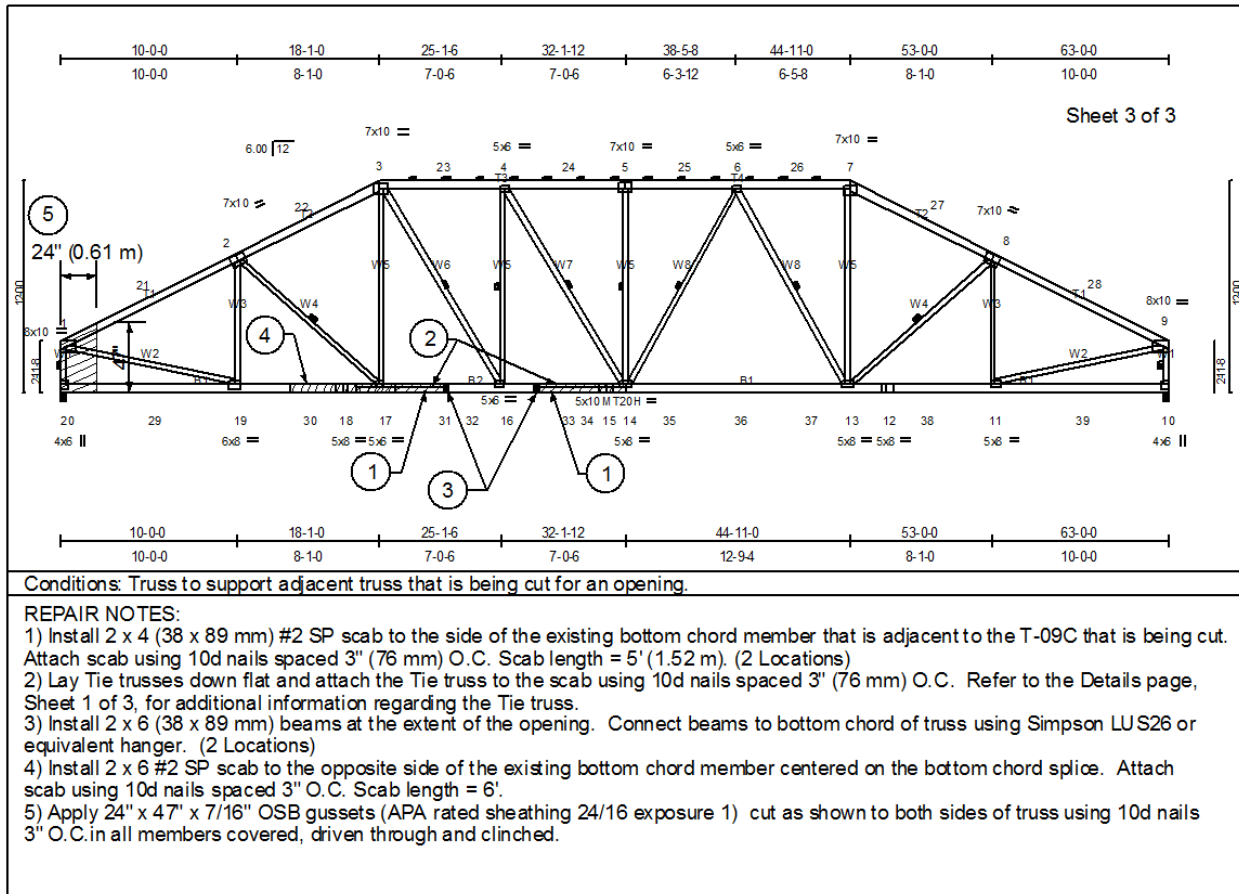
In order for the adjacent bottom chord members to share the load, a mechanism must be designed to transfer the tension force. The concept of transferring a lateral force through a truss is not new. Trusses are regularly used to transfer shear loads down through the structure. The only difference here is that the tie truss is oriented horizontally rather than the traditional vertical orientation for shear transfer. For this repair a tie truss was designed to transfer the 3,506 lbs (15.60 kN) of tension force found in the modified T-09C to the adjacent trusses. The height of the tie truss is determined by the clear space between the trusses minus a little for working space and the length is controlled by the development length of the connection to transfer the tension force. In this case the height of the tie truss is 1'-9 3/4" (0.55 m) x 5' (1.52 m) long. As shown in the details, four of the tie trusses were manufactured and shipped to the jobsite to accomplish the goal of sharing the load.

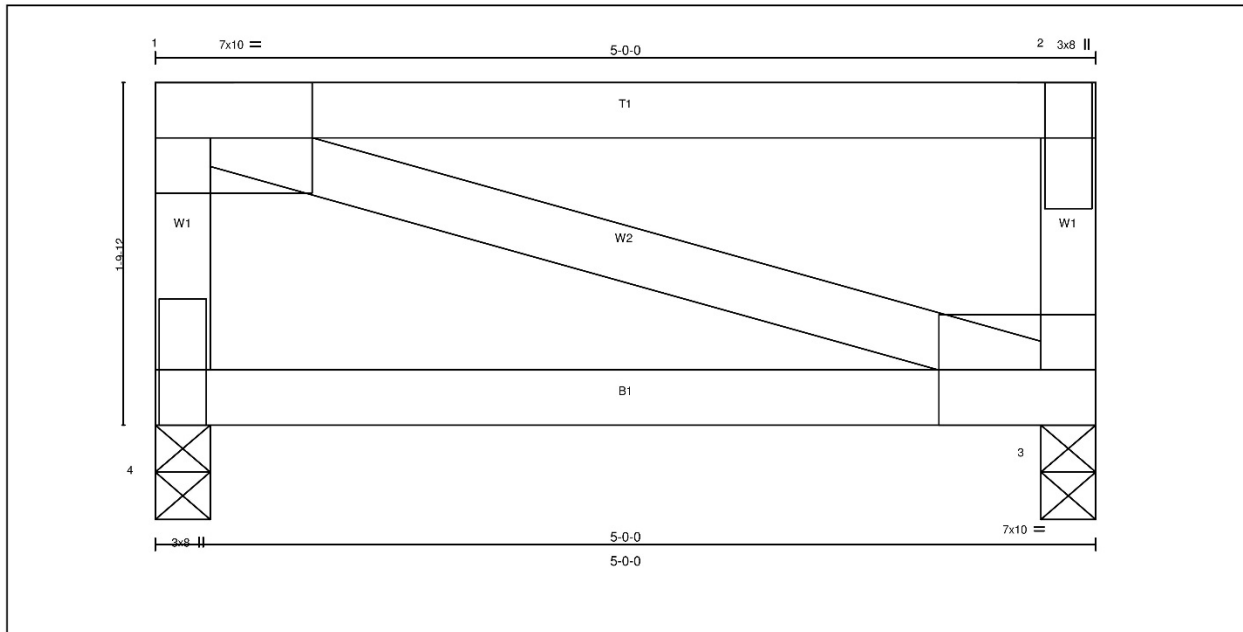
On the cut truss, bearings were placed at the extent of the opening, designed as vertical rollers. The remaining two bearings at the extents of the truss were designed as horizontal rollers. This can be seen in the reactions of the Modified T-09C truss. The vertical reactions were zero at joints 16 and 17 while the horizontal reactions were zero at joints 10 and 21. Due to the fact that this truss was 63' (19.20 m) long, the model did not work with the cut and the vertical rollers, so additional webs were needed to complete the triangulation and get the truss to pass the structural test. These new webs are shown on both the modified T-09C truss graphic and the Sheet 2 of 3 of the actual repair.

The supporting trusses performed well in the model with the extra load except for a minor plate change at the left heel. It is the policy of this truss manufacturer to use a minimum 2x6 (38x140 mm) chord for trusses with a span of 45' (13.72 m) or longer. Because of the larger chord size, the nice regular shape, the height of the truss, and the triangulated webbing, the Combined Stress Index (CSI) in that region of the bottom chord was only 0.29. With a CSI that low, each supporting truss was easily able absorb the extra load.

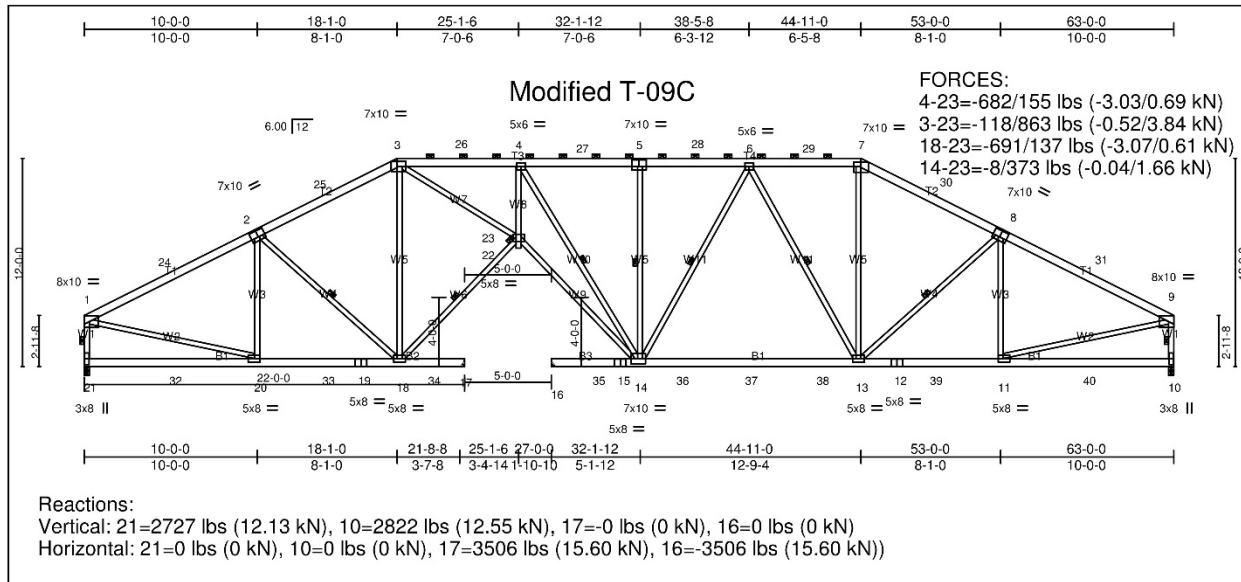
The 5' (1.52 m) long 2x4 (38x89 mm) scab applied to both the cut truss and the supporting trusses act as a little ledge to lay the tie truss flat which provides a good connection to each of the T-09C trusses. There is also a 2x6 (38x140 mm) beam at the extent of the opening connected with hangers. In this example, the 2x6 (38x140 mm) member acts to transfer nominal vertical loads and, more importantly, force the three trusses to deflect together and act as a unit.

Both the vertical load distribution method discussed in Example 9-6 and the horizontal load distribution method discussed here are effective methods of allowing the pull-down stairs to penetrate the truss. Due to the long span of the trusses in this example, the horizontal tie truss repair was the most cost effective solution. The traditional vertical load transfer with the beams is an alternative solution in more time sensitive cases because of the time to manufacture the tie trusses.
