Florida's SIRS Visual Inspections

SIRS Structural Integrity Reserve Study

The visual inspection portion of condo 3s by Florida Professional Engineers

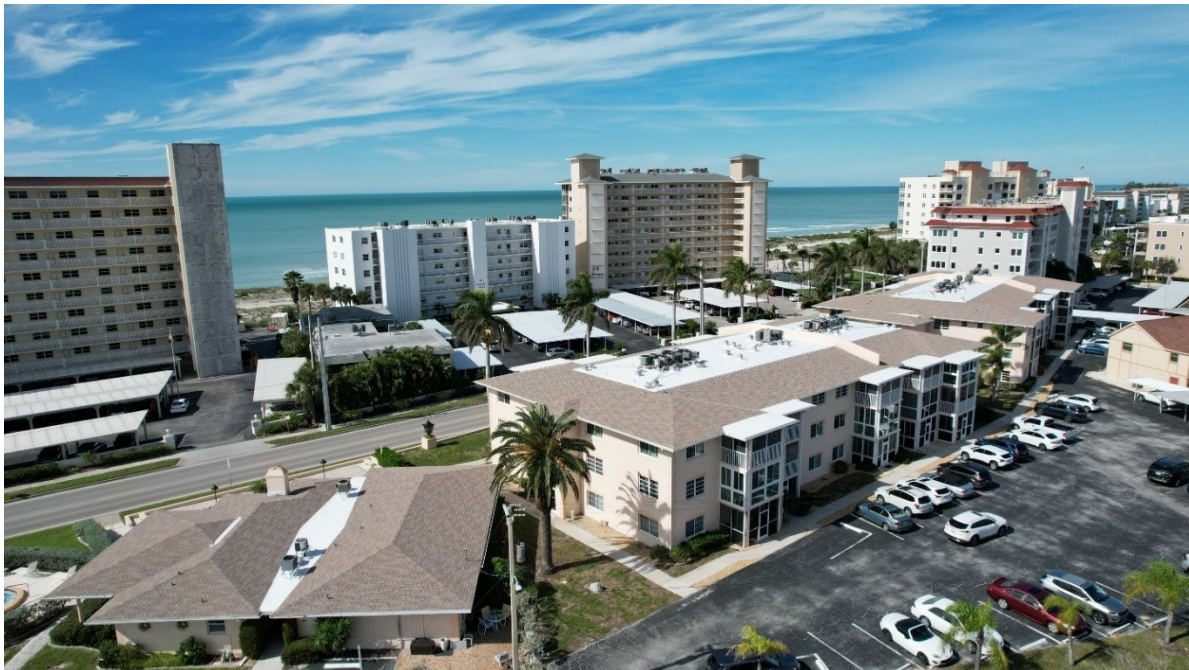
Condos inspected by the author:
*Six-story near the Gulf of Mexico
and separate three-story buildings in the foreground.*

Note that the Clubhouse (in the lower left-hand corner of the picture above) associated with the three-story condo buildings need not be visually inspected for the SIRS, but may typically have Reserve Funds for repairs, etc. The Condo Association financial responsibility extends to all Common property, but only the Condo 3's need PE visual inspection.

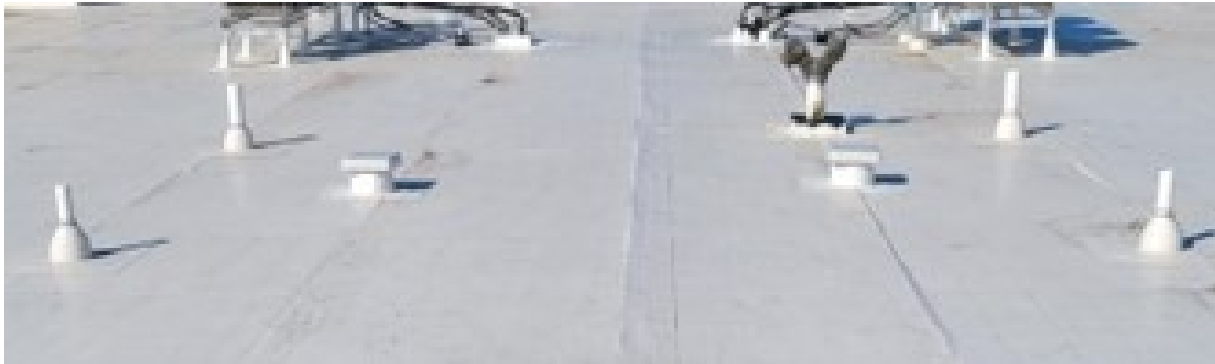
Typical TPO (thermoplastic polyolefin) single ply membrane with plumbing vents.

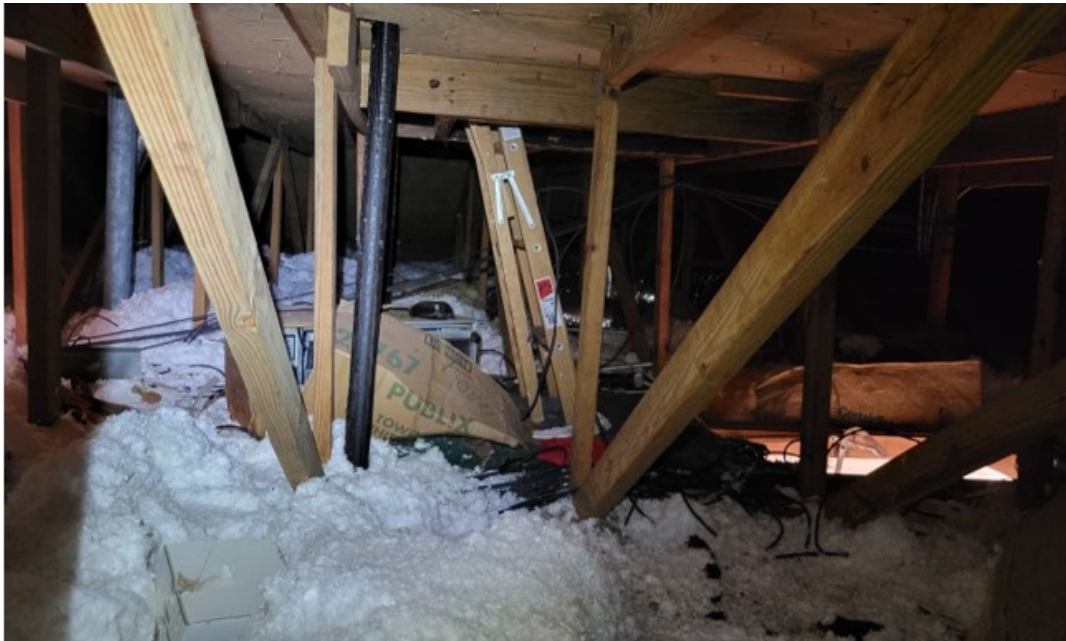
Roof trusses in attic crawl space with access hatch and blown in ceiling insulation.

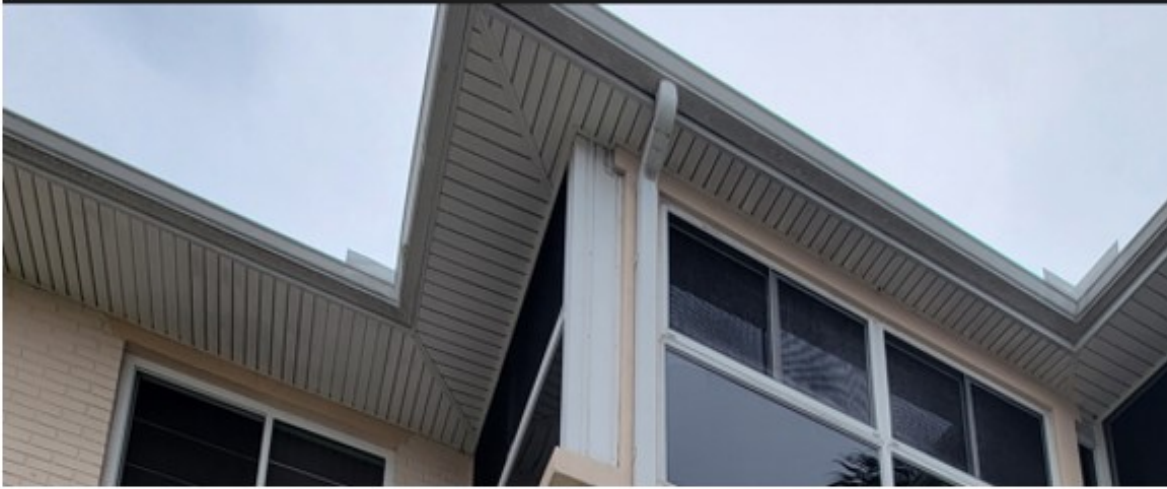
Eaves, (includes fascia) soffit (underside) & gutter condition to be noted.

(Considered part of roof.)

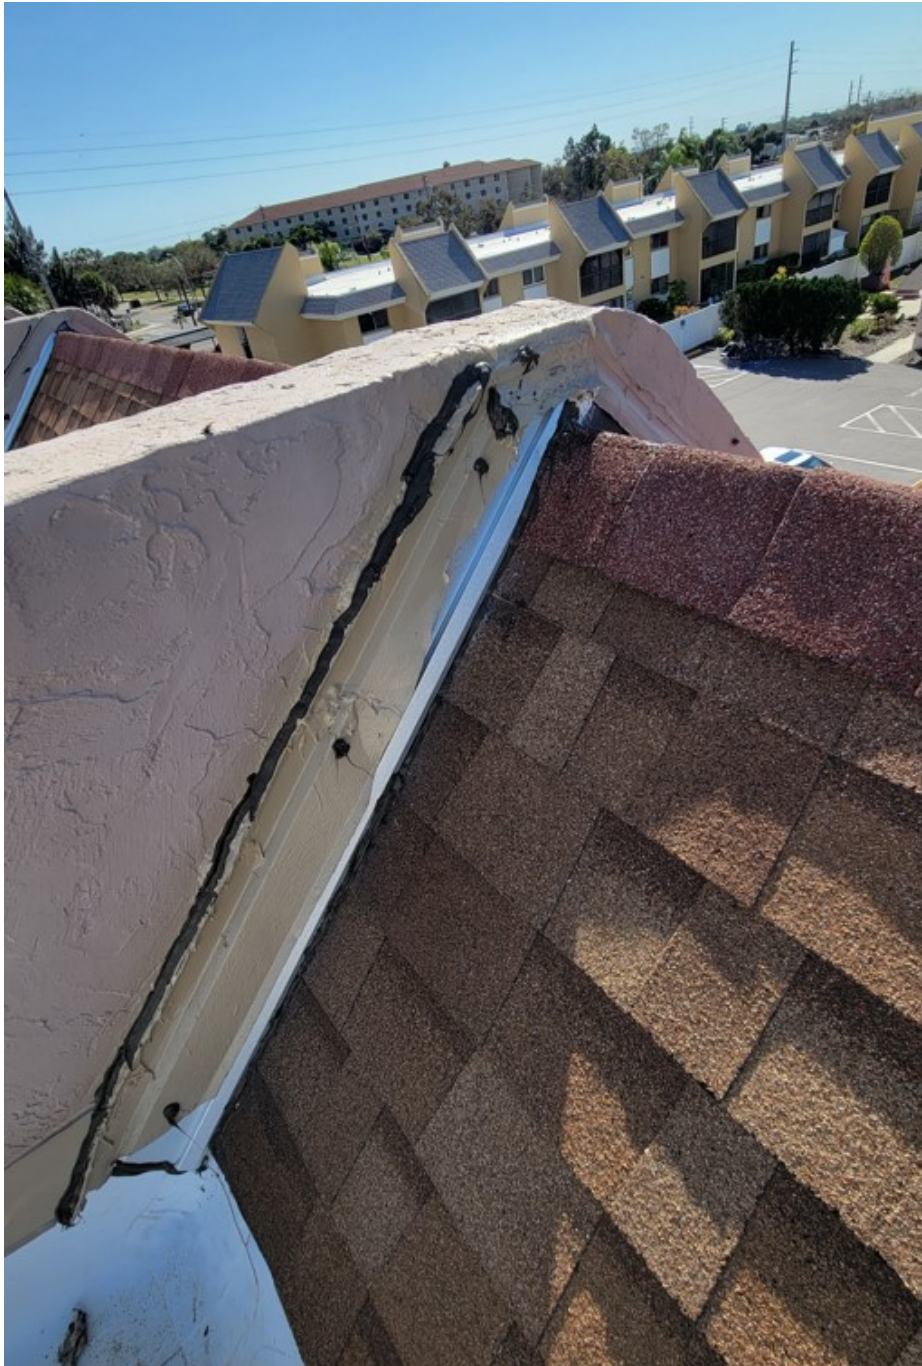
Asphalt Shingles with typical 15-year life or if architectural shingle, with >25-year life.

Florida insurance companies request replacement every 15 years or have it inspected.

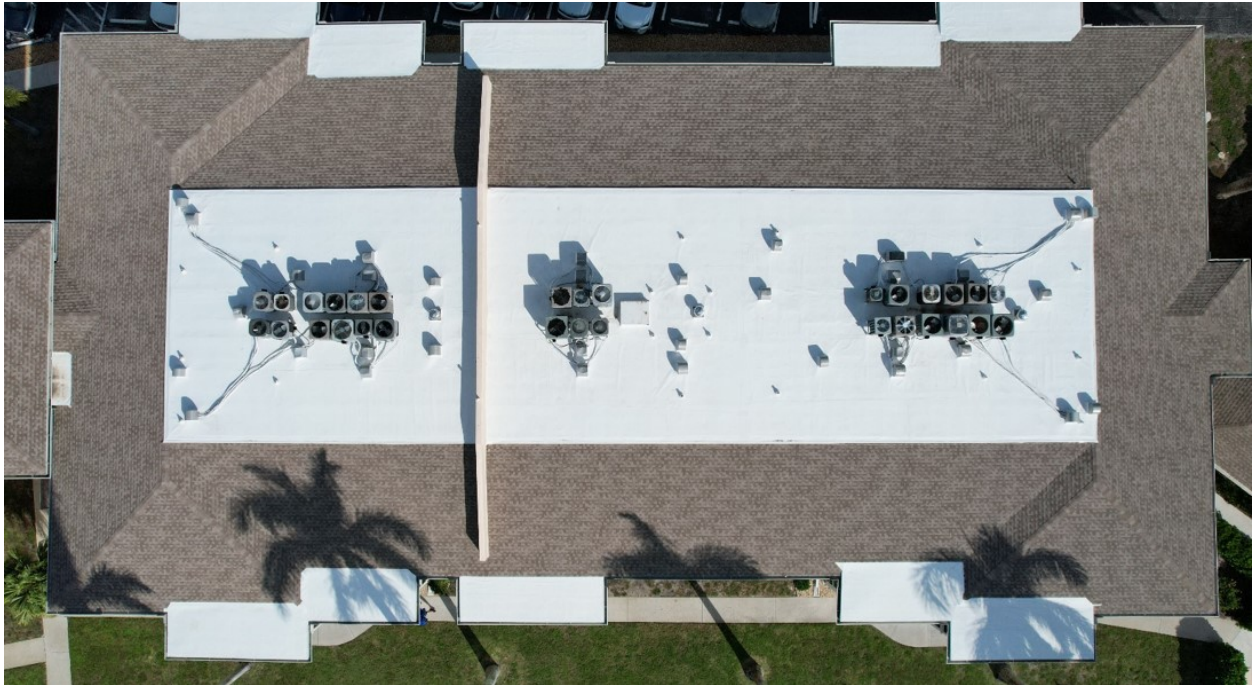
An overall roof view by drone is helpful.

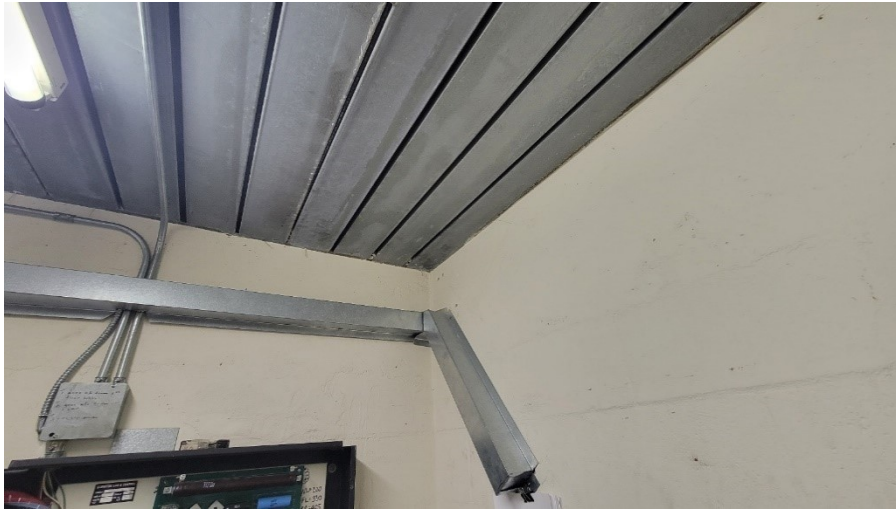
Load bearing walls beneath Q deck.

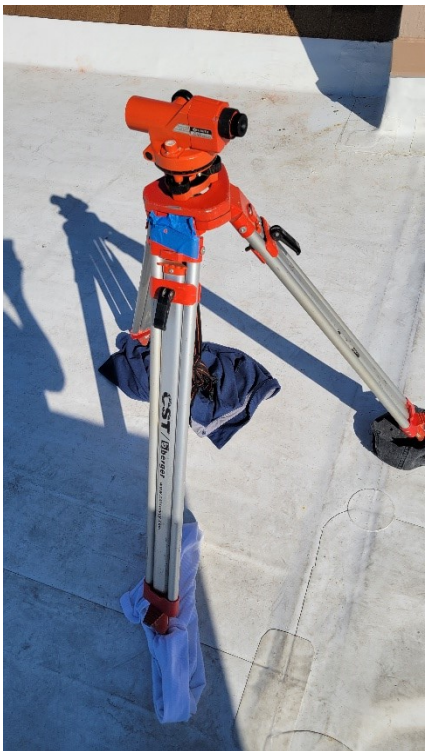
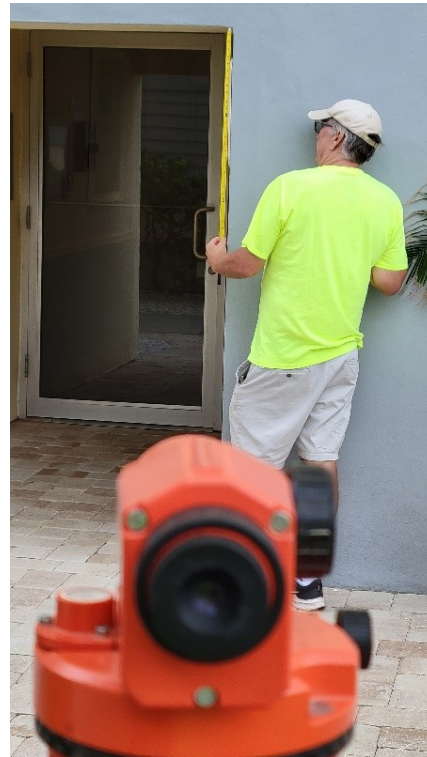
One way to check overall building stability is to check for differential soil settlement. This is done by taking level instrument readings across distant building components. Minor variances in level elevations can be judged as non-critical. Data can be kept for readings in the future and 10 years later at the renewed SIRS time. This may be beyond visual inspection or considered visual.

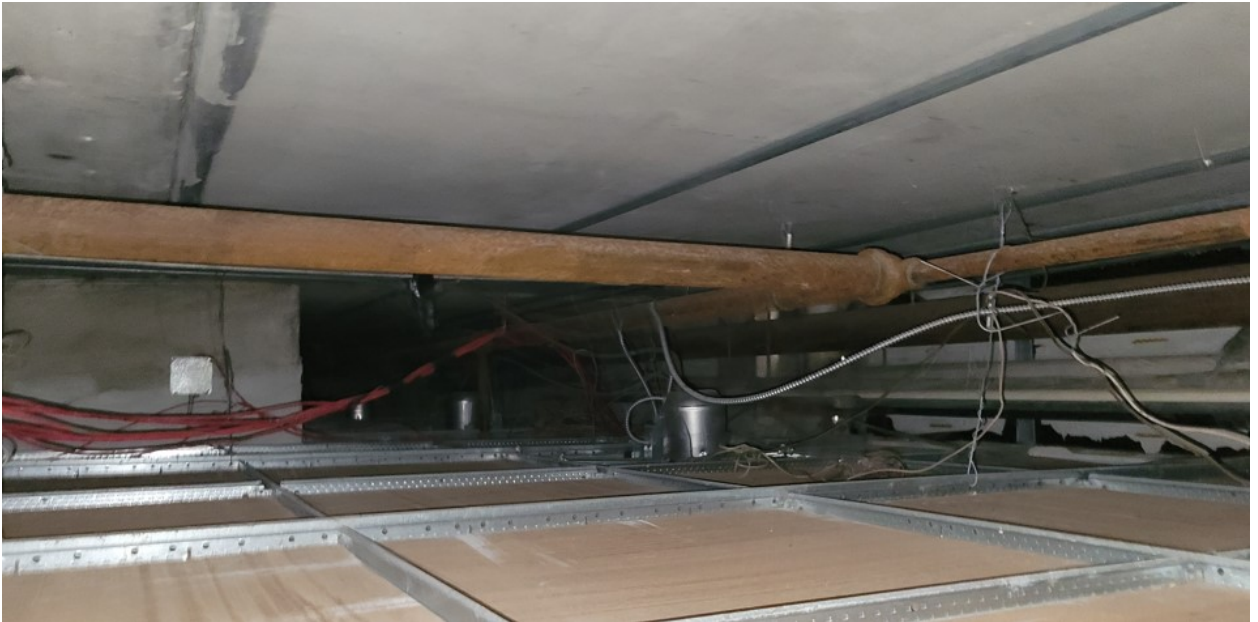
It is recommended that the visual inspector access above common area drop ceilings (like in a lobby) to see structure, plumbing, wiring, etc.

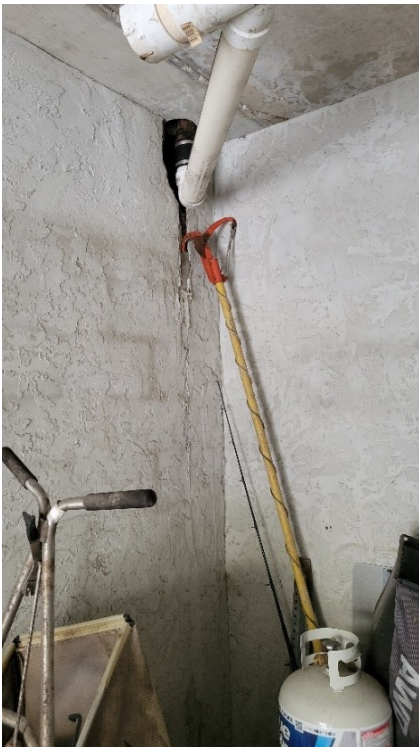
Load bearing block wall as seen through light interior stucco and paint.

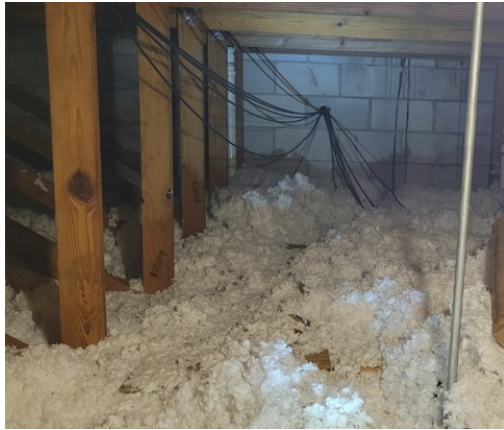
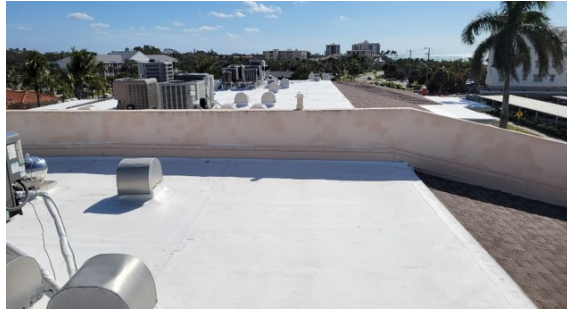
Block fire wall.

Construction Type: ISO 6 refers to fire resistive - noncombustible construction with masonry and concrete walls and slabs. Note condition of firewalls as seen in attic and on roof.

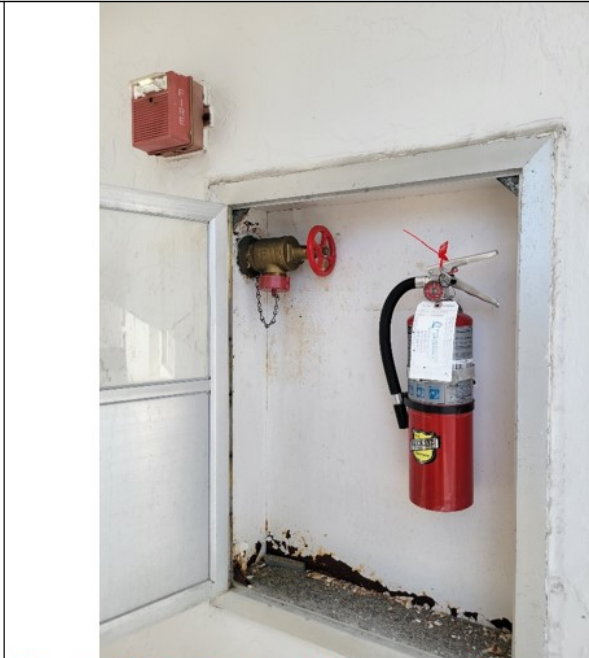
*Typical Fire Extinguisher on walkway.
Inspected regularly. But metal cabinet needs
rust inhibitor and enamel.*

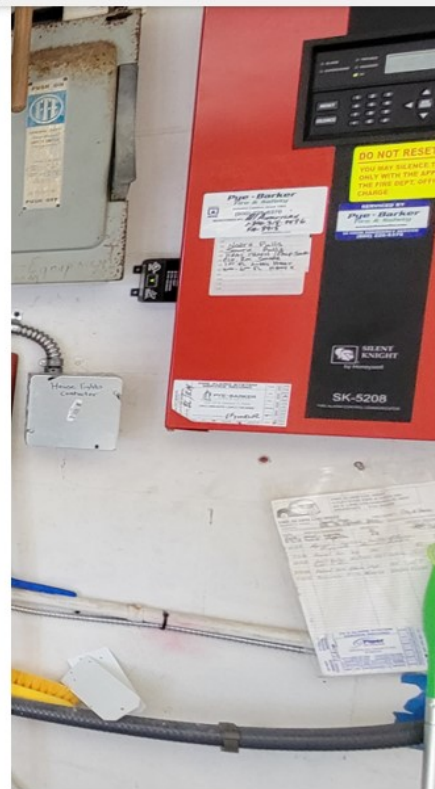
Take sample photos and refer to the Fire Alarm monitoring or sprinkler inspection contracts and documents, etc.

Usually the FACP (Fire Alarm Control Panel), part of a Fire Alarm Control Unit is in a locked first floor room. Be sure to have maintenance personnel unlock this for the visual inspection. Sprinkler heads are inspected separately by authorized inspectors.

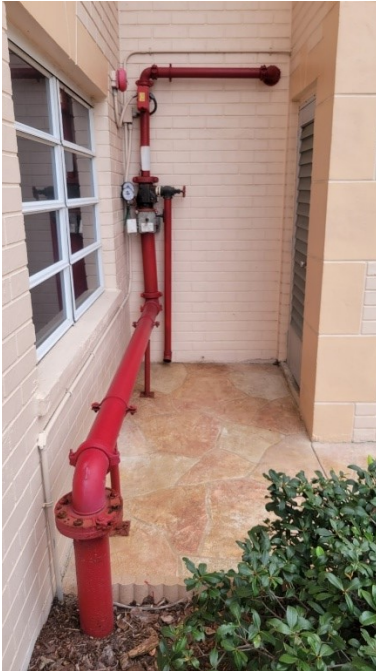
Supply line

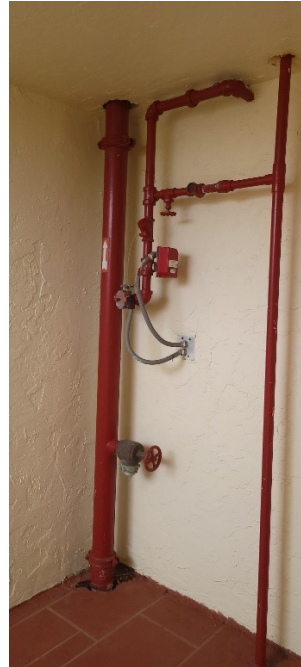
Fire protection water lines painted red

This Sprinkler supply line visual inspection would be under the fire protection category.

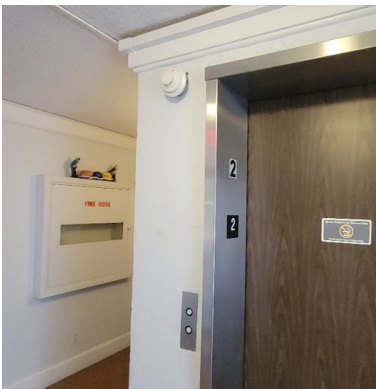
Smoke alarm noted.

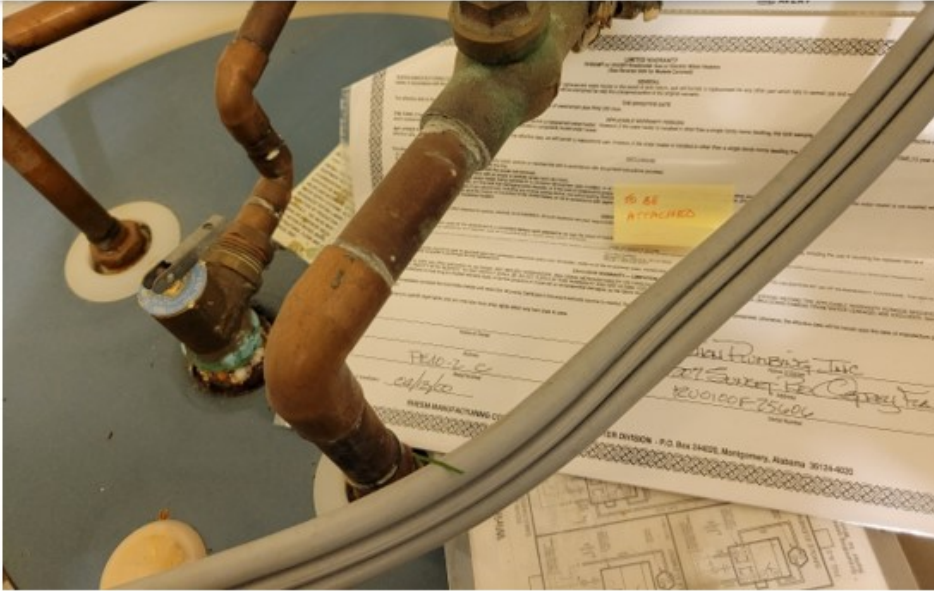
The Clubhouse/lounge hot water heater tank was installed on April 13, 2000. It should be replaced at a cost of \$2000.

Restroom fixtures and floor drains are fine.

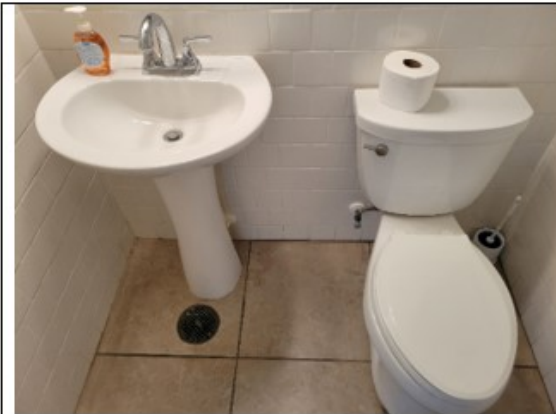
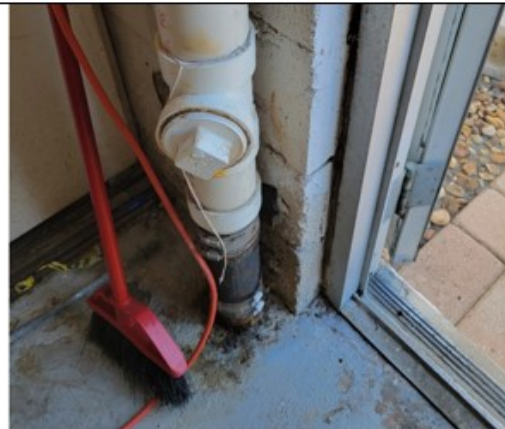
Small leak in FACP room can be fixed under routine maintenance.

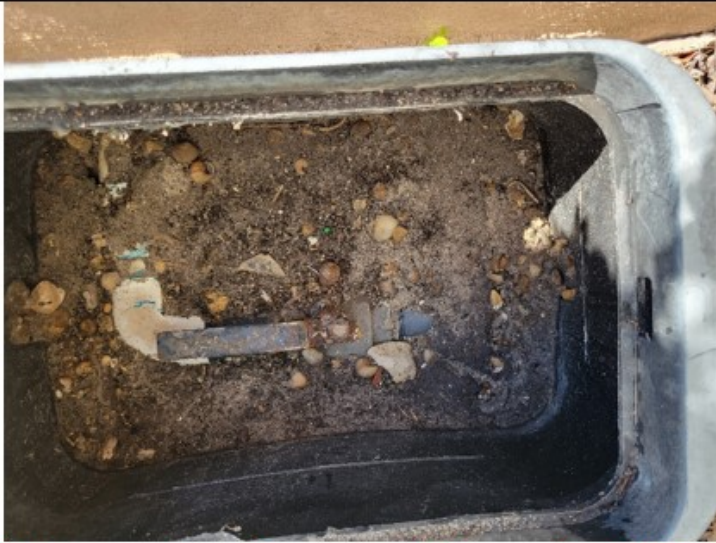
Valve vault north appears frozen. Could be replaced with plastic or stainless steel.

The Buried Valve Box(es) might be considered part of a Condo 3 building as an appurtenance, but unlike a driveway or fence.

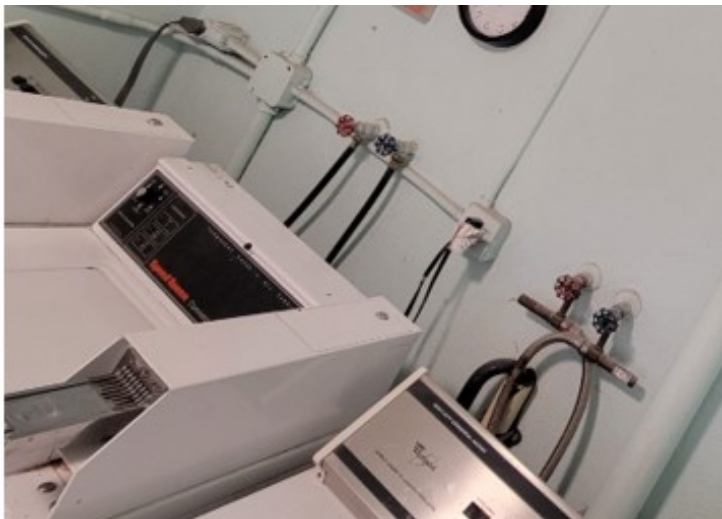
Laundry Rooms are common property under the Association's responsibility if supply or drainpipes show signs of failing. Washers and dryers are probably not "Plumbing". Check for Cast Iron piping that insurance companies dislike.

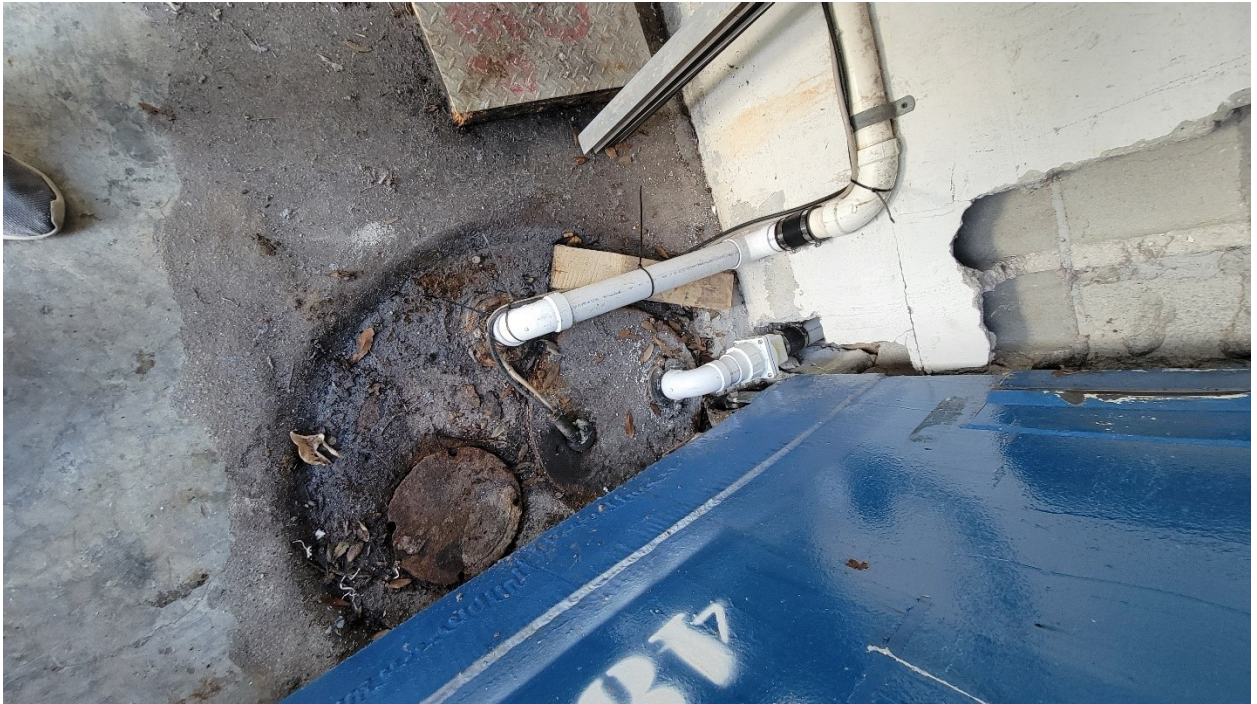
Trash room sump pump would be the Association's responsibility.

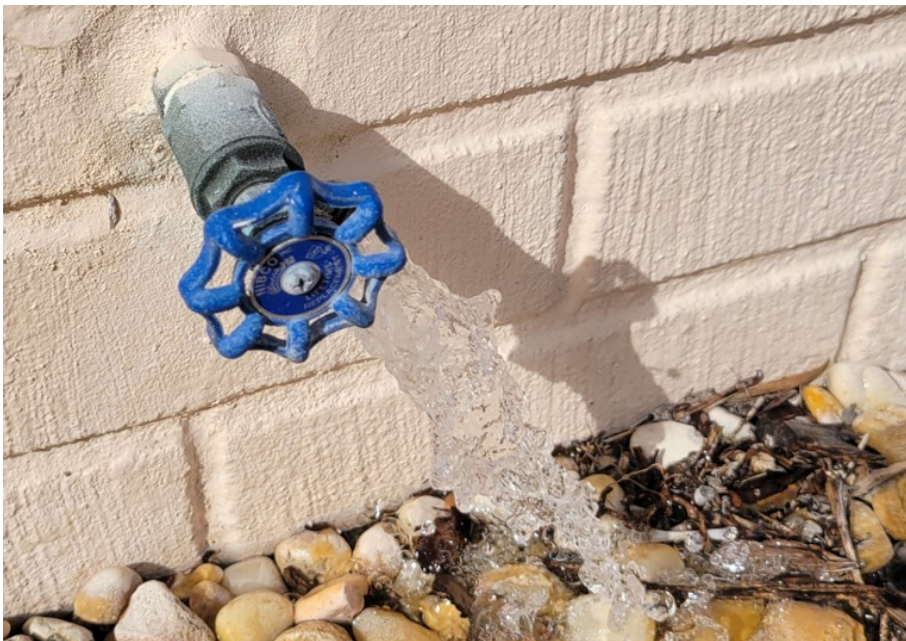
Spigot works if valves are open.

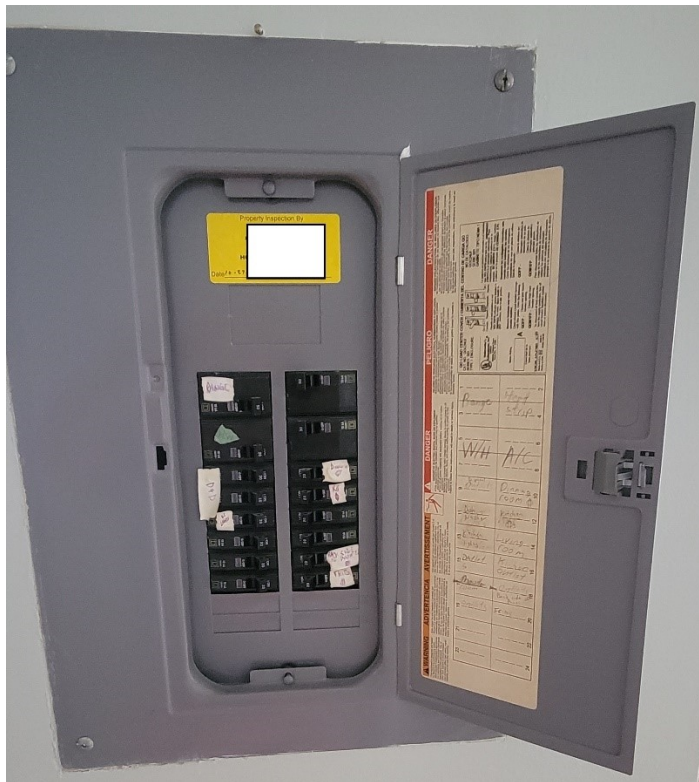
Conforming panel box.

If unsafe Federal Pacific Electrical panels are still in use, they may be called out as part of a Phase 1 Mandatory Milestone inspection under “Unsafe or dangerous conditions.”

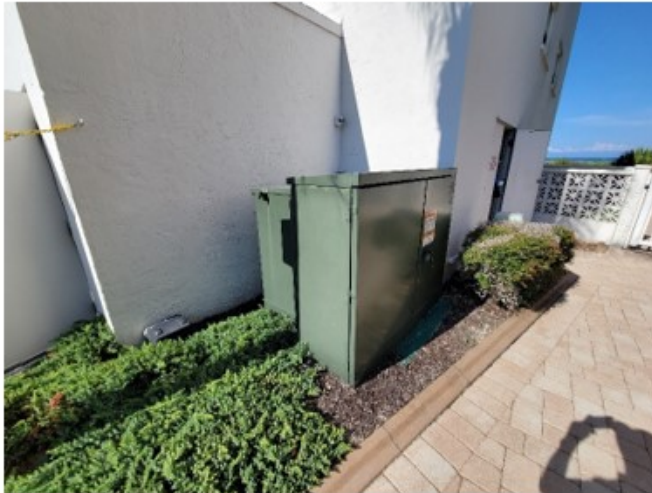
Electric transformer box – responsibility of Florida Light and Power not condo.

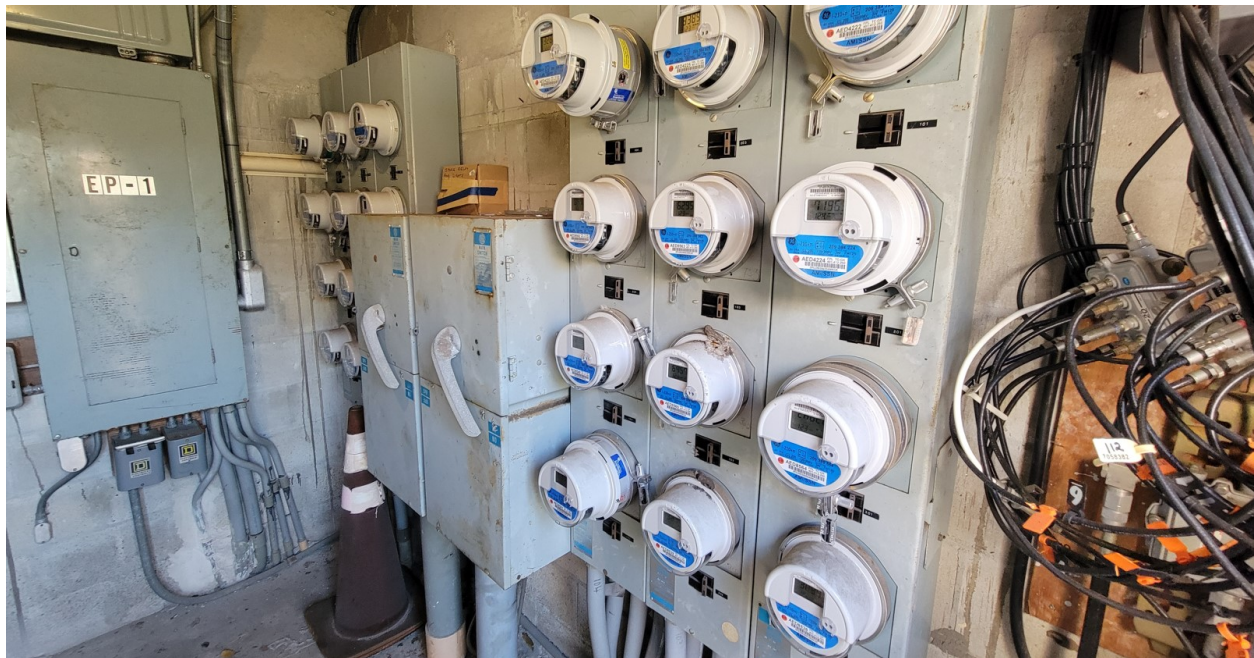
This FL&P responsibility also extends to meter boxes that cannot be touched by other than FL&P authorized personnel.

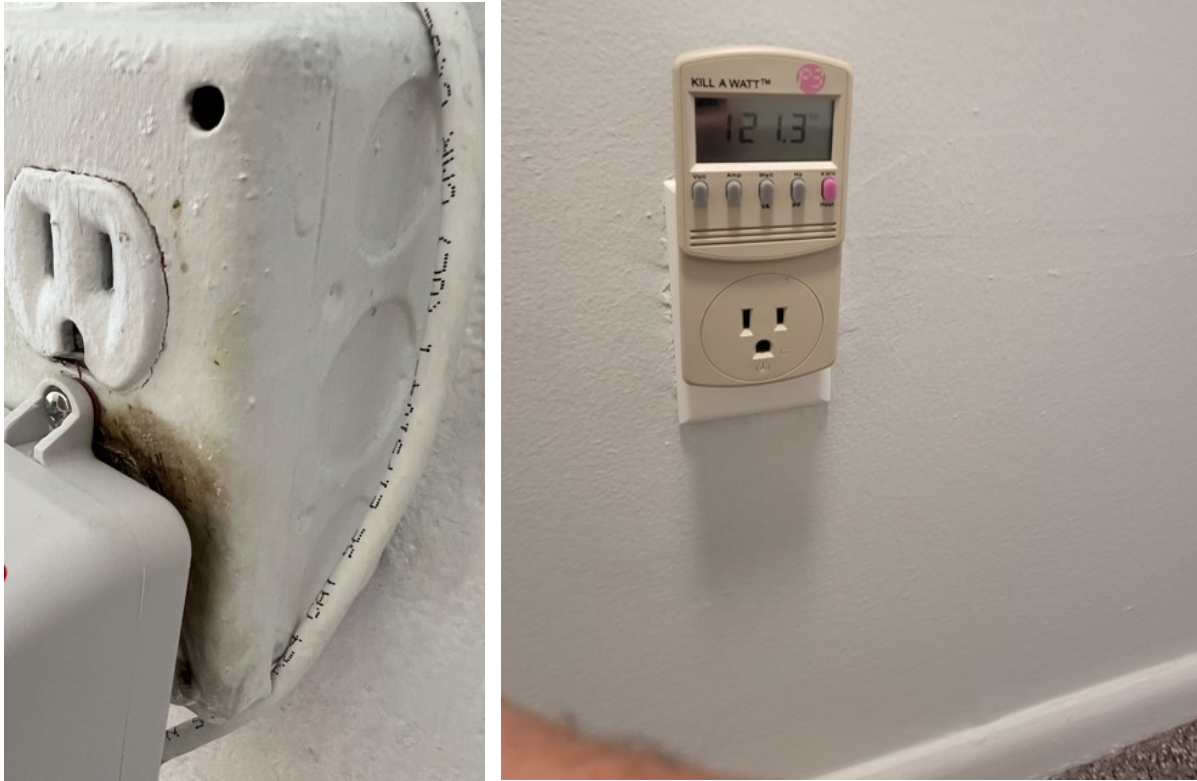
One indication of electrical issues may be the black charred receptacle such as this below that could be noted.

By using a Kill-A-Watt meter as shown on the right, a semi-visual inspection can assure proper voltage such as the 121.3 volts documented for the outlet above.

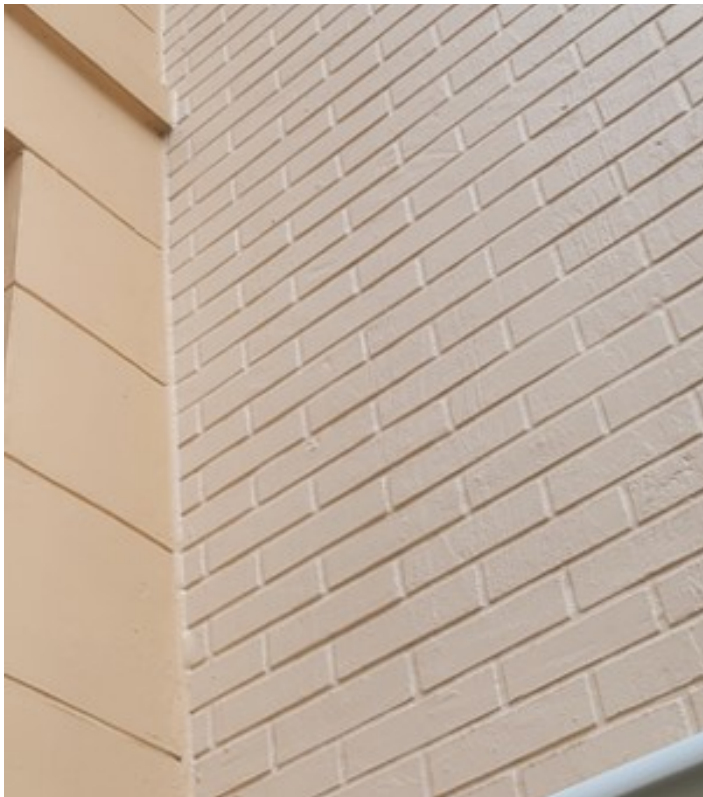
Brickwork paint in good condition.

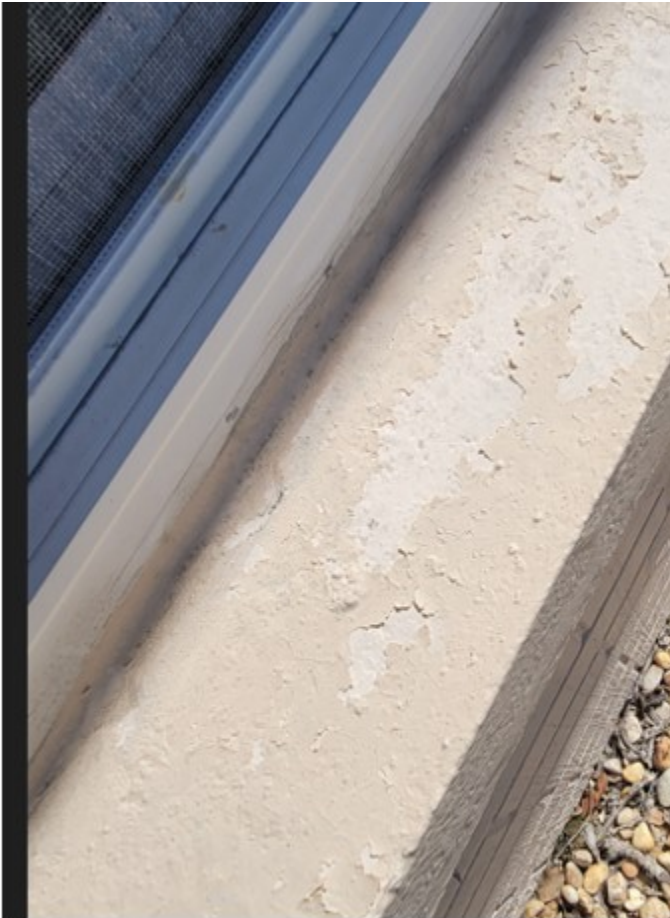
Paint blisters on first floor windowsill.

Standing water on flat surfaces requires more attention but could be handled under the routine maintenance budget.

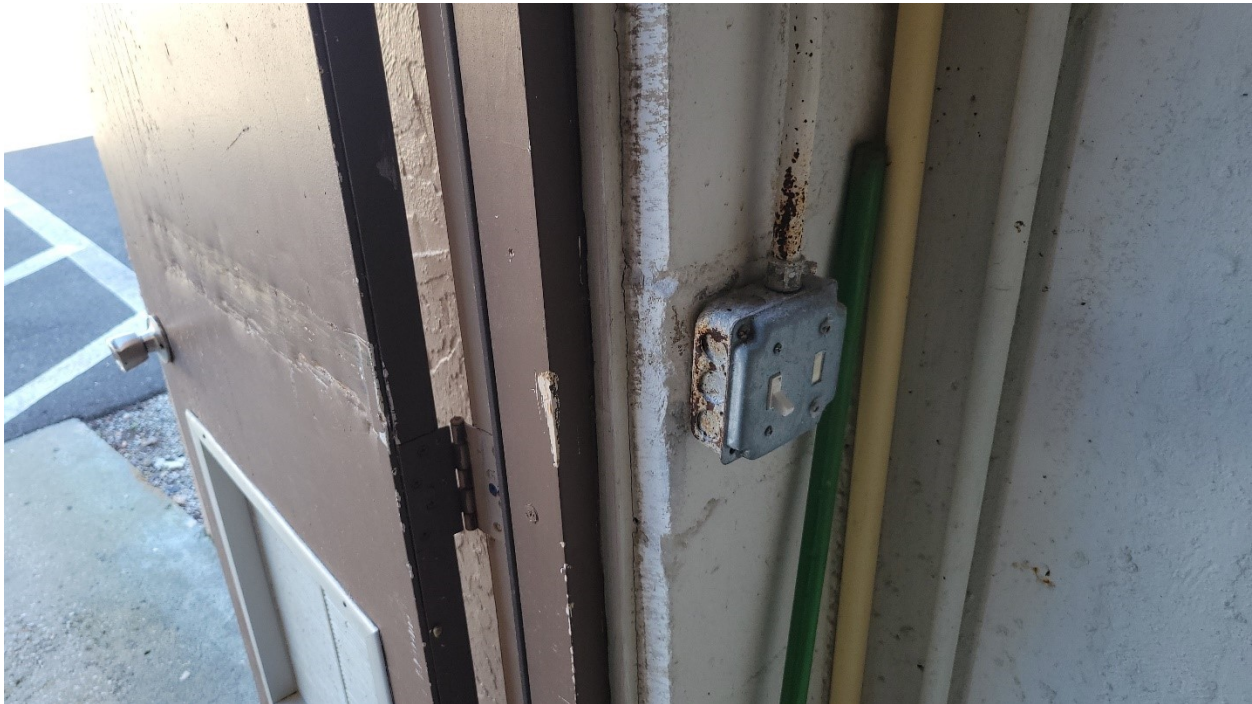
Hearty exterior door

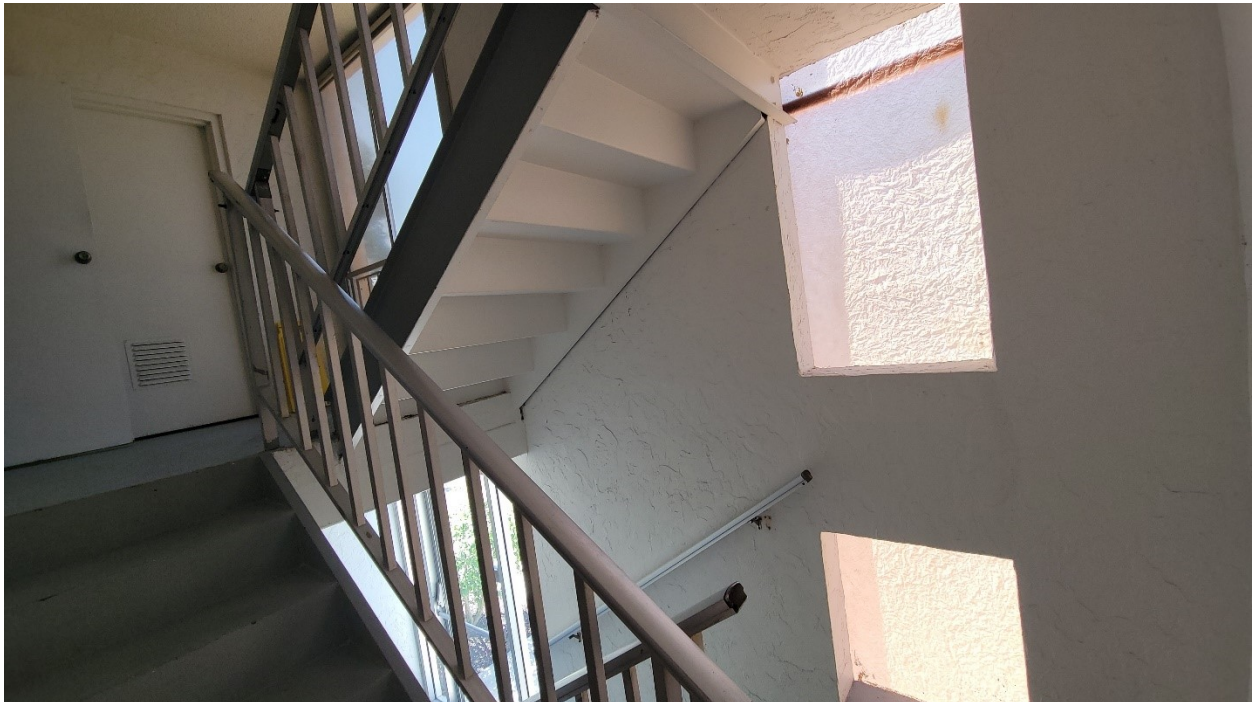
Common area windows.
