A SunCam online continuing education course

Ethics Case Study on Lake Peigneur Disappearance

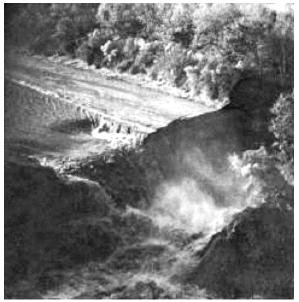
Figure 6: Delcambre Canal flowing backwards with a waterfall after the disaster. Source: https://en.wikipedia.org/wiki/File:Lake_Peigneur_Waterfall.png, Unlicensed

As surrounding water began filling the empty lake, sections of the shoreline collapsed and moved vehicles, trees, Jefferson Island, and even parts of the surrounding landscape. The drop of water level was so great that it temporarily reversed the flow of the nearby Delcambre Canal which now flowed backward into the lake and even created a temporary waterfall as shown in Figure 6.
