Continuing Education Course #219  
Repair Techniques for Metal Plated Wood Trusses  
Part 1: Introduction and Simple Repair Concepts

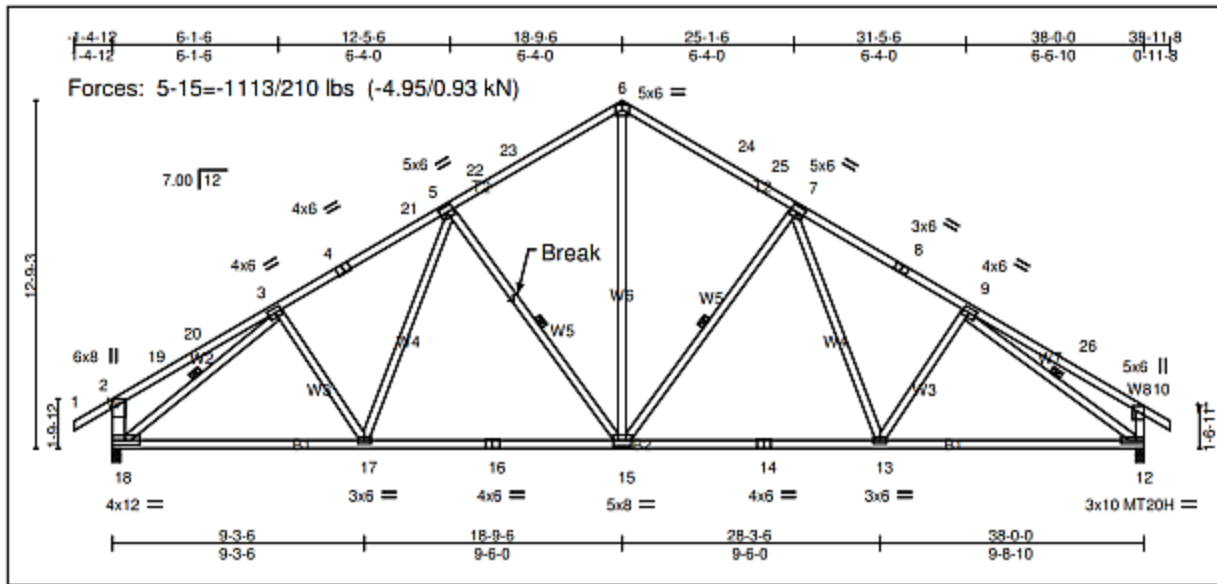
21. The web identified as W5 in the truss shown has a break that is nearly perpendicular to the length of the web and near the middle of web. The web member is a 2x4 (38 x 89 mm) and is made of Southern Yellow Pine (SP) lumber. The maximum compression and tension forces in the member are respectively -1113 lbs (-4.95 kN) and 210 lbs (0.93 kN). It has been determined that 2x4 (38 x 89 mm) Spruce-Pine-Fir (SPF) lumber scabs should be applied with one row of 10d nails 3" o.c. to both sides of the truss member. Using the nail values from Table 3-1 on Page 15 and the information provided in Chapter 4, what would the minimum recommended length be for the scabs?

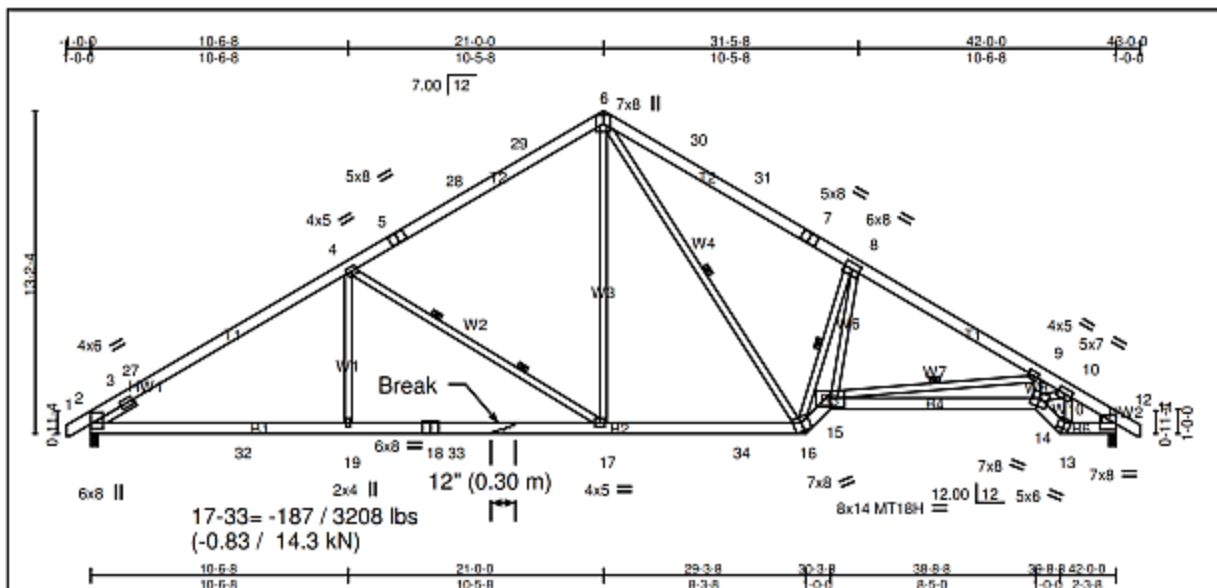
22. The bottom chord member is a 2x6 (38 x 140 mm) made of SP lumber and is broken between joints 17 and 33. The horizontal projection of the break is approximately 12" (0.30 m) in length. The maximum forces are -187 lbs (-0.83 kN) in compression and 3,208 lbs (14.3 kN) in tension. 2x6 (38 x 140 mm) SP scabs are to be applied to both sides of the truss member using 2 rows of 10d nails 3" o.c. Using the nail values from Table 3-1 on Page 15 and the information provided in Chapter 4, what would the minimum recommended length be for the scabs?

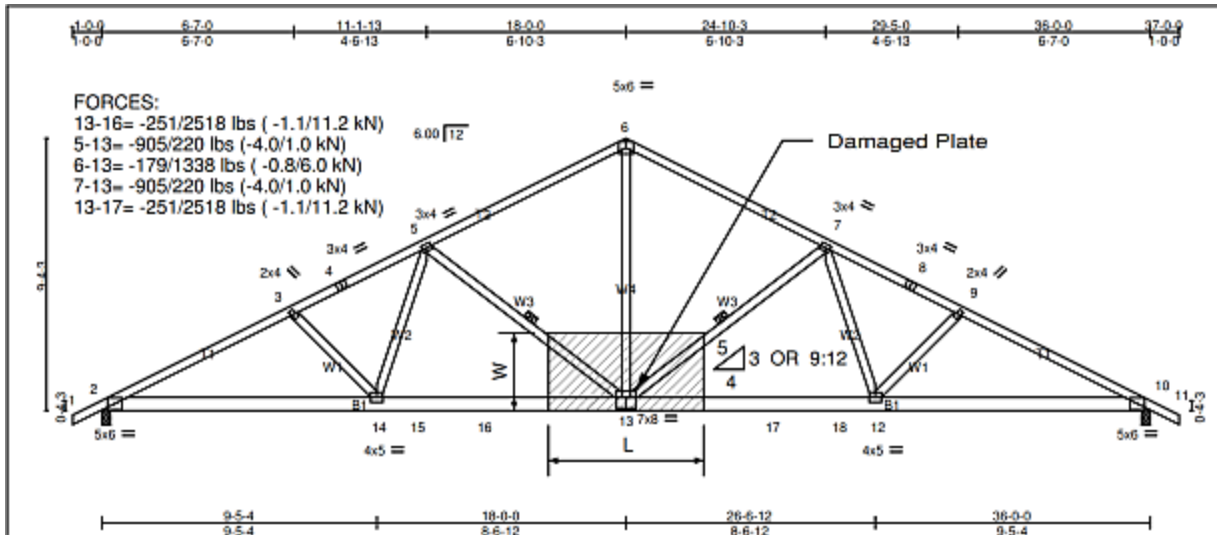
30. The symmetric roof truss shown below has a damaged plate at joint 13 which is also a bottom chord splice joint. The bottom chord of the truss is 2x6 (38 x 140 mm) SP allowing for 2 rows of nails and all webs are 2x4 (38 x 89 mm) SP allowing for only one row of nails for the repair. The W3 webs are at a 9:12 pitch, 7/16" (11 mm) OSB gussets are to be applied to both sides of the truss, the nails are to be spaced at 3" o.c. (76 mm), and the forces for each member are shown in the truss design drawing. Using the appropriate shear capacity for a 10d gun nail from Table 3-1 and the information provided in Chapter 5, what would the minimum recommended L and W dimensions be for this OSB gusset repair?
